**Railway Accident  
Investigation Unit  
of Ireland**

**Annual Report 2013**

Report number: 2013-AR2013

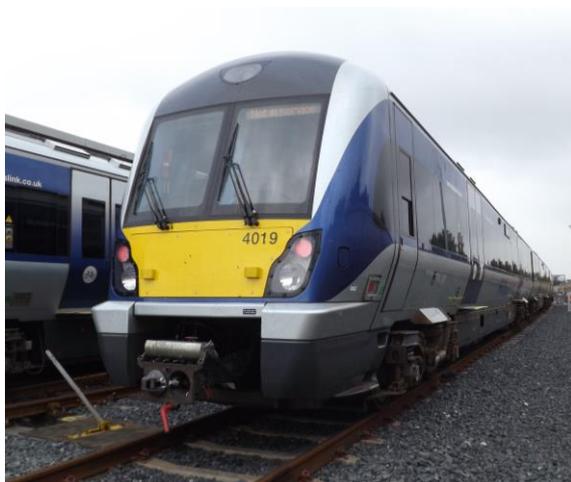
**Figure 3 – Rolling stock used for cross border service on 23<sup>rd</sup> March**

On Friday, 22<sup>nd</sup> March 2013 weather conditions between Dundalk and Newry were such that there was a heavy downfall of snow and localised flooding in the area, causing landslips. This resulted in degraded conditions on the railway line running cross-border between the Republic of Ireland and Northern Ireland. Single Line Working (SLW) with a Pilotman was introduced over the Down Line, between Dundalk and Newry, to keep the rail services operational.

On the morning of Saturday 23<sup>rd</sup> March 2013, the Down Line remained clear for rail traffic and SLW was reintroduced between Newry and Dundalk. During the SLW operation two trains were allowed to travel from Dundalk to Newry in the same SLW section.

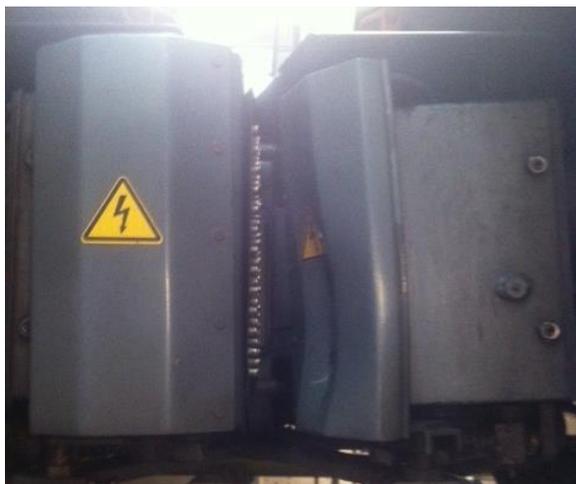
At approximately 08:50 hours (hrs) on Saturday 10<sup>th</sup> August 2013, the DART service from Howth to Greystones was stopped at Salthill & Monkstown DART Station. When the driver had observed that all passengers had alighted and boarded the train, the driver pressed the 'door close' button. The driver noticed that the door interlocking light was illuminated, a light used by drivers for confirmation that the doors are closed. However, as the driver was about to take power, he looked back along the train, and he saw that the exterior amber lights were illuminated, indicating that the doors were open, and in the process of closing, which is contravention with the driver's guidelines and it not a failsafe mechanism which may have resulted to injuries to passengers. On inspection of the train, one of the autocouplers was found to be damaged, and although mechanically coupled the coupler was not electrically coupled.

Figure 4 Damaged to autocoupler

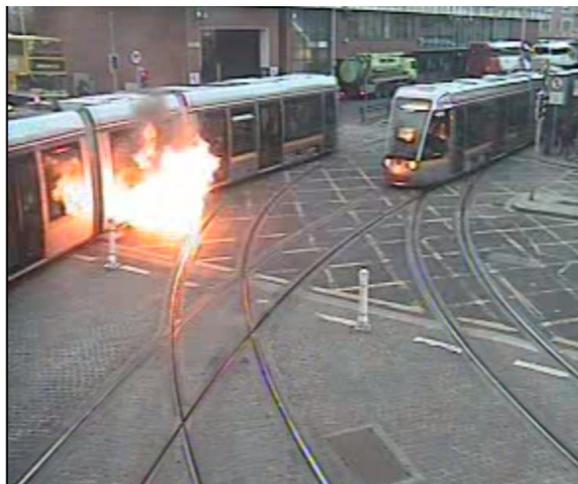
On Thursday, 7<sup>th</sup> November 2013 at approximately 14:30 hours a Luas tram, operating on the Red Line Service, travelling from The Point to Tallaght experienced a failure resulting in significant fire protruding from the right side of the tram for a short period of time at the junction of Amiens Street and Store Street.

Figure 5 Fire on LUAS tram

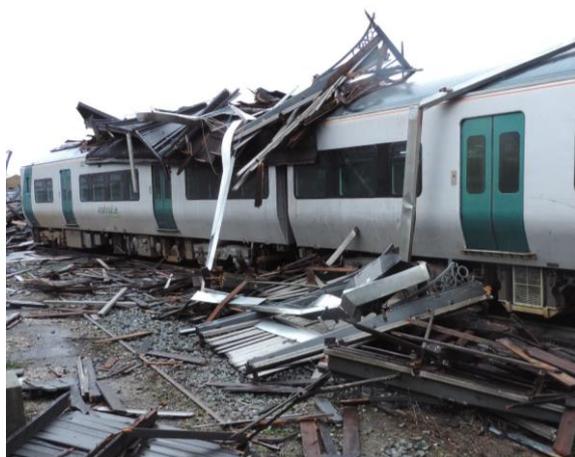
On Thursday 18<sup>th</sup> November 2013 at approximately 15:01 hours the canopy covering platforms one and two at Cork Kent station collapsed. The canopy structure comprised of a timber roof supported by seventeen cast iron columns.

Figure 6 Debris on train at Cork station

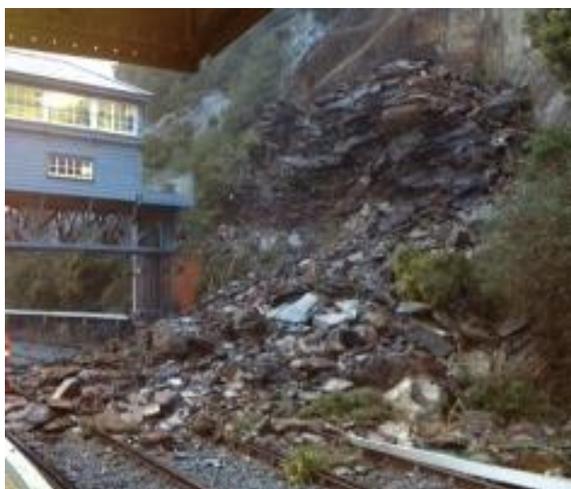
On Tuesday 31<sup>st</sup> December 2013 at approximately 20:10 hours a large amount of rock fell from a IÉ cutting at Waterford Station. The debris occupied two lines at the station and fell close to base of the elevated signalling cabin structure. There were no trains operational at the time of the incident, with no reported injuries to staff.

Figure 7 Landslide obstructing track

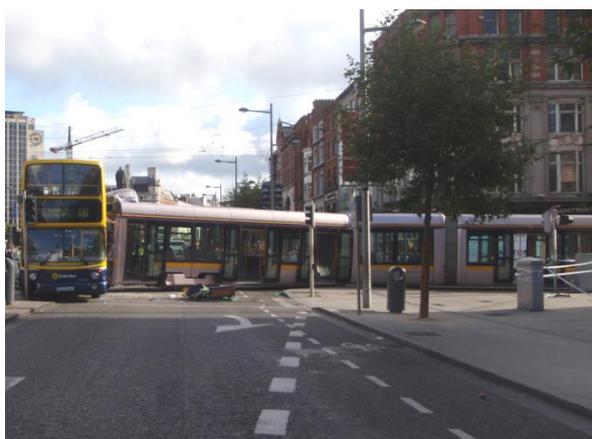
**Figure 8 Tram collision with bus**

On Wednesday the 16<sup>th</sup> of September at approximately 14:55 hours a Luas tram, operating on the Red Line Service, travelling from Tallaght to Dublin Connolly collided with a Dublin Bus at the junction of O'Connell Street and Abbey Street. Twenty-one people, including the driver of the tram, were injured as a result of the collision; three of which sustained serious injuries.

The immediate cause of this collision was as a result of a lapse in concentration by the tram driver. There were no contributory or underlying factors identified in this report and no safety recommendations were made as a result of this accident.

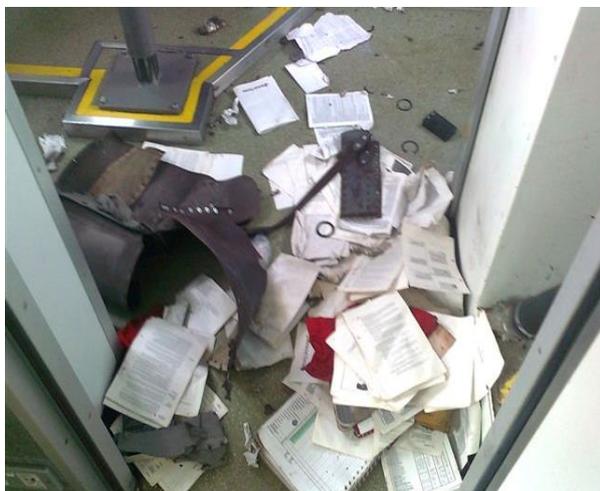
**Figure 9 Damage to driver bag and cabin**

On the 6<sup>th</sup> March 2012 the 08:00 hours DART service from Greystones to Malahide was stationary at Platform 2, Bray Railway Station awaiting a driver change over. The relief driver entered the driving cab at 08:10 hours, intending to drive the DART to Malahide

The driver sustained injuries to his hand and suffered some temporary loss of hearing. The interior of the cab was superficially damaged.

During the investigation it was found that the fog signal supplier had changed the fog signals supplied to Iarnród Éireann to a less robust fog signal. Iarnród Éireann had not been notified of this change and had not noticed the difference in fog signals until after the accident.

Although the immediate cause of the explosion of the fog signals could not be ascertained, the RAIU identified the following causal, contributory and underlying factors.

- The fog signals storage tube, designed by Iarnród Éireann, allowed the fog signals to impact on one another which may have caused them to degrade over time;

The RAIU made three new safety recommendations, related to the occurrence, as follows:

- Iarnród Éireann should ensure that their procurement and quality control processes verify that goods received are of the correct specification as those ordered;
- Iarnród Éireann should introduce appropriate procedures and standards for the safe issue, storage and transportation of fog signals;
- Iarnród Éireann drivers should receive adequate training in the safe handling of fog signals.

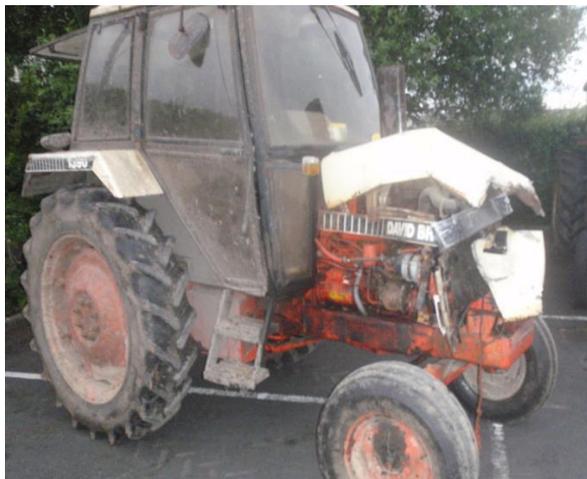
**Figure 10 Damage to tractor**

On the 20<sup>th</sup> June 2012 at 14:50 hours the 14:15 hour's passenger train travelling from Limerick to Galway was involved in a collision with a tractor at level crossing number XE020 which is located close to Cratloe, County Clare on the R462. The driver of the train was initially unaware of the collision and continued to Sixmilebridge Station. The tractor driver although shocked was uninjured and the tractor sustained frontal damage.

The immediate cause of the accident was that that tractor entered the swept path of the train as the train was travelling through the level crossing.

- The viewing distances failed to meet the requirements set out in of Iarnród Éireann's CCE-TMS-380, Technical Standard for the Management of User Worked Level Crossings;
- The Tractor Driver had to position the tractor within the swept path of the train in order to look for trains;
- The Tractor Driver had been using the railway signals to estimate train approaching times, a system which may have been adopted due to the poor viewing distances at the level crossing but contradicts the instructions given in the Safe Use of Level Crossings guidance booklet.

- Having been unable to close the level crossing due to a lack of agreement between the relevant land owners, Iarnród Éireann did not introduce adequate safety measures as a result of the inadequate viewing distances at the level crossing;
- Iarnród Éireann may not have prioritised work at this level crossing as a result of the low risk rankings awarded by Iarnród Éireann's Level Crossing Risk Model.

The RAIU made three new safety recommendations, related to the occurrence, as follows:

- Iarnród Éireann should close, move or alter the level crossing in order to meet the required viewing distances in Iarnród Éireann's technical standard CCE-TMS-380 Technical Standard for the Management of User Worked Level Crossings;
- Iarnród Éireann should review their systems of managing level crossings that fail to meet the viewing distances in Iarnród Éireann technical standard CCE-TMS 380 Technical Standard for the Management of User Worked Level Crossings to ensure that any mitigation measure that is introduced is effective at reducing the risk to level crossing users;
- Iarnród Éireann should audit their Level Crossing Risk Model, to ensure it correctly identifies high risk level crossings; and identifies appropriate risk mitigation measures for individual level crossings.
