# Railway Accident Investigation Unit (Ireland) Annual Report 2009

Railway Accident Investigation Unit

<b>Title</b>	Annual Report (2009)
<b>Document type</b>	Annual Report
<b>Document number</b>	2010-AR2009
<b>Document issue date</b>	30 <sup>th</sup> September 2010

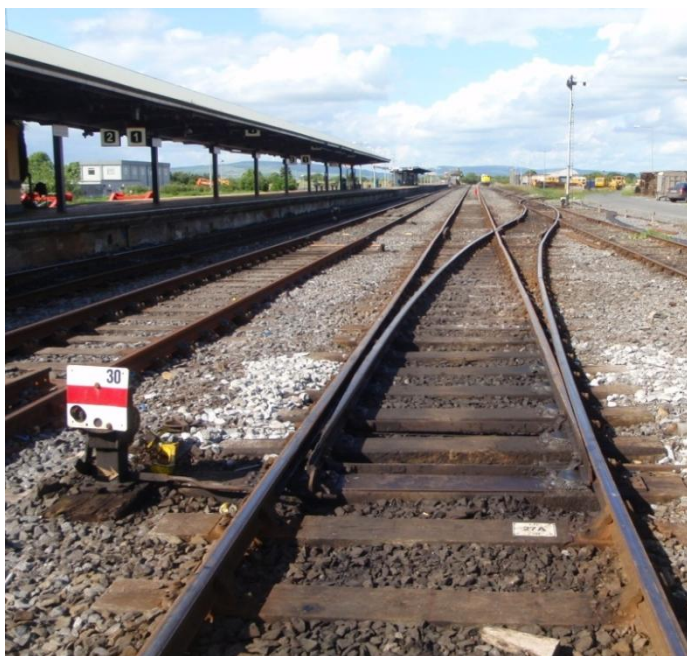
At approximately 04.50 hrs on the 3<sup>rd</sup> of July 2009 an IÉ regulator and tamper were travelling at less than 10 kilometres per hour from the down main line to the sidings at Limerick Junction station when the leading axle derailed. The points were set for the movement and the shunt signal was displaying a proceed aspect at the time of the derailment. The points and shunt signal were operated mechanically from the Limerick Junction South cabin. The down main line was blocked by the derailment.

Photograph 1 – Points at Limerick Junction

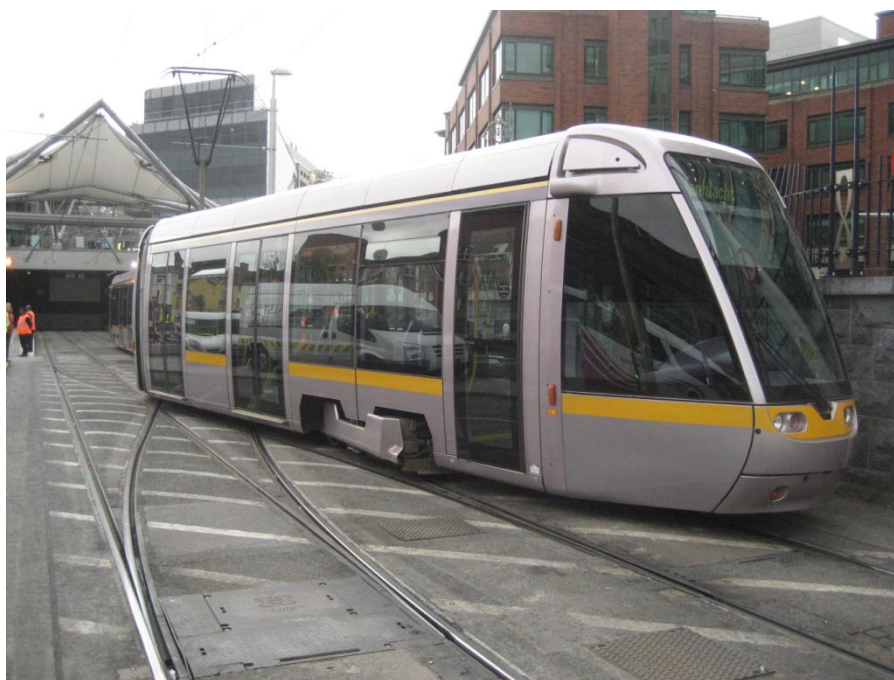
Photograph 2 – Derailed LUAS at Connolly Stop

Whilst travelling outbound the tram driver heard a loud bang and stopped the tram. Off-duty LUAS staff were present at the scene and checked the tram, not noticing any sign of derailment, however they did notice what appeared to be an item of clothing under the tram. The driver then continued a short distance before stopping when seeing the driving cab was swerving towards the wall which ran parallel to the tracks, due to the second wheelset of the tram travelling in the diverging direction.. The driver then derailed the passengers from the rear of the tram. There were no injuries to passengers.

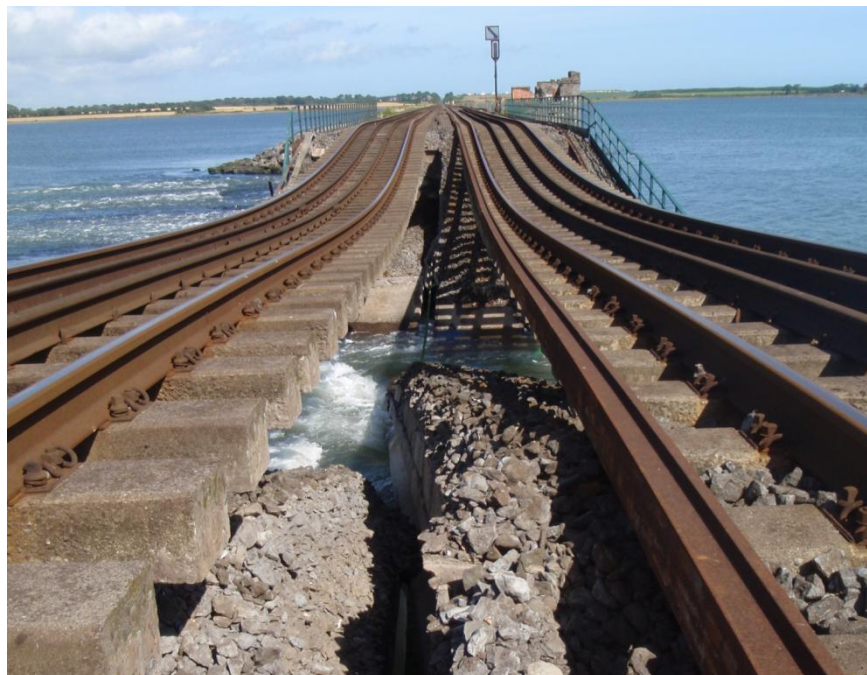
At approximately 18.07 hrs on the 21<sup>st</sup> of August 2009, a train driver, travelling between Donabate and Malahide Stations over the Broadmeadow Estuary in north County Dublin, reported a partial collapse of the Malahide viaduct. The viaduct is a 176 metre structure, with eleven stone masonry piers, which support a concrete deck.

Photograph 3 – Malahide Viaduct Collapse

The train driver immediately called the controlling signalman who isolated the track section on the viaduct and stopped all train services travelling over the viaduct. A rock weir runs between the piers of the viaduct mitigating the effects of tidal flow on the viaduct. When the RAIU arrived at the site, one of the supporting masonry piers of the viaduct had crumbled, causing a twenty metre section of the deck (track, sleepers and ballast) to collapse.

Initial investigations of the viaduct structure, indicate that scour undermining of the pier was a causal factor to the accident.

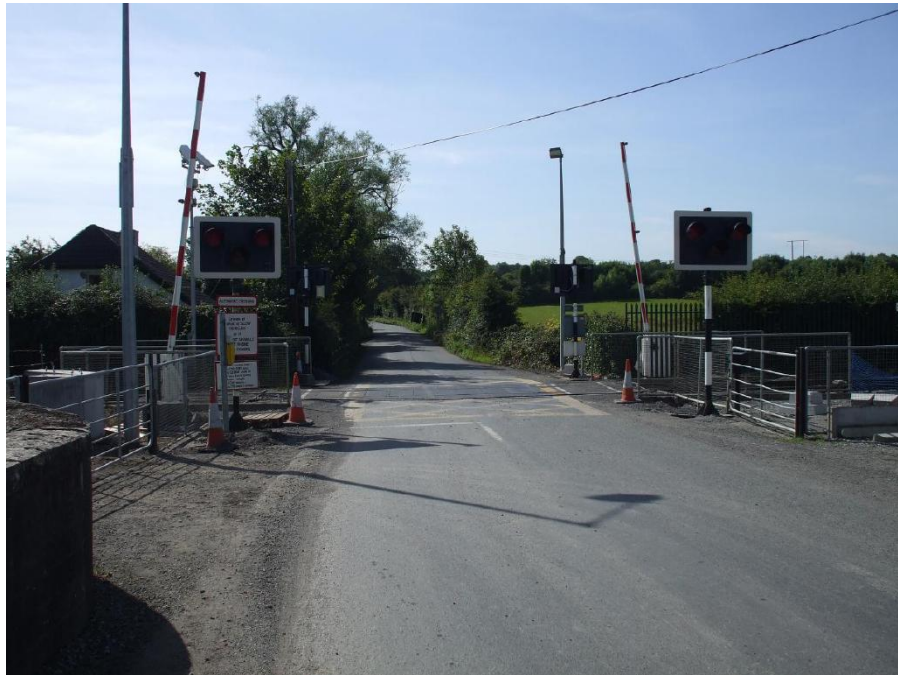
On Wednesday 2<sup>nd</sup> September 2009 the 11.00 hrs passenger service from Sligo to Connolly passed through Ferns Lock Automatic Half Barrier level crossing at 13.33 hrs while the barriers were in an upright position. At the time of the incident the crossing was in a degraded operation under the control of an Emergency Operator. The Emergency Operator was on the line at the time of the incident.

Photograph 4 – Ferns Lock Automatic Half Barrier

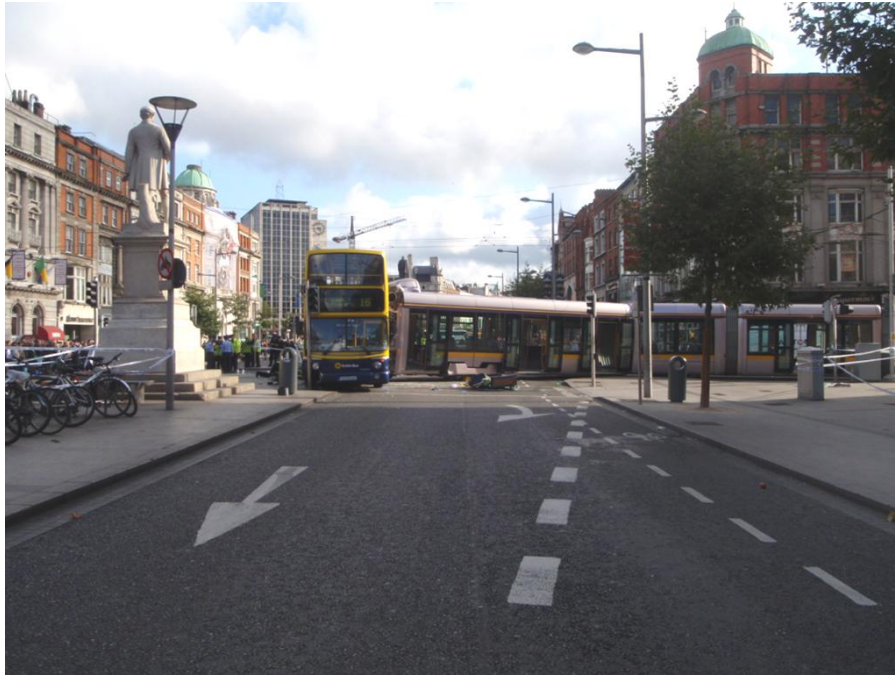
On Thursday the 16<sup>th</sup> September 2009, a LUAS tram collided with a double-decker Dublin Bus at the junction of Abbey Street and O'Connell Street in Dublin City Centre. Twenty-one people were treated at hospital, three of whom were seriously injured.

Photograph 5 – LUAS tram collision with double decker bus

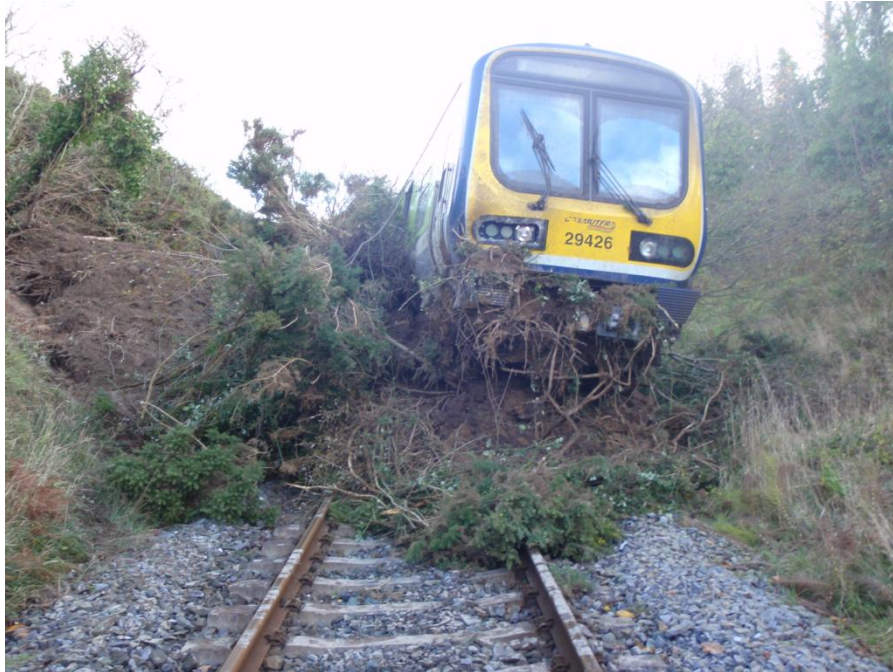
At approximately 06.30 hrs on the 16<sup>th</sup> of November 2009, an empty railcar struck a landslide South of Wicklow Station and the first vehicle had derailed all wheels with the railcar coming to rest with the front of the vehicle elevated by approximately one metre above rail level. The unit was an empty coaching stock service. The landslide was of a substantial size and stretched across the base of the cutting. Likely contributory factors include soil saturation of clay subsoil from heavy rain and deposition of large volumes of soil by a third party at the top of the cutting.

Photograph 5 – Wicklow derailment
