# Annual Report 2010

Ireland

Title	Annual Report 2010
Document type	Annual Report
Document number	2011-AR2010
Document issue date	28 <sup>th</sup> July 2011

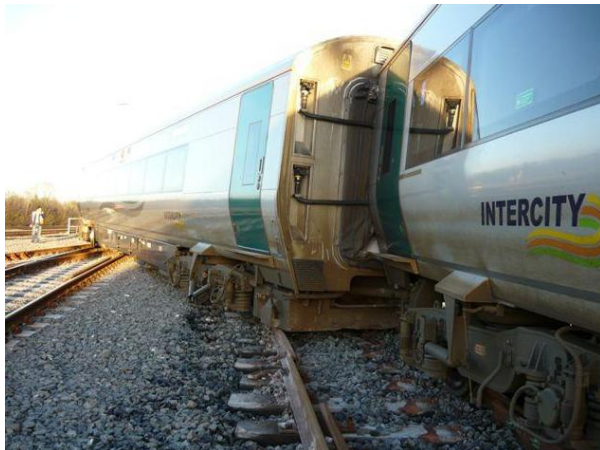
Figure 3 – Derailed train

At approximately 15:25 on the 20<sup>th</sup> January 2010, a Class 22000 six carriage train began to depart Laois Traincare Depot with assistance of a shunter positioned on the ground. A set of points were moved as the train passed over them, leading to the third and fourth carriages taking diverging routes and derailling.

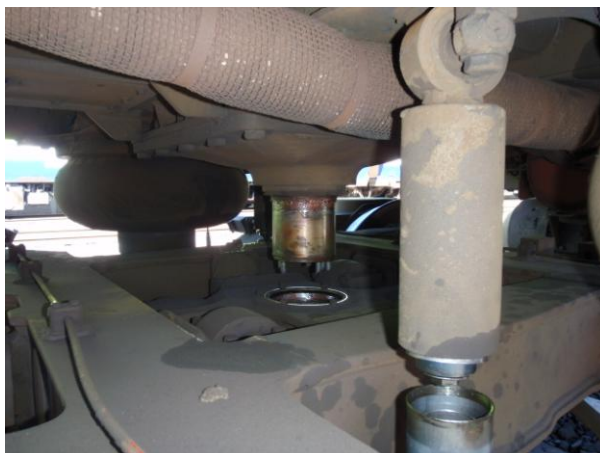
Figure 4 – Carriage underframe equipment

At approximately 22:50 on the 7<sup>th</sup> May 2010, shortly after a Class 29000 Diesel Multiple Unit had returned from passenger service, a member of the train cleaning staff working at Connolly Station observed that carriage 29310 was raised relative to the adjacent carriage, 29410, and reported this to IÉ staff. The secondary suspension was found to have over-inflated and the bogie centre pivot retaining plate bolts had failed with the bogie centre pivot lifted out of the bogie centre.

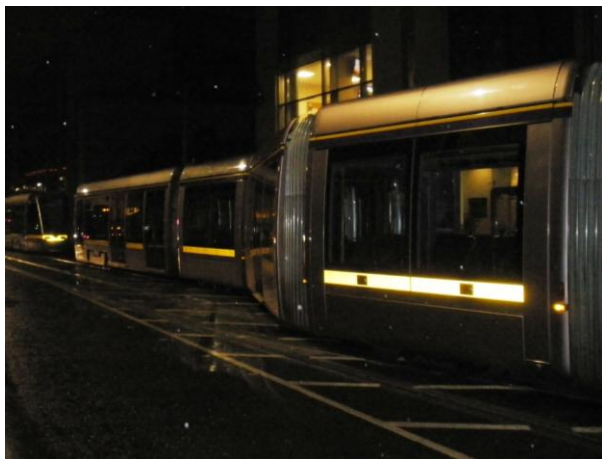
Figure 5 – Derailed tram at Point stop

At approximately 22:10 on the 13<sup>th</sup> May 2010, a tram arriving into The Point Stop on the Luas Red Line entered the Event Platform, which was already occupied by another tram, whilst intending to travel to the Inbound Platform. The tram driver stopped the tram and contacted the Central Control Room to advise the controller of the situation. The tram driver was advised to move to the other driving cab in order to return to the outbound track and allow movement towards an unoccupied platform. As the tram began to move away from the Event Platform it derailed on a set of points.

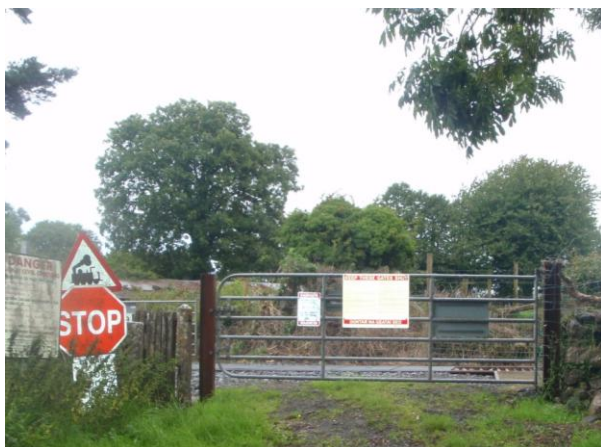
Figure 6 – Level crossing XE039

At approximately 22:10 on the 27<sup>th</sup> June 2010, the 21:45 passenger service from Ennis to Limerick struck and fatally injured a farmer at level crossing XE039, outside the town of Sixmilebridge, County Clare. The farmer was travelling on foot and had been attempting to move a cow across the railway at the time of the accident. XE039 is a manually operated level crossing.

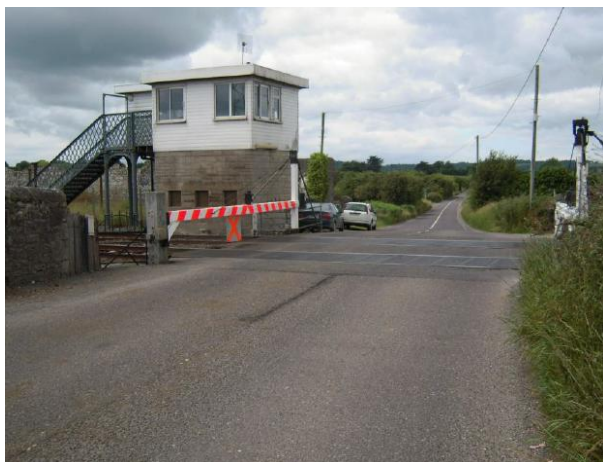
At approximately 10:23 on the 2<sup>nd</sup> July 2010, the 08:00 passenger service from Dublin to Cork passed over level crossing XC219 to the west of Buttevant, County Cork, with the gates closed across the road. Seconds later, a Track Recording Vehicle approached the level crossing from the Cork side as the Level Crossing Keeper was in the process of closing the gates across the railway. The Track Recording Vehicle struck one of the gates destroying it. The level crossing is a type CX crossing, which are normally kept closed across the railway.

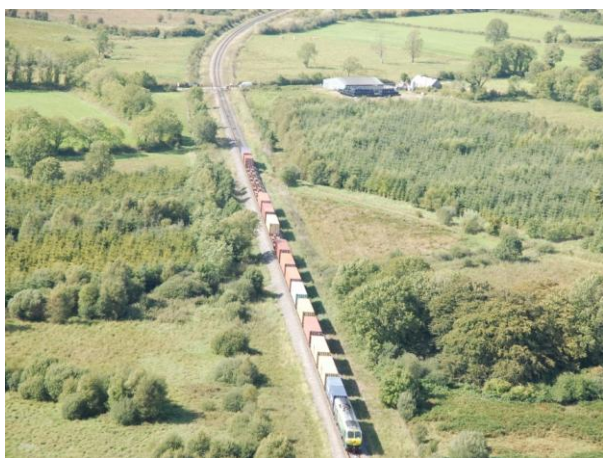
At approximately 11:13 on the 2<sup>nd</sup> September 2010, as the 09:30 freight service from Ballina to Dublin approached manually operated level crossing XM096 in the townland of Ballymacfrane, County Roscommon, the train driver observed a tractor stopped on the railway line at the level crossing. The train struck the tractor, destroying the tractor and fatally injuring the tractor driver.

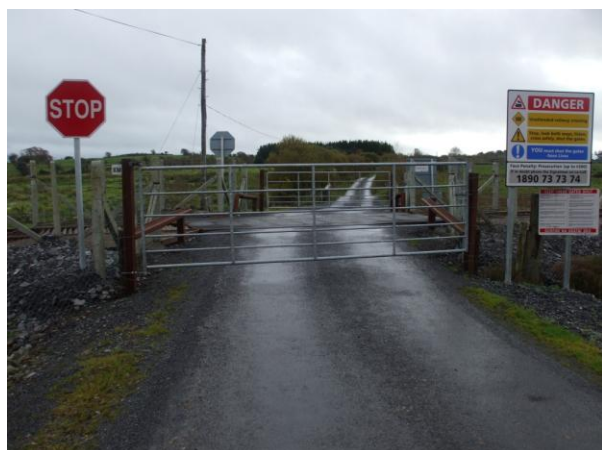
Figure 9 – Level crossing XM250

At approximately 11:50, on the 24<sup>th</sup> October 2010, the 10:15 passenger service from Athlone to Westport approached level crossing XM250 in the townland of Knockaphunta outside Castlebar, County Mayo. The train driver observed a car approaching the level crossing on the road and applied the emergency brake. The train struck the car, resulting in significant damage to the car.

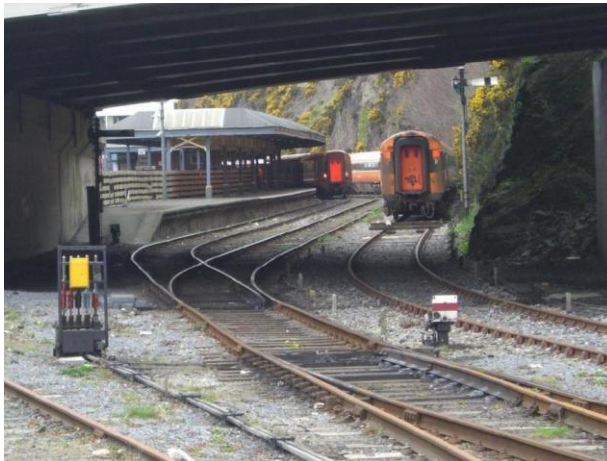
**Figure 10 – Plunkett station**

On the 29<sup>th</sup> March 2009 at 20:12, the 17:35 service from Dublin to Waterford arrived on the Platform Line at Plunkett Station in Waterford. The carriages were uncoupled from the locomotive in order to move the locomotive from one end of the carriages to the other. The locomotive was moved over a set of points onto the Up Main Line. The train driver then tried to change cab to travel in the opposite direction by deselecting the cab he was in but could not as the MU-2-B1 valve that allows this was defective and therefore drove from the rear cab

of the locomotive without a shunter controlling the movement from the leading cab. The locomotive was incorrectly routed back onto the Platform Line towards the carriages by the signalman. When the train driver became aware that the locomotive was mis-routed the train driver applied the brakes, however the locomotive collided with the carriages. The coupling systems on all the carriages were damaged and the four wheels on one bogie of the first carriage struck derailed. A shunter, who was at the rear of the carriages at the time, was struck by the moving carriages. There were no fatalities. The shunter was hospitalised and released the same day. Two other members of staff, who were in the carriages at the time of the collision, suffered minor injuries. There were no passengers on the carriages at the time of the accident.

- The lack of formal requirements for refresher training and assessment of signalmen in cabins where they work as a relief signalman;
- The locomotive was in service with a defective MU-2-B1 valve;
- The lack of train driver instruction in the correct operation of the MU-2-B1 valve.

- IÉ should review their systems for training and competency management of signalmen ensuring working as a relief signalman is taken into account;
- IÉ should ensure procedures are put in place for the operation and maintenance of the MU-2-B1 valves.

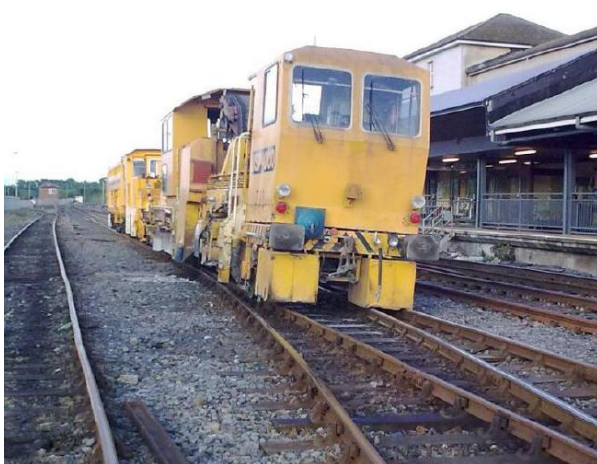
**Figure 11 – Derailed on track machine**

At approximately 04:50 on the 3<sup>rd</sup> July 2009, a train consisting of two coupled On Track Machines, ballast regulator 703 and tamping machine 743, was travelling from a work site on the Dublin side of Limerick Junction Station to the Limerick Junction Sidings. For the final part of the movement unit 703 was leading. The leading left wheel of unit 703 did not follow the route the no. 27A points were set for, it travelled over the top of the left switch rail of the points and along the stock rail before derailing.

- The derailment of the wheels as a result of the wheels taking diverging routes on the track due to the poor interface created by degraded condition of the switch rail and the wheel profile.

- The poor condition of the no. 27A points;
- The flange sharpness of the wheels on the leading wheelset of the On Track Machine.

- IÉ should put in place a formalised process to ensure that life expired points are removed from service, where this is not possible a risk assessment should be carried out and appropriate controls should be implemented to manage the risks identified;
- IÉ should ensure On Track Machine maintenance personnel are trained and competent to examine the wheelsets.

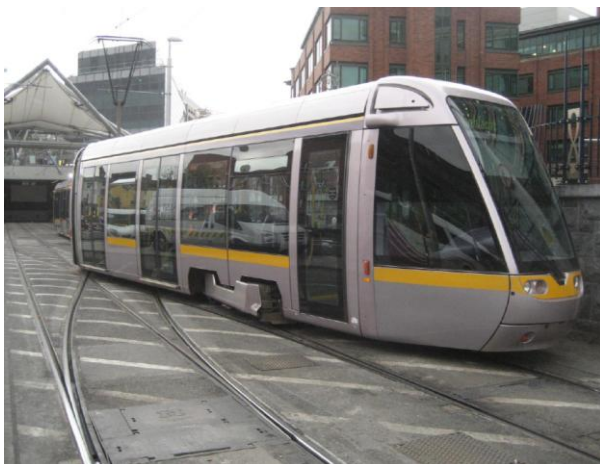
**Figure 12 – Derailed tram at Connolly stop**

On the 16<sup>th</sup> July 2009 at approximately 17:10, the driver of LUAS red line Tram 3006 changed cabs at Connolly Station and proceeded to drive on the normal outbound route towards Tallaght with passengers on board. The tram travelled past the Points Position Indicator for the facing points adjacent to the tram stop and was travelling over the points when the driver heard a loud bang and stopped the tram. This loud bang was as a result of the second wheelset of the first bogie derailing and rerailing. Two off-duty Veolia staff checked the tram and did not notice

any sign of derailment, however, they did notice an item of clothing under the tram. The driver then continued a short distance before stopping again as the driving cab was swerving towards the adjacent wall, which was due to the second wheelset travelling in the diverging direction. The investigation found that the Points Position Indicator for the points was displaying a single dot aspect prior to the driver departing the stop, meaning the facing points were not properly set for the normal outbound route. The points not being set for the route was a result of an item of clothing being stuck in the points. The driver did not check the PPI due to human error omission.

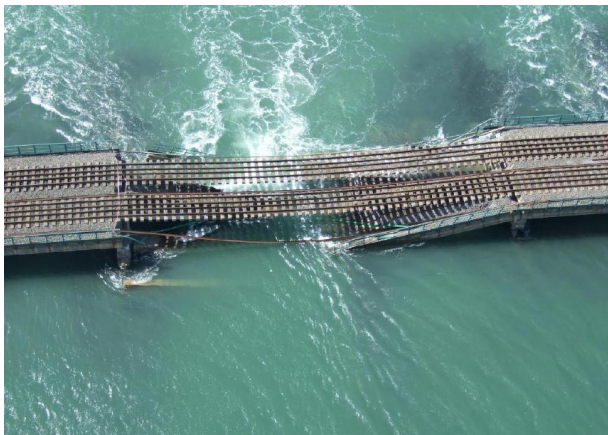
**Figure 13 – Collapse of Malahide Viaduct**

On the 21<sup>st</sup> August 2009, as an IÉ passenger service, travelling from Balbriggan to Pearse, passed over the Malahide Viaduct the driver witnessed a section of the viaduct beginning to collapse into Broadmeadow Estuary. The driver reported this to the controlling signalman who immediately set all relevant signals to danger ensuring no trains travelled over the viaduct. Within minutes of the report of the accident Pier 4 of the Malahide Viaduct had collapsed into the Broadmeadow Estuary. All post accident

- An inspection carried out on the Malahide Viaduct three days before the accident did not identify the scouring defects visible at the time;

- A scour inspection undertaken in 2006 did not identify the Malahide Viaduct as a high-risk structure to the effects of scouring;
- IÉ's likely failure to take any action after an independent inspection carried out on the Malahide Viaduct in 1997 identified that scouring had started at the base of Pier 4 and that the rock armour weir was "too light for the job";
- The historic maintenance regime for the discharge of stones along the Malahide Viaduct appears to have ceased in 1996, resulting in the deterioration of the weir which was protecting the structure against scouring.

- IÉ had not developed a flood/scour management plan at the time of the accident, despite the International Risk Management Services Implementation Review (2001) and the AD Little Review (2006) recommending that this plan be developed. Contributory to IÉ not developing this flood/scour management plan was the fact that the RSC closed this recommendation in 2008;

- There existed an unrealistic requirement for patrol gangers to carry out annual checks for scour, as they do not have access under the structure and in addition, they did not have the required specialist training/ skills to identify defects caused by scouring;

- There was a loss of corporate memory when former IÉ staff left the Division, which resulted in valuable information in the relation to the historic scouring and maintenance not being available to the staff in place at the time of the accident;
- There was a dearth of information in relation to the Malahide Viaduct due to IÉ's failure to properly introduce their information asset management system;
- IÉ's inadequate resourcing of Engineers for structural inspections to be carried out at the Malahide Viaduct;

- IÉ's failure to meet all the requirements of their Structural Inspections Standard, I-STR-6510, in that:
  - Visual inspections were not carried out for all visible elements of structures;
  - Bridge Inspection Cards, for recording findings of inspections, were not completed to standard or approved by the relevant personnel;
  - A formal programme for systematic visual inspections of all elements of a structure, including hidden or submerged elements, despite an independent review recommending that IÉ implement this programme in 2006.

- IÉ should amend the Track Patrolling Standard, I-PWY-1307, to remove the requirement for track patrollers to carry out annual checks for scour;
- IÉ should formalise their 'Civil Engineering and Earthworks Structures: Guidance Notes on Inspections Standard', I-STR-6515, which should include guidance for inspectors on conducting inspections and identifying structural defects. On formalising this document IÉ should re-issue, in the appropriate format, to all relevant personnel;

- IÉ should carry out inspections for all bridges subject to the passage of water for their vulnerability to scour, and where possible identify the bridge foundations. A risk-based management system should then be adopted for the routine examination of these vulnerable structures;

- 
- IÉ should adopt a formal process for conducting structural inspections in the case of a report of a structural defect from a member of the public;
  - IÉ should introduce a training, assessment and competency management system in relation to the training of structural inspectors, which includes a mentoring scheme for engineers to gain the appropriate training and experience required to carry out inspections;

- The RSC should review their process for the closing of recommendations made to IÉ by independent bodies, ensuring that they have the required evidence to close these recommendations. Based on this process the RSC should also confirm that all previously closed recommendations satisfy this new process;

- The RSC, in conjunction with IÉ, should develop an action plan in order to close all outstanding recommendations in the AD Little Review (2006) and the International Risk Management Services Reviews (1998, 2000, 2001). This action plan should include defined timescales for the implementation and closure of all these recommendations.

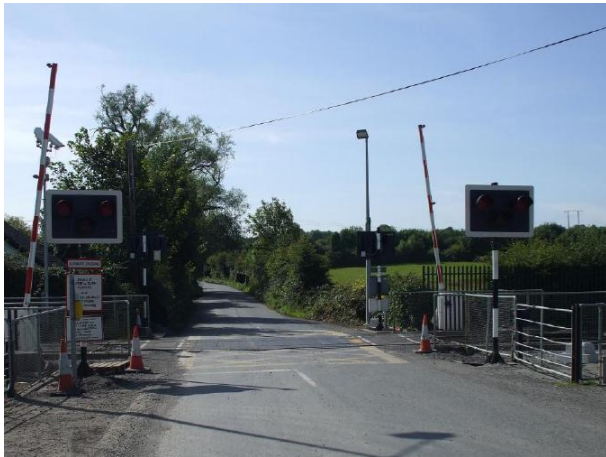
**Figure 14 – Level crossing XG019**

On the 2<sup>nd</sup> September 2009, upgrading work was being undertaken at Automatic Half Barrier level crossing XG019, Fern's Lock, when an IÉ power cable was inadvertently severed. This disabled the external power supply to the level crossing, causing the crossing to fail and the barriers to automatically lower to the failsafe position. An Emergency Operator from Maynooth took control of the crossing while repairs were being undertaken to the cables to ensure that a train can only use the level crossing when the barriers are down, preventing

- The controlling signalman did not follow the requirements for the 'General Instructions to Signalmen' during degraded operations at an Automatic Half Barrier.

- The controlling signalman was unfamiliar with the 'General Instruction to Signalmen' when an Emergency Operator is on duty at an Automatic Half Barrier as he had never experienced an AHB in a degraded mode either in training, operationally or through the current competency management system.

- The competency management system did not ensure that relief signalmen were adequately trained to deal with degraded operations at an Automatic Half Barrier crossing.

- IÉ should review the competencies of all signalmen to ensure that when signalmen are assigned relief duties they have the required training and experience to perform these duties appropriately.

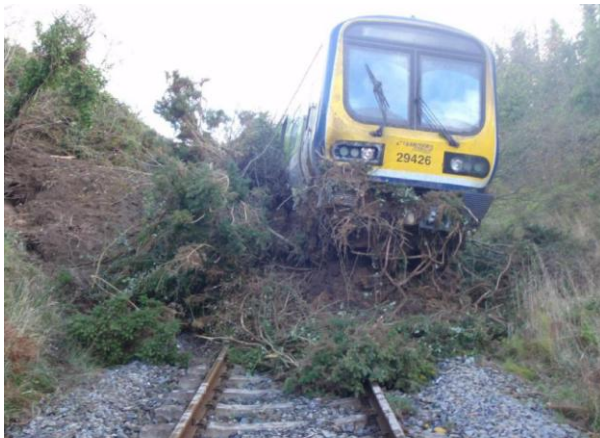
**Figure 15 – Derailed train on landslip**

At approximately 06:20 on the 16<sup>th</sup> November 2009, an empty train travelling from Connolly to Arklow collided with soil obstructing the railway line as a result of a landslip and derailed south of Wicklow Station.

- The patrol ganger was unable to identify defects associated with the early signs of the landslip as the cutting was covered in dense vegetation, resulting in an unrealistic expectation that the patrol ganger could carry out these inspections effectively;

- The patrol ganger was unable to identify the water pouring down the pedestrian overbridge as an early defects associated with the failure of the cutting due to poor drainage as this was not identified as a condition to be looked for in the Track Patrolling Standard, I-PWY-1307, and not included in track patrolling training, again resulting in an unrealistic expectation that the patrol ganger could identify all signs of defects associated with cuttings;

- The only formal monitoring of cuttings during periods of heavy rainfall is through inspections carried out by the patrol ganger, through the Standard for Track Patrolling, I-PWY-1307. Given the fact that the track patroller has not received the appropriate training to identify all defects associated with the early signs of earthworks failure, there is some doubt that only carrying out these inspections is sufficient;

- IÉ's Structural Inspection Standard, I-STR-6510, only requires for visual inspections to be carried out on cuttings greater than 3m, with no requirement for any geotechnical assessment to be carried out. As a result the sand lenses present in the cutting, which was identified as a contributory factor to the accident occurring, were not identified. Therefore, there is some doubt as to the efficacy of only having visual inspections, when a more intrusive inspection would identify the geotechnical properties of the cutting, allowing IÉ to identify structures that may be vulnerable to failure;

- IÉ should review the effectiveness of their standards in relation to conducting earthworks inspections during periods of heavy rainfall, ensuring that earthworks vulnerable to failure are inspected during these periods by appropriately trained patrol gangers or inspectors;

- IÉ should review their Standard for Track Patrolling, I-PWY-1307, for its effectiveness in identifying any third party activities that occur inside and outside the railway boundaries that could affect safety and where any deficiencies are found, IÉ should develop an alternative process for the identification of these third party activities;

- IÉ should review the effectiveness of their Structural Inspections Standard, I-STR-6510, with consideration for the possibility of more thorough inspections being carried out on cuttings to establish the topography and geotechnical properties of cuttings; and from this information identify any cuttings that are vulnerable to failure.
