Railway Accident Investigation Unit

INVESTIGATION REPORT

Tractor struck train at level crossing XE020,
County Clare
20th June 2012

RAIU Report No: R2013 – 002
Published: 17/06/2013

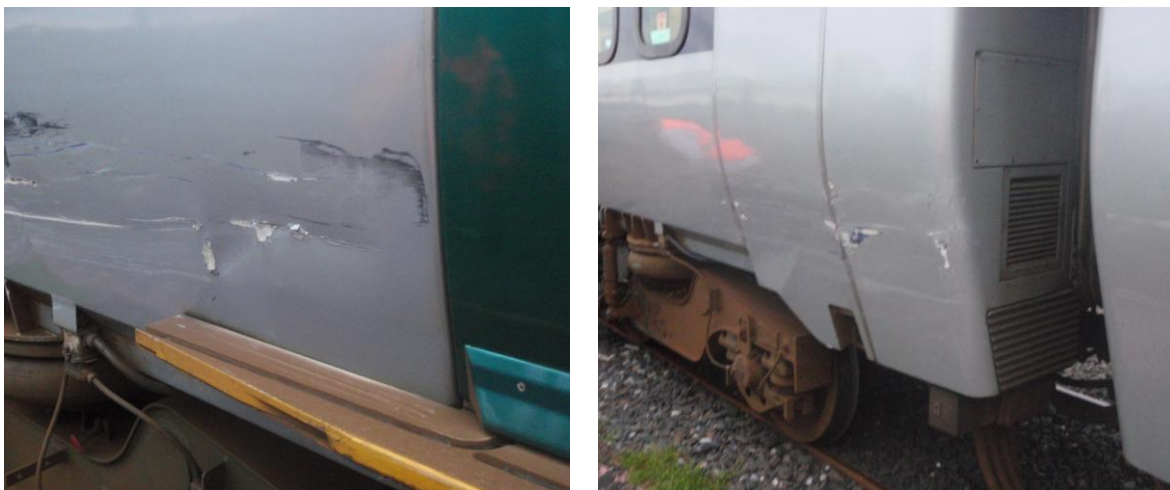
Figure 2 – Damage to train

- 15 There was superficial damage to the right side of the train, see Figure 2 for photographs of the damage.
