Railway Accident Investigation Unit

INVESTIGATION REPORT Tractor struck train at level crossing XE020, County Clare 20th June 2012

RAIU Report No: R2013 – 002
Published: 17/06/2013

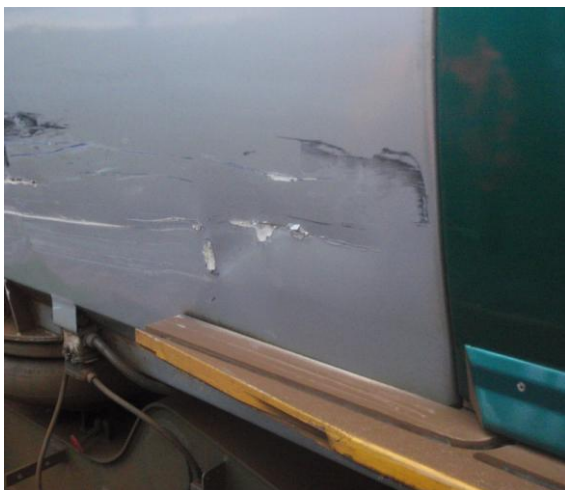
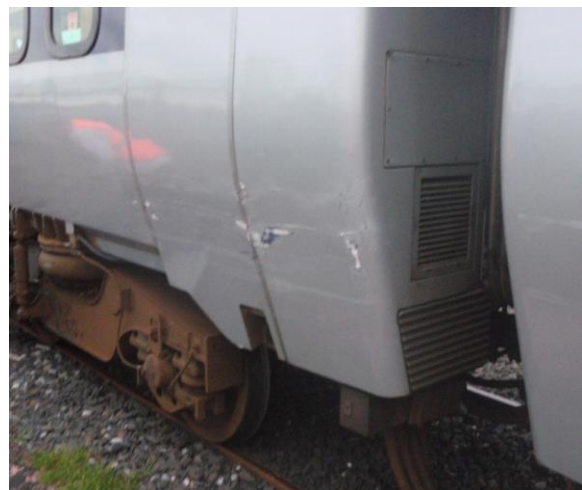
Figure 2 – Damage to train

- 15 There was superficial damage to the right side of the train, see Figure 2 for photographs of the damage.
