Railway Accident Investigation Unit of Ireland

Annual Report 2014

Report number: 2014-AR2014

Published: 30/09/2015

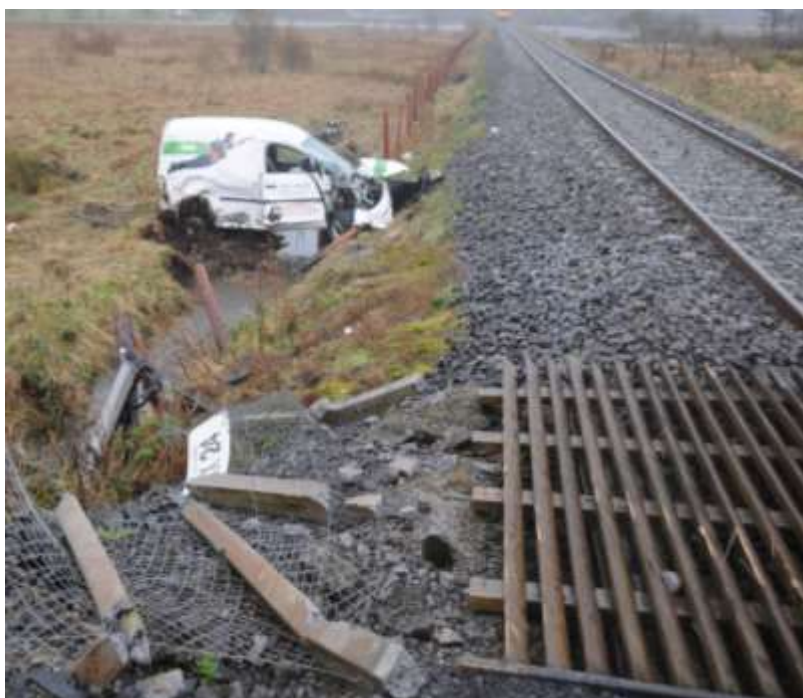
At approximately 09:55 hours (hrs) on Wednesday, 12th February 2014, an An Post van approached Corraun Level Crossing with the level crossing gates open and drove onto the Level Crossing. At the same time, the 09:35 hrs IE passenger service from Ballina to Manulla Junction was travelling through Corraun Level Crossing and struck the van. On impact, the van was thrown clear of the train and into the adjacent drainage ditch before coming to a stop, see Figure 5.

As a result of the accident, the van driver sustained six fractured ribs, fractured nose and eye socket, chipped shinbone and an injury to his left leg. There were no injuries to the six passengers and two members of IÉ staff on board the train at the time of the accident.

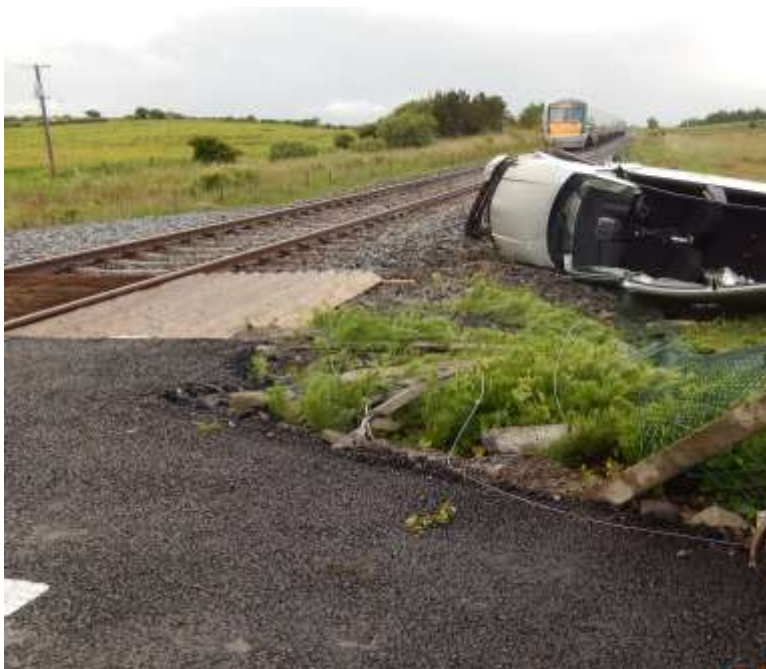
At approximately 18:42 hrs on Sunday 8th June 2014, the 15:35 hrs passenger service from Heuston Station (Dublin) to Westport (Mayo) was approaching Knockaphunta level crossing (asset number XM 250), situated at Knockaphunta, near Castlebar Co. Mayo when a Toyota Auris approached the level crossing from the Castlebar direction. As the train travelled through the level crossing, the car drove onto the level crossing and into the side of the train. The car was thrown clear by the impact and into the adjacent drainage ditch next to the level crossing, see Figure 6.

The single occupant of the car was cut free from the wreckage by the emergency services and conveyed to Mayo General Hospital, Castlebar. The driver of the car was not seriously injured and was released from hospital after treatment.

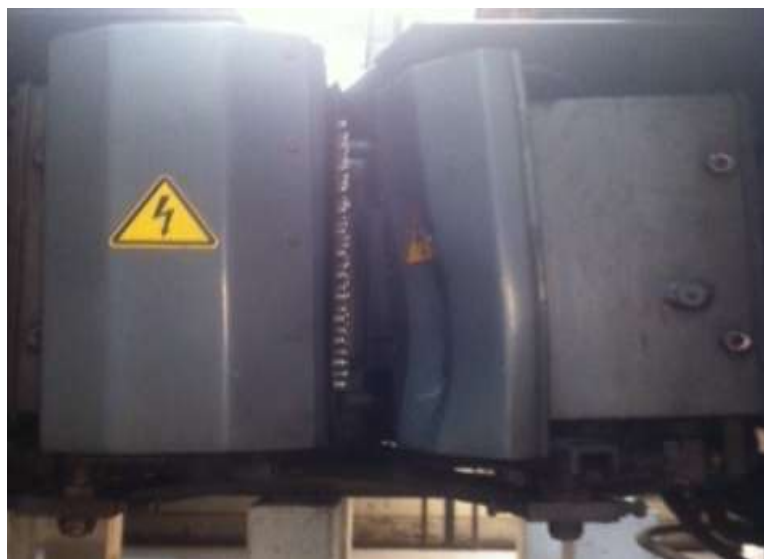
Figure 7 – Damaged autocoupler

On the 10th August 2013 at 08:50 hours the driver of the DART service from Howth to Greystones was stopped at Salthill & Monkstown Station, when he noticed that the blue Door Interlock Light, a light used by drivers for confirmation that the passenger doors are closed, was illuminated while the rear passenger doors of the train were open. After a number of checks, the driver found that the coupler was damaged and the rear units of the train were incorrectly coupled (see Figure 7). He contacted the Chief Mechanical Engineers Department (CME) and the train was taken out of service and sent to Fairview Depot for inspection.

This design weakness was first recorded on the 26th August 2010; in February 2012 after reports of two similar incident, an investigation was carried out by the CME which resulted in a number of recommendations, including a recommendation in relation to a design modification to rectify the design weakness and an interim mitigation measure of a 'Coupler Electrical Head Integrity Test' to be carried out by drivers after coupling to ensure correct coupling. These recommendations were not fully implemented at the time of the incident.

The immediate cause of the blue Door Interlock Light illuminating while the passenger doors were open, causing a wrongside failure, was as a result of the autocouplers on carriages 8102 and 8314 being incorrectly coupled, which resulted in the Door Closed Circuit not passing through the incorrectly coupled carriages, resulting in the driver's display indicating that all doors were closed.

- One of the electrical head doors of carriage 8102 was damaged at some time previous to the coupling on the day of the incident, which stopped the electrical coupler head from moving in either direction, preventing correct coupling;
- A design weakness in the autocoupler, known to the CME prior to the incident, allowed the blue Door Interlock Light to illuminate when passenger doors remained open;
- A train driver did not carry out the full train preparations and therefore did not notice the damage to the electrical coupler head.

- The CME did not fully adhere to their relevant SMS documents (CME-SMS-001 & RU-SMS-007) as they did not adequately address the recommendations from their own internal investigation report in relation to the design weakness of the autocoupler.

- The CME (IÉ RU) should introduce a visual indicator on the driving console to indicate to the driver that coupling has been completed successfully (or a visual or audible indication that coupling has failed);

- DART Operations (IÉ RU) should update the Drivers' Manual to include specific guidance on the requirement for the examination of couplers. The update should also include guidance on associated testing of coupler integrity and guidance on any indications in the driving cab that would assist the driver in detecting any coupler failure;

- The CME (IÉ RU) should review and modify the processes set out in their SMS for closing recommendations to ensure recommendations from investigations are recorded, monitored and closed. When these processes have been established, they should be audited (by a party external to the CME) at predefined intervals to ensure compliance.

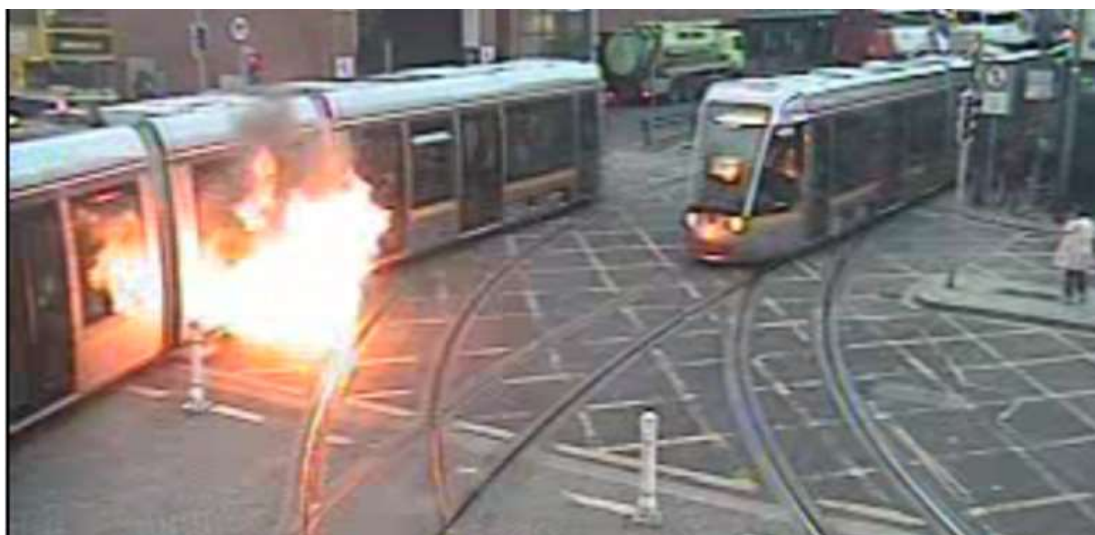
Figure 8 – Fire on LUAS

On the 7th November at 16:30 hours, a flash fire occurred on Luas Tram 3002 as it approached Busaras stop in Dublin City. The tram was operating a Red Line Service. Travelling from The Point to Tallaght (see Figure 8). There were no injuries as result of the fire and the damage to the tram was minor.

The immediate cause of the fire on Tram 3002 was the combination of an arc in traction Cable 1 and a rupture in hydraulic Hose 1 atomising and igniting the fluid producing a flash fire. Contributory Factors associated with the accident are as follows:

- The interaction between Hose 1 and Cable 1 led to both components sustaining damage that ultimately initiated the fire;
- The cable involved in the accident did not contain the protective braid which was present in the original 401 fleet which may have provided additional protection to the conductor;
- A number of the free lengths on the traction cables were measured to be longer than the length detailed in the original design which may have allowed a greater degree of movement in the cables during operation;
- The electrical protection built into the traction system did not isolate the arcing fault, which may have led to the arc being sustained for a longer period of time.

- The requirement to maintain Hose 1 at a 15° offset from the vertical was not prescribed in relevant maintenance instructions;
- The 401 fleet hazard log did not identify the undesirable event of the interaction between the braking hoses and traction cables and the resultant potential events, for example a flash fire;
- Maintenance defect management processes in Alstom had not identified the potential consequences of fretting between the braking hoses and traction cables and there were also no procedures directly related to the repair of traction cables;
- The investigation undertaken in 2008, into the failure of the hydraulic brake circuit, and resulting actions was insufficient to avoid reoccurrence

- Transdev should ensure that Alstom, as the contracted VMC, add the interaction between the braking hoses and traction cables and the potential event of a flash fire to the hazard log of the 401 Type Tram and implement all identified mitigation actions;

- Transdev should ensure that Alstom, as the contracted VMC, review the performance requirements for the isolation protection system in the MIC bogie to ensure that it meets the requirements of the 401 hazard log or revise the 401 hazard log accordingly;

- Transdev should ensure that Alstom, as the contracted VMC, review the defect priority matrix with regards to damage to traction cable insulation and fretting between these components and hydraulic hoses. In addition to this, maintenance procedures should be introduced to specify actions for the repair of traction cables;

- Transdev should ensure that Alstom, as the contracted VMC, review their incident / accident investigation process to ensure that investigations are of sufficient depth and produce clear recommendations.

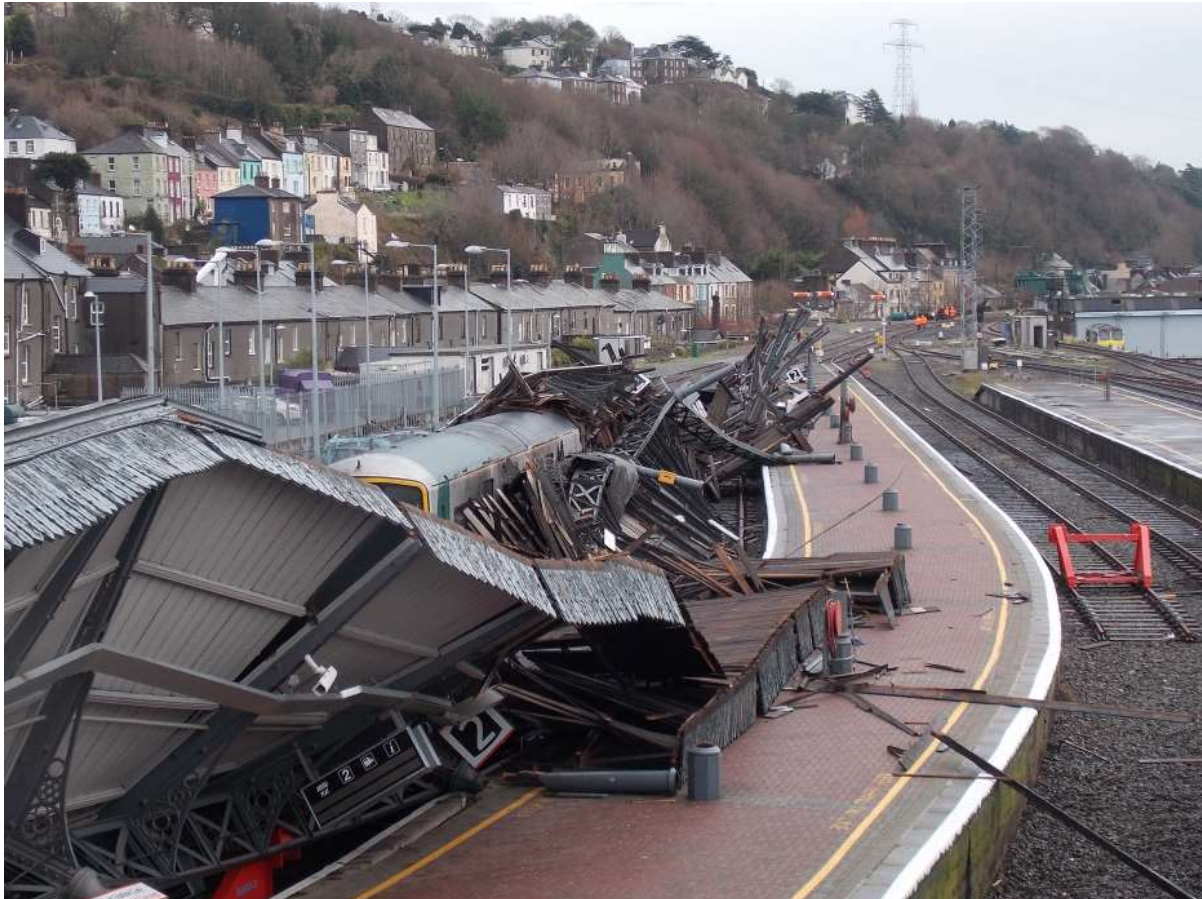
Figure 9 – Canopy collapse

On the 18th December at 15:01 hrs, the canopy over Platforms 1 and 2 at Kent Station, Cork was exposed to unusably high winds and collapsed. The canopy consisted of mainly timber cantilevered roof supported by seventeen cast-iron columns which were braced longitudinally by lattice girders. The design of each column included a decorative feature at the base of the column at which fourteen of the seventeen columns fractured. This feature acted as a stress raiser and therefore an inherent weak point in the design, see Figure 9.

A structural dynamics and wind loading study was undertaken by Fluvio R&D Limited (Fluvio) to determine the collapse mechanism. This work concluded that the structure initially failed at the end furthest away from the station and then the columns fractured sequentially towards the station. This model was supported by witness statements and CCTV footage. The work also calculated that a peak wind speed of between 39 metres per second (m/s) and 50 m/s would be required to initiate the collapse and concluded that speeds of this magnitude would be associated with a rare event.

The immediate cause of the accident was a significant increase in wind speed leading to greater pressure acting on the canopy over Platforms 1 and 2 resulting in the rapid failure of the cast-iron columns.

- The use of cast-iron and the decorative details in the column meant that the design of the structure contained inherent weaknesses;
- Weather conditions in the vicinity of Kent Station included unusually high winds.

- IÉ CCE did not have a weather management protocol in place which included actions to be taken to protect structures at risk from adverse weather conditions.

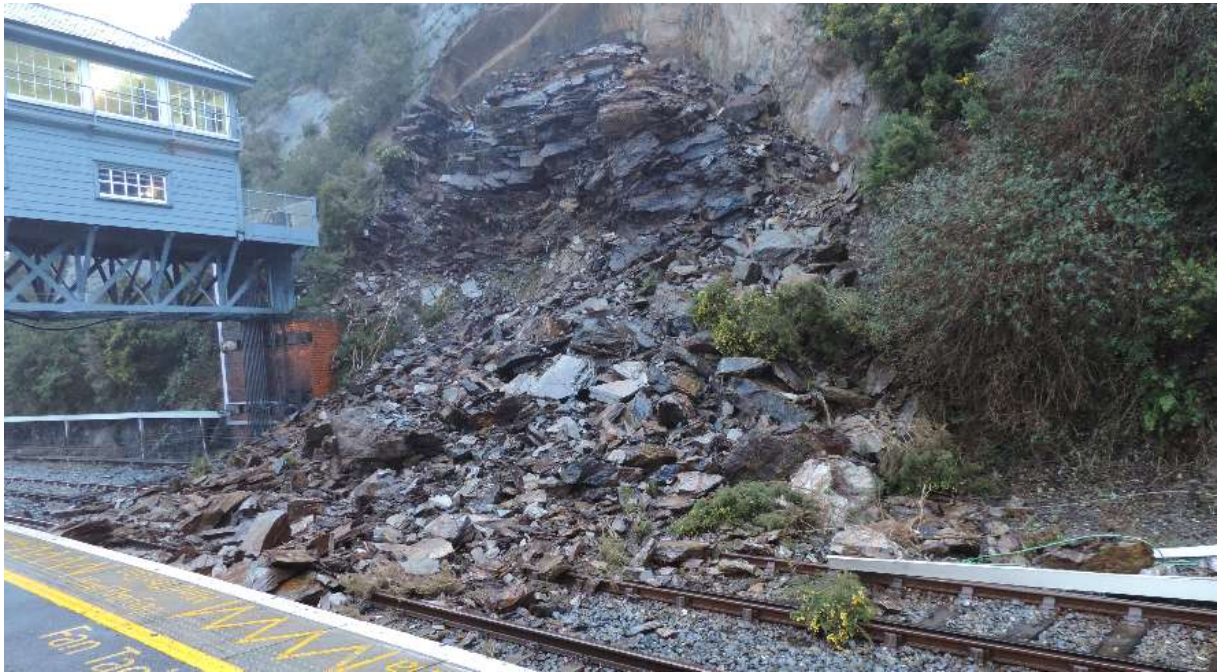
Figure 10 – Rockfall at Waterford Station

On the 31st December at 18:45 hours, the Signaller at Waterford Central Cabin (Signal Cabin) heard a loud rumble from outside. When the Signaller went out onto the steps of the Signal cabin to investigate, he saw a large portion of the *rock face* running adjacent to the station had collapsed onto the two tracks which run under the Signal cabin and through Plunkett Station (Waterford), see Figure 10.

Consultant geologists were engaged to inspect the rock face after the incident concluded that the immediate cause of the rock fall at Plunkett Station was likely due to the toppling of the upper part of the rock mass to the north of the structure, followed by rotation of the toppled rock mass, resulting in rock fall debris flowing onto the ground. Possible contributory factors include the actual formation of the rock (steeply inclined structure with pervasive joints and faults). The final trigger was likely due to the intense rainfall of the preceding weeks.

The RAIU investigation, and the consultant geologist's report, determined that it is unlikely that the potential for rock fall could have been identified during routine IÉ inspections. It is also unlikely that a member of IÉ staff would have been able to identify that the structure would fail, or that there would have been any warning to the imminent failure prior to the day of the incident.

- The condition rating scoring tool, set out in CCE-STR-STD-2100 and CCE-STR-GDN- 2802, does not appear to be an effective system for Structures Inspectors in illustrating the condition of the asset or applying inspection frequencies;
- Inspection cards appear to be consistently failing to meet the requirements of CCE-STRSTD-2100, in that Structures Inspectors are editing the approved template, using incorrect terms and incorrectly labelling the inspection cards; and the Senior Track & Structure Engineer (STSE) is not approving the documents;
