Railway Accident Investigation Unit

INVESTIGATION REPORT DART Wrongside Door Failure, Salthill & Monkstown Station, 10th August 2013

RAIU Report No: R2014 – 003
Report published: 30th July 2014

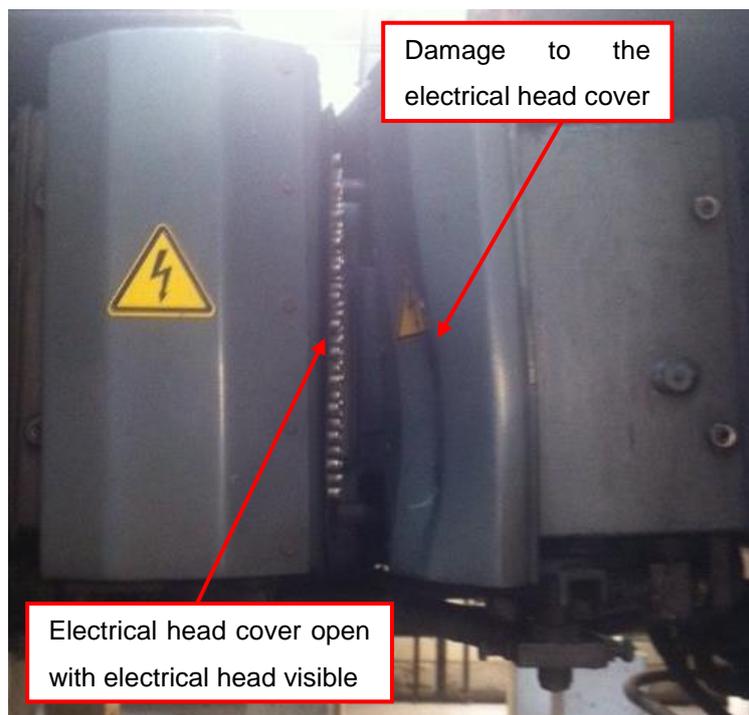
Figure 3 – Damage to coupler electrical head cover

18 Figure 3 shows the damage to the electrical coupler head cover, preventing the door opening. No other coupler mechanisms on the train were found to be damaged.

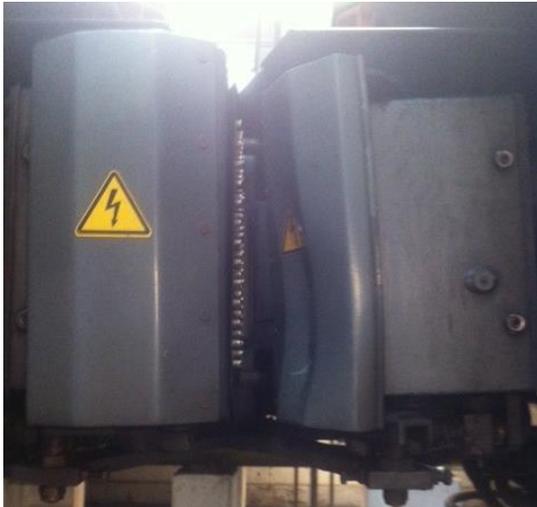
Figure 9 – Damage to electrical head cover

49 The autocoupler was examined when returned to Fairview depot on the 10th August 2013. One of the electrical coupler head covers was damaged (Figure 9) which prevented the electrical coupler head from moving in either direction (Figure 10); this resulted in the opposing electrical pins not connecting, resulting in the autocoupler being incorrectly coupled.

- 76 At some after the last maintenance inspection on the 6th August the electrical coupler head cover was damaged. This damage is likely to have been caused by impacting with the cone of another coupler during a previous coupling activity.

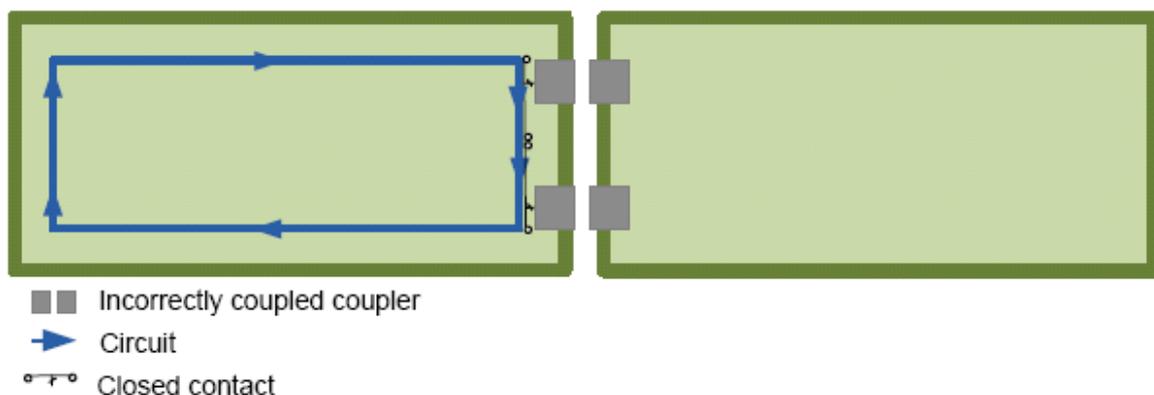
Figure 11 – Electrical coupler incorrectly coupled, with circuit not flowing through the uncoupled carriages

51 The testing by CME also identified that a gap of three millimetres (mm) between the autocouplers can cause unwanted isolation of certain safety critical circuits. Therefore, when the electrical coupler head is not coupled, or incorrectly coupled, the circuit is returned via the normally closed contacts behind the moveable pins, see Figure 11.

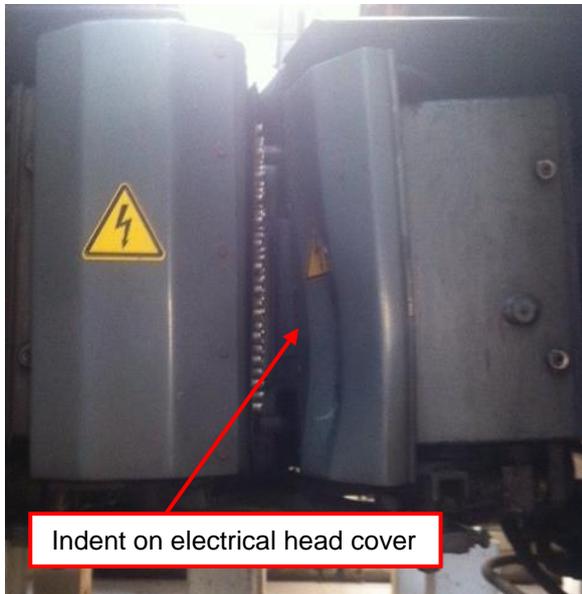
Figure 12 – Indentation on electrical head cover

52 The size, shape and position of the indentation on the electrical head cover (Figure 12) is consistent with the cover coming into contact with the mechanical coupling cone section (see Figure 13) of another autocoupler.

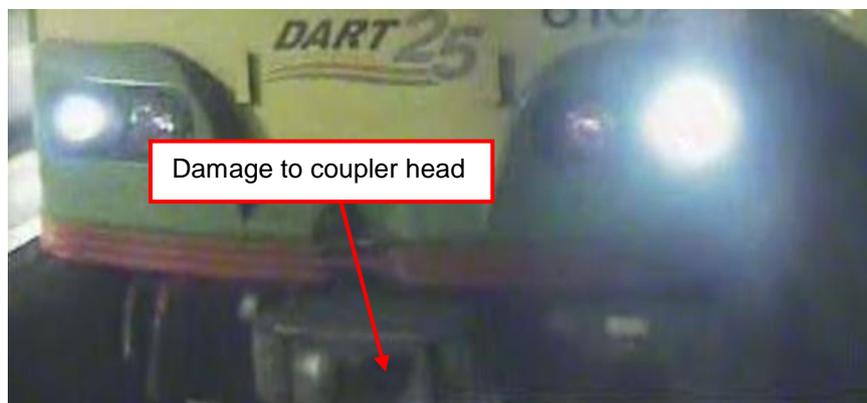
Figure 23 – CCTV still showing damaged and closed autocoupler electrical head door

- 78 In the early morning of the 10th August 2013, Train Driver A was responsible for the coupling of the train carriages of the train for service, including carriages 8102 and 8314, as per Section 8.4 of the Drivers' Manual. Although, there was low ambient light at the time of coupling, the forward facing CCTV from 8314 shows damage to the coupler head door, which prevented the electrical coupler head from moving in either direction, see Figure 23. Train Driver A did not notice this at the time of coupling (as he was not required to check the couplers before or after coupling).

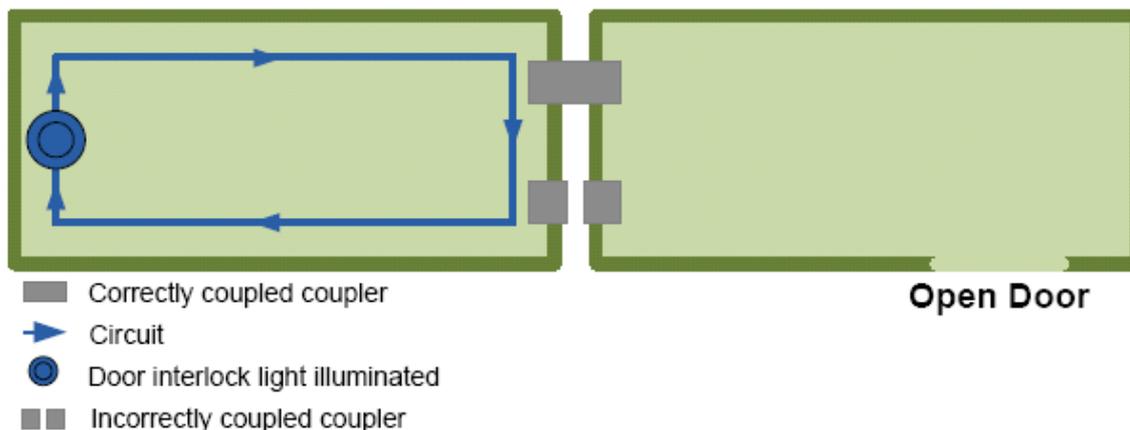
Figure 26 – Incorrectly coupled units, with door open and blue Door Interlock Light illuminated

99 However, on the day of the incident, the electrical coupler heads were not coupled correctly, which resulted in the Door Interlock Circuit not being sent through to all the carriages and the circuit looped through the coupled carriages, resulting in a complete circuit for those carriages, omitting the incorrectly coupled carriages, see Figure 26.
