**Report into the Fatality at Level Crossing XX 032 between
Ballina and Manulla Junction on the 28th of February 2008**

Executive Summary

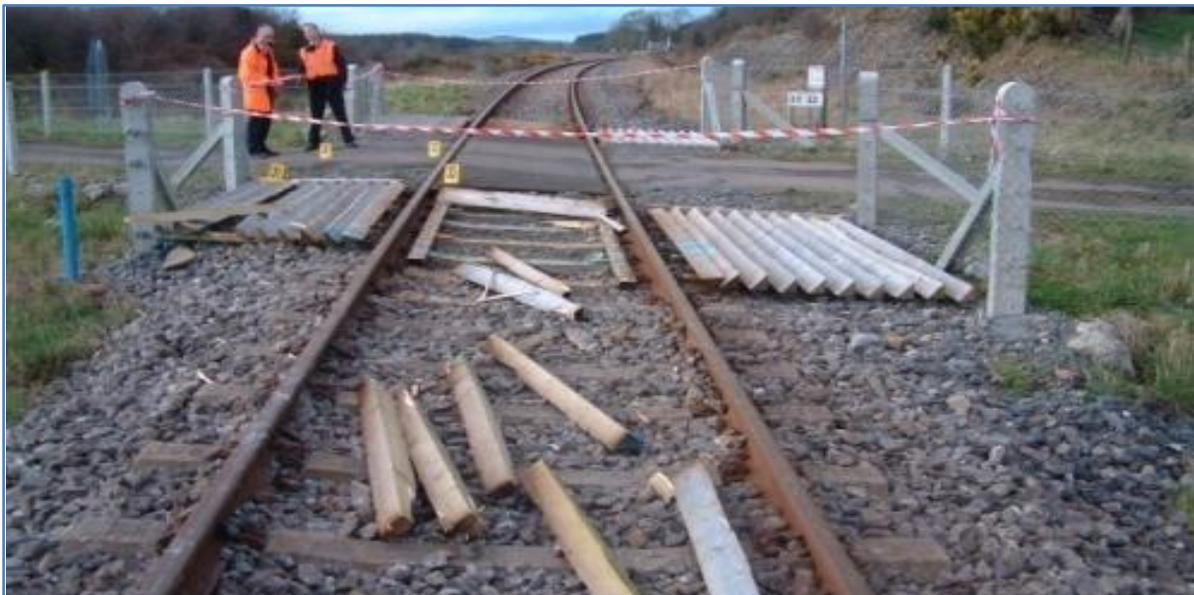
Photo 1 - Damage to infrastructure

There was only minor damage to the infrastructure, damage was caused to the cattle grids at the crossing and a railing on the railway bridge was dislodged when struck by the car (Photo 1 – Damage to infrastructure).

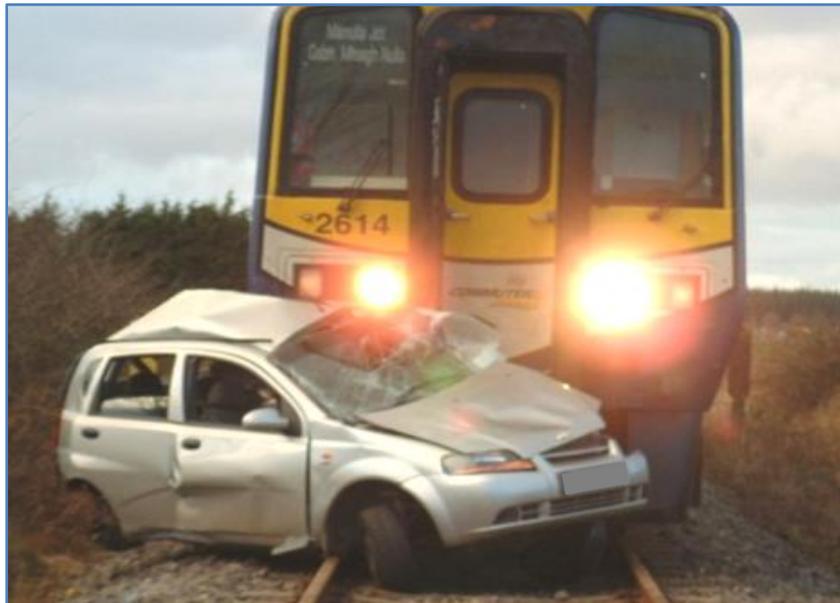
Photo 2 – Damage to road vehicle

The road vehicle, a silver Chevrolet Kalos was extensively damaged in the collision, the impact was to the passenger side of the vehicle forcing in both doors and the door sill, the front passenger seat was crushed with the back of the seat forced behind the driver's seat. The centre pillar was over against the driver's seat and the back of which was slightly crushed. The dash was crushed and the roof was forced over the passenger side to the centre of the vehicle (Photo 2 – Damage to road vehicle).

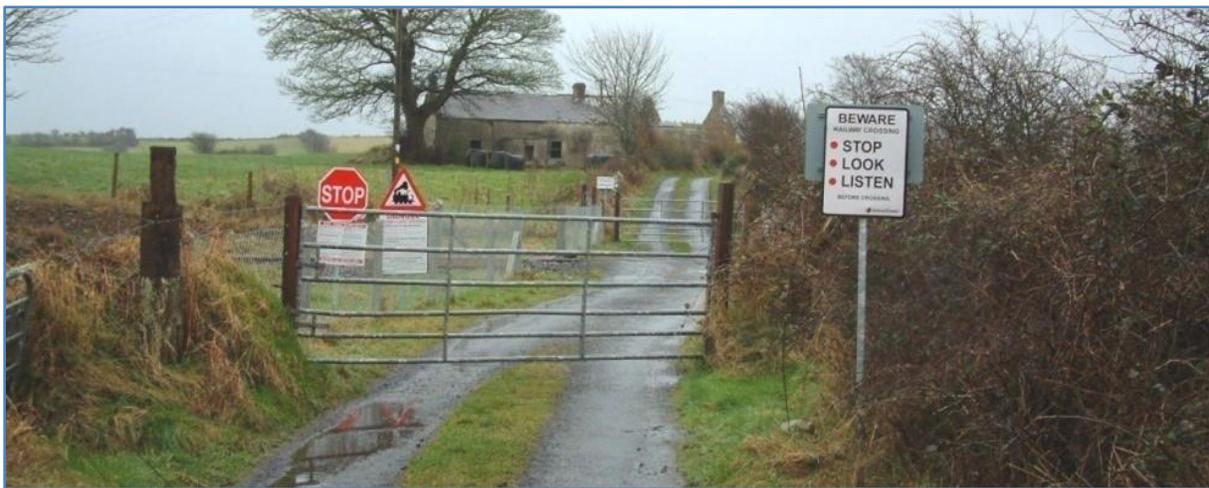
Photo 3 – Signage at crossing XX 032

Approaching the crossing from the T junction, approximately 55.6m from the railway line on the left hand side, there is a warning sign “BEWARE Railway Crossing Ahead Stop before You Cross the Railway”. On the right hand side approximately 23.8m from the railway line there is a warning sign “BEWARE Railway Crossing STOP LOOK LISTEN before crossing”. There is also a “Have you shut the gates” sign on the back of this sign. The gate is positioned approximately 19m before the railway line. On the left hand side approximately 8.4m from the railway line there is a warning sign “DANGER RAILWAY LEVEL CROSSING” beside this sign is a “STOP” sign with a “Keep These Gates Shut” sign below it (Photo 3 – Signage at crossing XX 032).

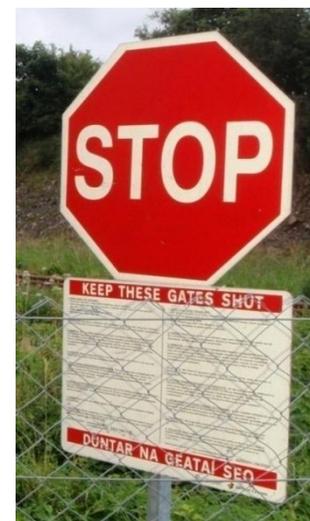
Photo 4 – ‘Keep these gates shut’ sign

Currently IÉ do not have a standard that clearly identifies the specification and signage required at crossings. A list of signage for user worked crossings was provided to the RAIU by IÉ (see appendix 1). In addition, the Maintenance of Way Technical Information Sheet MW50, dated 01/01/1983 (MW50) (Iarnród Éireann, 1983) identifies a list of signage to be fitted as does the Report of Committee of Inquiry into Accommodation Level Crossing Safety, dated 13/07/1990 (Iarnród Éireann, 1990). The signage at the crossing was consistent with all three lists of required signage for this type of crossing. The KEEP THESE GATES SHUT sign contains a considerable amount of information which may not be easily read by vehicle users (Photo 4 – ‘Keep these gates’ shut sign).

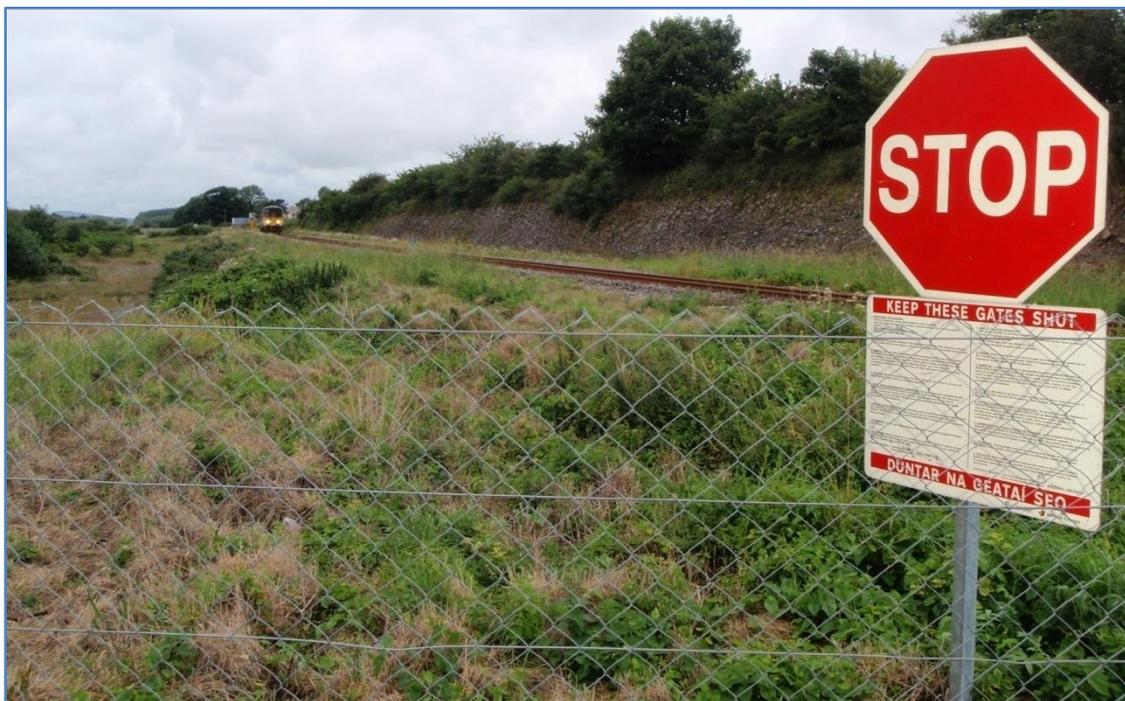
Photo 5 – View from crossing

A viewing distance from the crossing (Photo 5) in excess of 1600 m was recorded on the side that the car approached from, facing the direction from which the train approached the crossing.

For the Ballina to Manulla Junction line this gives a minimum required view at crossings of 300 m for the permanent speed restriction of 95 km/h (60mph).

$$\text{Minimum view} = 26.66 \text{ m/s} \times 16 \text{ sec} = 427 \text{ m}$$

This viewing distance (Photo 5) was also in excess of this.
