Investigation Report 08120201

**Collision of a train with the gates of level crossing XH066,
Bridgetown, on the Limerick Junction to Rosslare Strand line**

2nd of December 2008

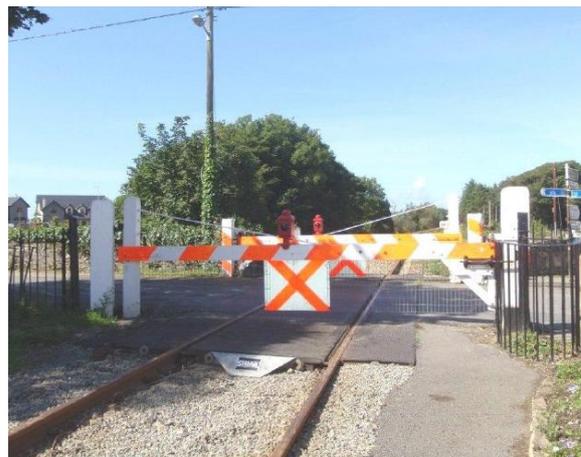
Photo 1 – LC XH066

The gates of the LC, the shooting bolt on one of the gates and the gate lamps were destroyed.

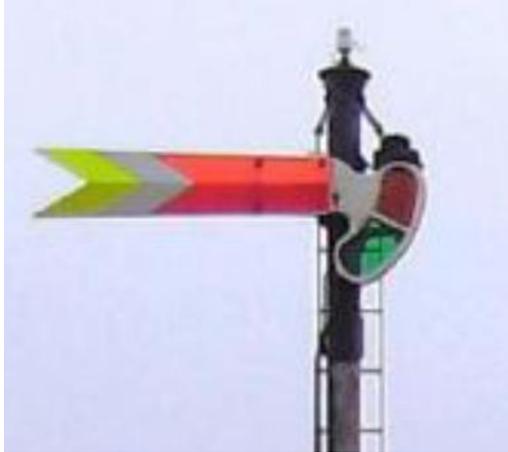
Photo 2 – Front of Down Distant Signal

The Down Distant Signal is positioned at the top of a rising gradient with a straight approach for over 1000 m. During hours of darkness the signal can be seen by the train driver due to the train headlights lighting up the reflective surface of the signal.

The train crew reported that the Distant Signal was OFF when the train passed. A member of the train crew walked back to the Distant Signal to verify its aspect after the accident, it was displaying an ON aspect.

It is possible that the tensioning wire was not correctly adjusted, leading to an OFF or WRONG aspect. This could have occurred due to the lack of adjustment of the tensioning wires or the cold weather overnight. Issues with the lack of correct adjustment of tensioning wires were found in the review of the photos from the RSC inspection.

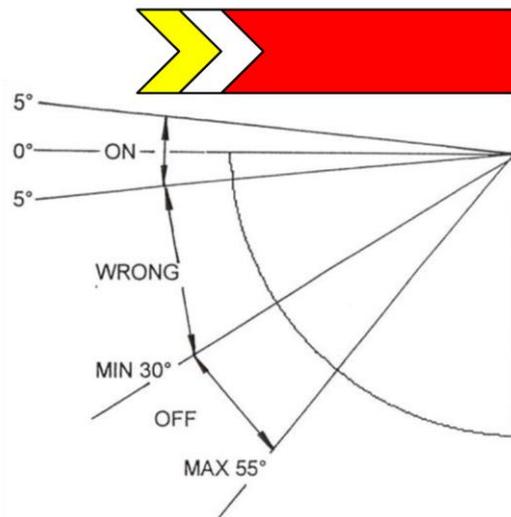
Figure 3 – Semaphore signal aspect

The semaphore signals display two aspects, ON and OFF. In between ON and OFF the signal is considered to be displaying an incorrect aspect and is called WRONG. For less than 5 degrees (°) above or below horizontal the signal is ON, from 5° to 30° below horizontal the signal is WRONG and from 30° to 55° the signal is displaying OFF, see Figure 3¹.

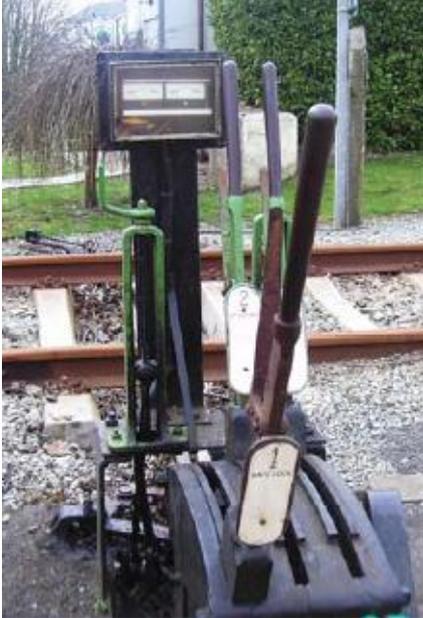
Photo 4 – Distant Signal controls

The LC gates and the Distant Signals are interlocked with a three-lever ground frame located on the Rosslare Strand side of the crossing, see Photo 4.

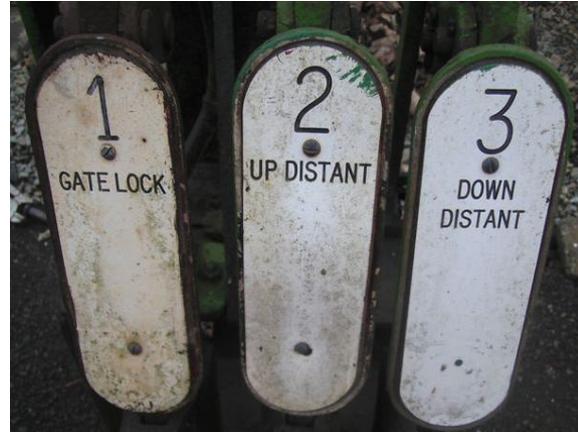
Photo 5 – Close up of Levers

In this ground frame, No. 1 lever works the gate locks and levers No. 2 & 3 operate the distant signals, as seen in Photo 5. The gate lock lever is interlocked with the two signal levers. In the position shown in Photo 4 with the No. 1 lever out of the frame, the gates are unlocked and the distant signal cannot be pulled to the OFF position.

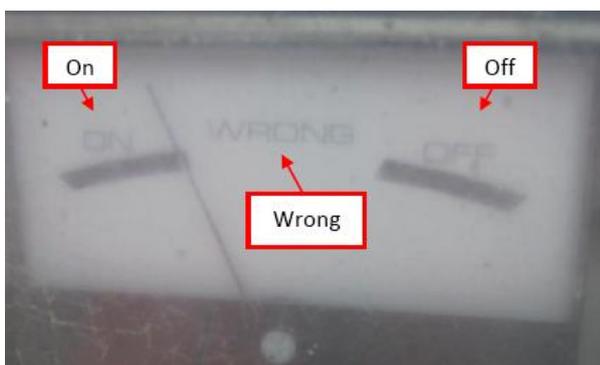
Photo 6 – Down Distant Signal Indicator

There are indicators at XH066 positioned beside the levers that display the aspect of the Distant Signals for the gatekeeper, the display is shown in Photo 6. The indicators operate electrically and are powered by a battery. If the indicator needle is pointing to WRONG, the signal is to be considered to be showing an incorrect aspect and is regarded as having a fault. The indicators consist of black needles on a black and white background. The indicators operate by displaying ON, OFF or WRONG depending on the voltage detected. The indicator needles are spring mounted and in the absence of voltage to indicate either ON or OFF, they will return to WRONG.

The Distant Signal that each indicator relates to was not signed, the cover through which the indicators are read was in poor condition and the indicator display was not lit.

The design of the face of the indicators at XH066 was not found to offer a strong visual prompt for reading the information. The particular issues observed were the poor condition of the display cover, the colour coding of the display, the narrowness of the needle, the lack of lighting of the display and the lack of signage identifying the signals the indicators related to. This could have led the gatekeeper to omit to read the indicator, mis-read the indicator or read the incorrect indicator after the last train the previous night.

The signal repeater indications and associated battery power supplies at all the crossings along this route were examined. New illuminated housings have been ordered and a programme is in place to illuminate all repeaters by March 2010. These new housings will have clear covers over the repeater indications so as to improve their visibility. Repeater name plates will be fitted as part of the new illuminated housing installation programme.
