## **Investigation Report 2011-R004**

**Gate Strike at Buttevant Level Crossing (XC 219), County Cork,  
on the 2<sup>nd</sup> July 2010**

<b>Title</b>	Gate Strike at Buttevant Level Crossing (XC 219), County Cork, on the 2 <sup>nd</sup> July 2010
<b>Document type</b>	Investigation Report
<b>Document number</b>	2011-R004
<b>Document issue date</b>	27/06/2011

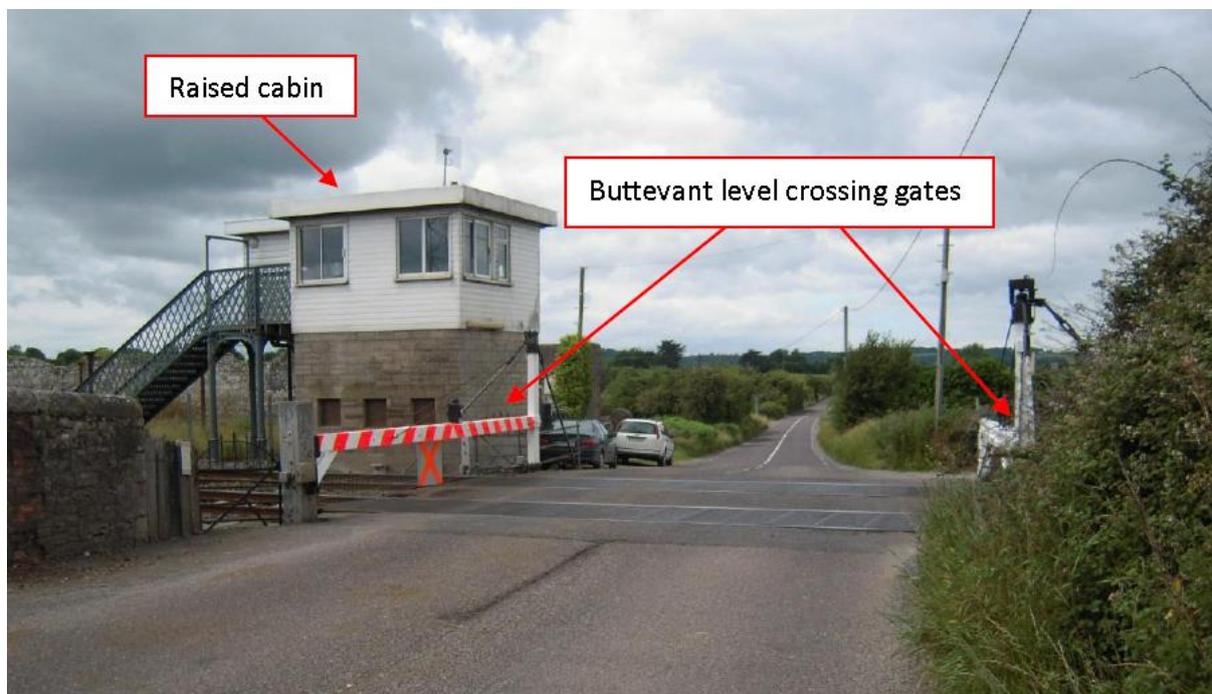
Photograph 2 – Buttevant Level Crossing with raised cabin

The Level Crossing, asset identification number (no.) XC 219, is a Gate Keeper attended 'CX' type crossing, which means that the default position of the Level Crossing gates is open to the public road (and closed across the railway line). The Level Crossing gates are opened and closed by the Gate Keeper who is located in the raised cabin adjacent to the Level Crossing where he has clear views of the railway line and public road, see Photograph 2.

A *risk assessment* exists in relation to the occupational safety of the Gate Keepers at the Level Crossing. However, no formal risk assessment in relation to the Level Crossing equipment design was created for the Level Crossing at the installation stage, or since its installation. IÉ have advised that, risk assessments would not have been customary at the time of installation, and a more informal approach to risk assessment was likely to have been adopted.
