## **Investigation Report 2011-R004**

**Gate Strike at Buttevant Level Crossing (XC 219), County Cork,  
on the 2<sup>nd</sup> July 2010**

<b>Title</b>	Gate Strike at Buttevant Level Crossing (XC 219), County Cork, on the 2 <sup>nd</sup> July 2010
<b>Document type</b>	Investigation Report
<b>Document number</b>	2011-R004
<b>Document issue date</b>	27/06/2011

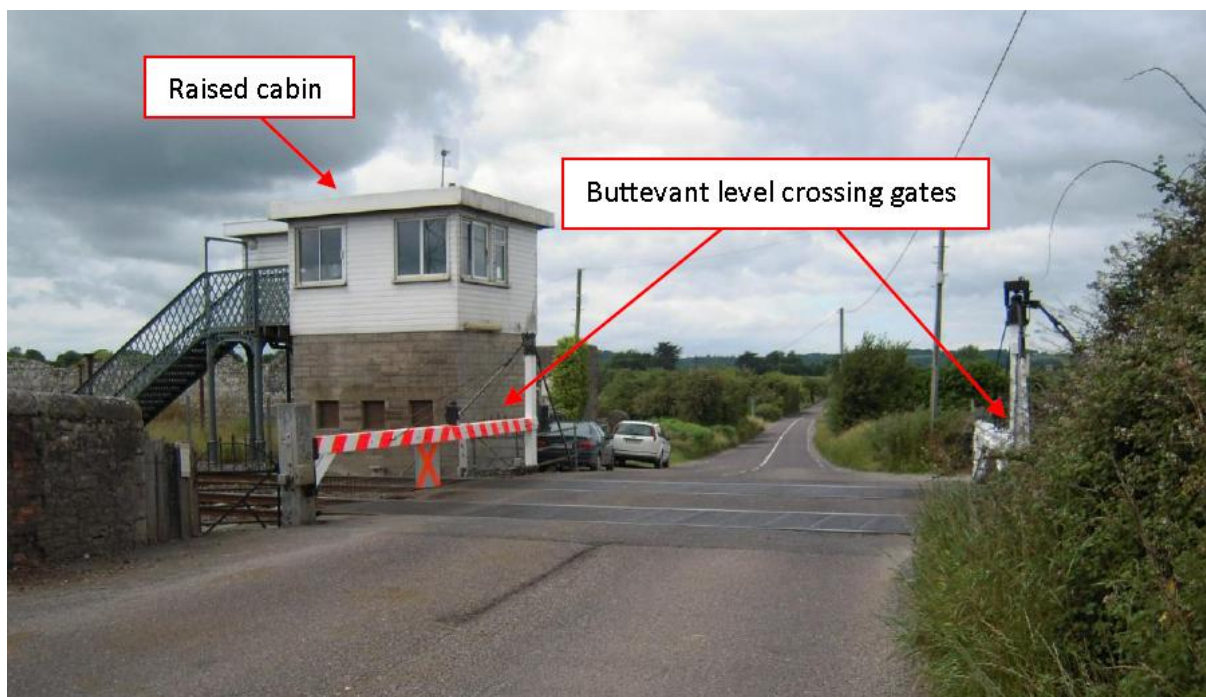
Photograph 2 – Buttevant Level Crossing with raised cabin

The Level Crossing, asset identification number (no.) XC 219, is a Gate Keeper attended 'CX' type crossing, which means that the default position of the Level Crossing gates is open to the public road (and closed across the railway line). The Level Crossing gates are opened and closed by the Gate Keeper who is located in the raised cabin adjacent to the Level Crossing where he has clear views of the railway line and public road, see Photograph 2.

A *risk assessment* exists in relation to the occupational safety of the Gate Keepers at the Level Crossing. However, no formal risk assessment in relation to the Level Crossing equipment design was created for the Level Crossing at the installation stage, or since its installation. IÉ have advised that, risk assessments would not have been customary at the time of installation, and a more informal approach to risk assessment was likely to have been adopted.

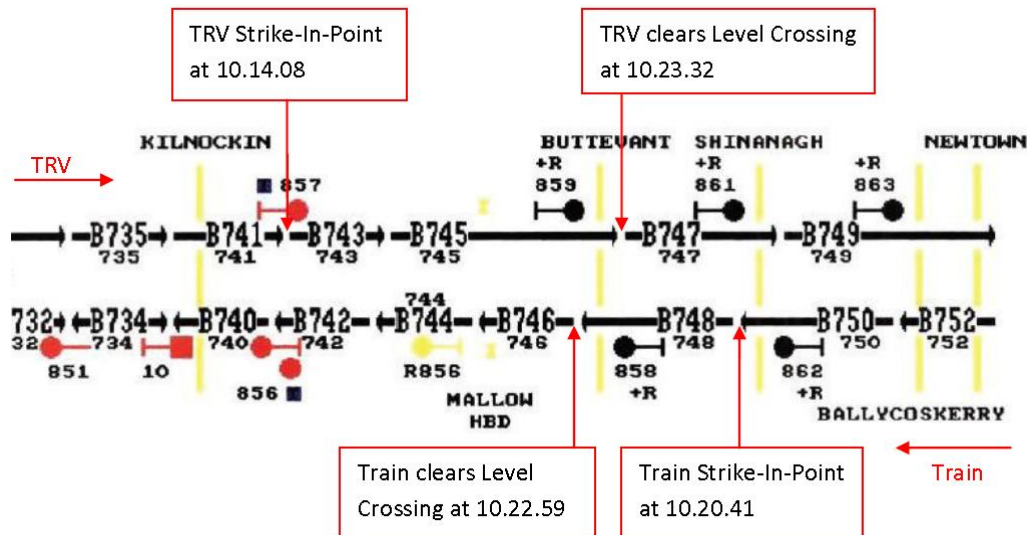
Figure 2 – Signalling system download

Information was downloaded from the signalling systems in relation to the *occupancy* of track circuits (illustrated as unique identifiers starting with the letter B in Figure 2) in the area of the accident. This download provides information on when the TRV and the Train approached the Level Crossing (illustrated as a yellow line in Figure 2). However, the download does not record information regarding aspects displayed in the automatic signals, position of the gates or actions of the Gate Keeper.

When the train/trains *clears* the track circuits associated with the Level Crossing the gate keeper can then begin the process of closing the gates to the railway. In the case of the Up and Down direction, the track circuits are B745 and B748, respectively.

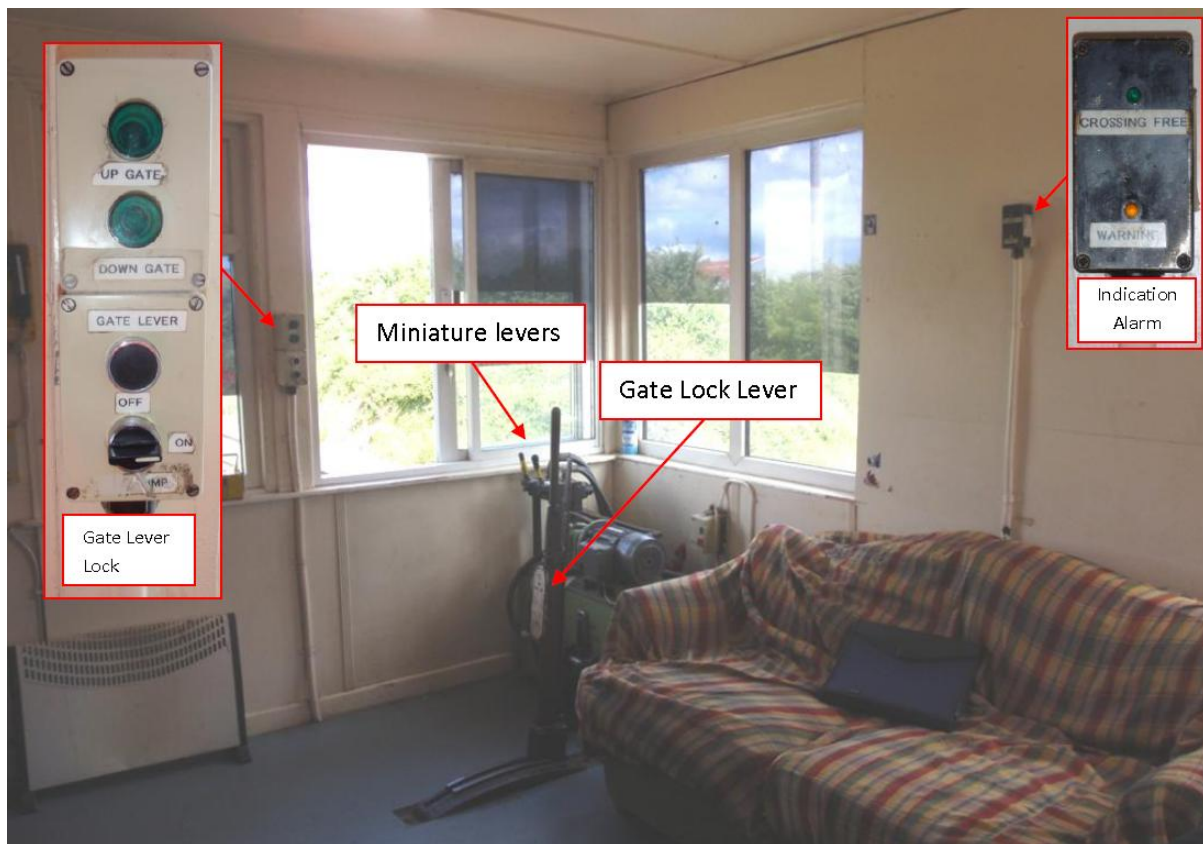
Photograph 3 – General arrangement of signalling equipment

It can be seen from Photograph 3 that all the above equipment is positioned in close proximity to each other, allowing the Gate Keeper to operate the equipment in a quick sequence from a single standing position, while maintaining a clear view of the Level Crossing.

IE staff, under the supervision of the RAIU, tested the Level Crossing equipment post accident, including the Indication Alarm and associated audible alarm, Gate Lock Lever and Gate Lever Lock. No faults were found with any of the Level Crossing equipment, and no faults have been recorded at the Level Crossing since the accident.

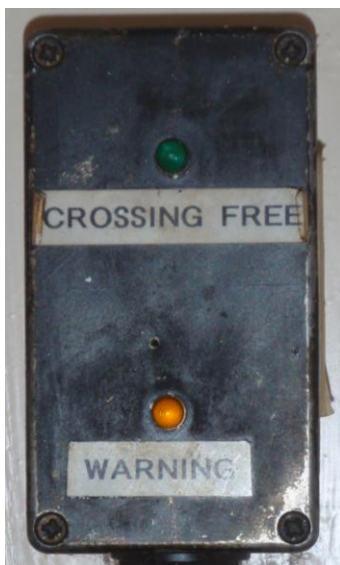
Photograph 4 – Indication Alarm

As a train approaches the level crossing, striking the Strike-In-Point, the yellow “Warning” lamp becomes illuminated, the audible alarm sounds, and the green “Crossing Free” lamp becomes extinguished on the Indication Alarm illustrated in Photograph 4.

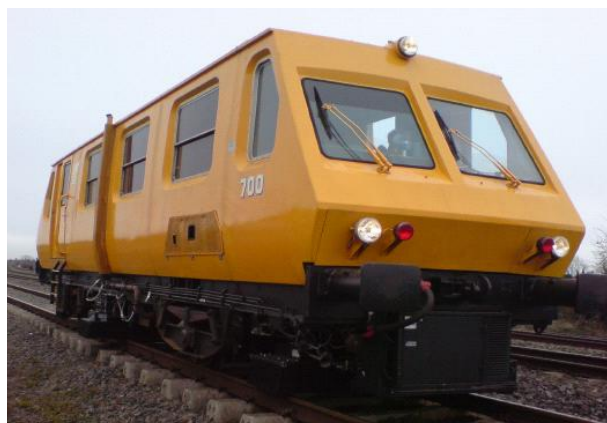
Photograph 7 – Track Recording Vehicle

The TRV involved in the incident is vehicle no. 700, train identification no. Y261, see Photograph 7. The TRV was not in recording mode at the time of the accident. The length and weight of the TRV are 12.8 m and 23 tonnes, respectively. The TRV does have a forward facing camera, however, this only operates when the TRV is recording, and therefore was not recording at the time of the accident. The TRV does not have an event recorder fitted. The *maximum permissible speed* for a TRV is 64 km/h. The TRV is not equipped with CAWS receiving equipment.

The TRV was travelling at approximately 64 km/h at the time of the accident.

The condition or operation of the TRV was not contributory to the accident.

The impact from the train striking the level crossing gate resulted in some minor damage to the TRV.
