## **Investigation Report 2010-R002**

**Derailment of LUAS tram at Connolly Station,**

**LUAS Red Line, Dublin City**

**16<sup>th</sup> of July 2009**

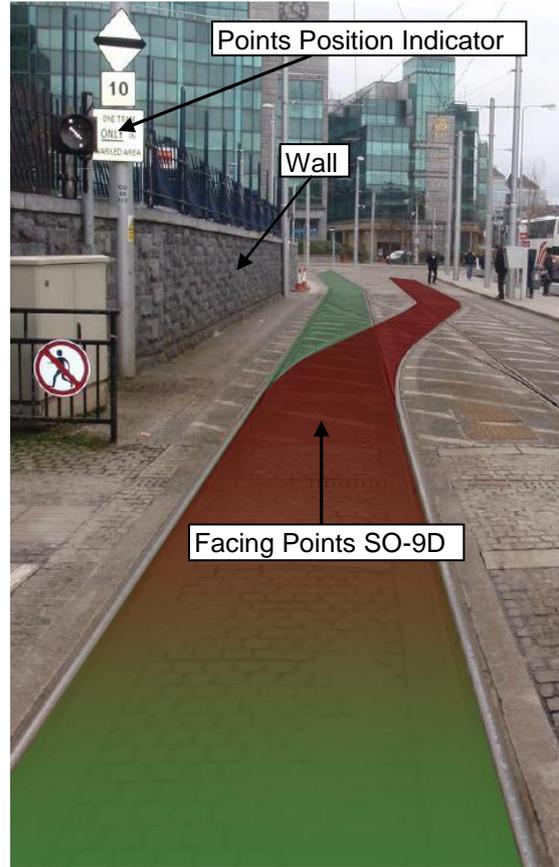
Photo 1 – View from Connolly Tram Stop

Whilst travelling outbound, in the *normal* direction (the green route indicated in Photo 1), the tram travelled 26 metres (m), past the *Points Position Indicator*<sup>2</sup> (PPI) for *facing points* SO-9D and over the points when the driver heard a loud bang and stopped the tram. Two off-duty Veolia staff were present at the scene and checked the tram, not noticing any sign of derailment, however they did notice what appeared to be an item of clothing under the tram. The driver then continued a further 10m before stopping when seeing the driving cab was moving towards the wall.

The tram stopped with the first *bogie* on the outbound route (green route) and the second bogie on the *inbound / reverse* route (red route).

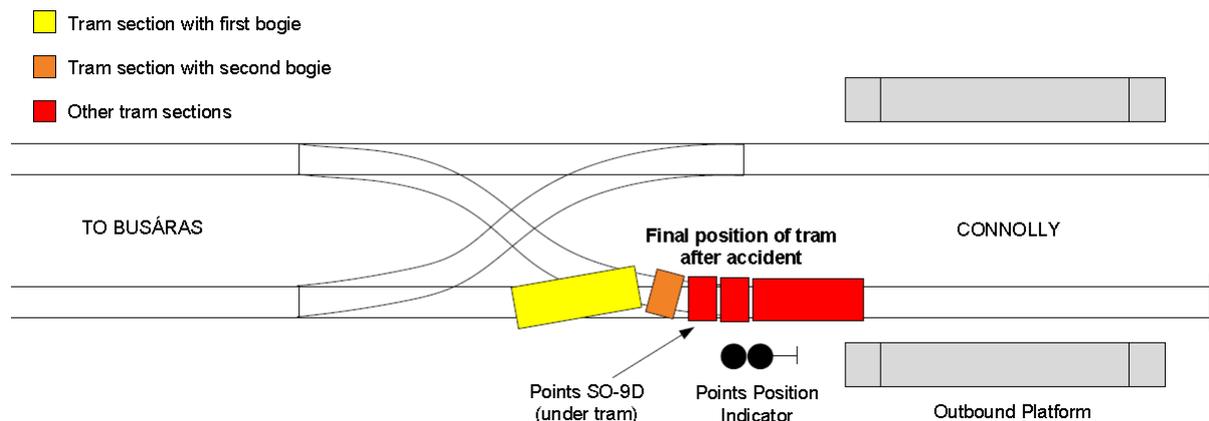
Figure 2 – Final position of the tram after accident

The driver contacted *Central Control Room (CCR)* to inform them there was a problem with the tram leaving Connolly. The driver then evacuated the passengers from the rear of the tram onto Connolly Station. There were no injuries resulting from this accident. The accident occurred during daylight hours. The weather was dry with good visibility. The final position of the tram is illustrated below in Figure 2.

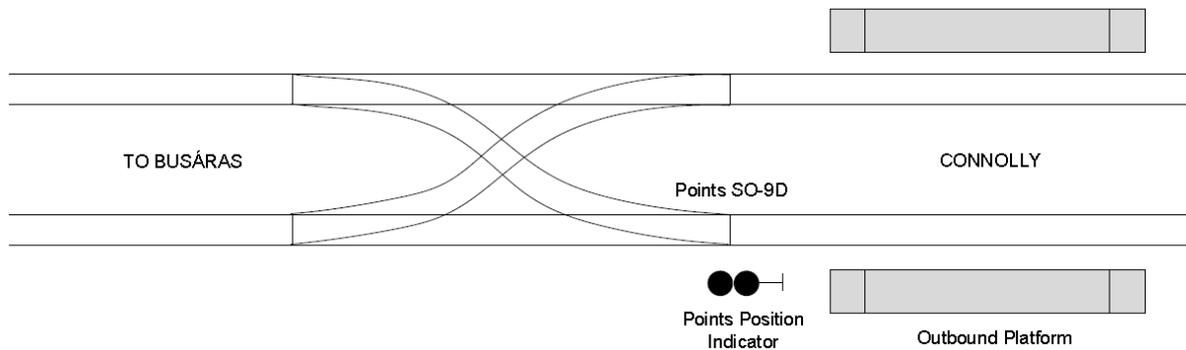
Figure 3 – SO-9D points layout

SO-9D are the fitted at the exit of the outbound platform at Connolly Station. The points are set in either *normal* or *reverse* positions. The points are spring actuated which means the points return to the normal position, outbound from Connolly (along the wall). The points are also fitted with a PPI before the points, which displays, to the driver, the status of the points. Figure 3 illustrates the layout of SO-9D points.

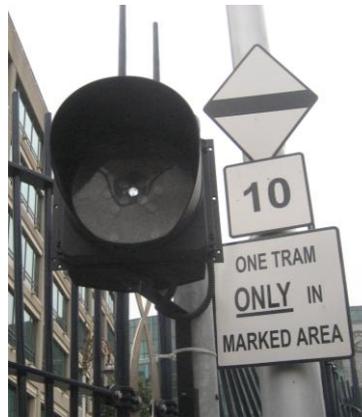
Photo 3 – Position of the points not detected

The 'Tramway Safety Instruction Manual'<sup>3</sup> states that when the 'points set to the left' aspect is showing, the driver can proceed in left direction if safe to do so, as this confirms to the driver that the route has been set. If the 'position of the points not detected' aspect (also known as the single dot aspect) is indicated the driver must stop, contact CCR for further instruction. The manual also states that for the single dot aspect there is a danger of derailment and a visual check of the points is required.

The download from the time of the accident indicates that the points did not close when the tram went into the outbound platform, therefore this suggests that the PPI was displaying a single dot aspect at the time the tram exited Connolly Station Platform.

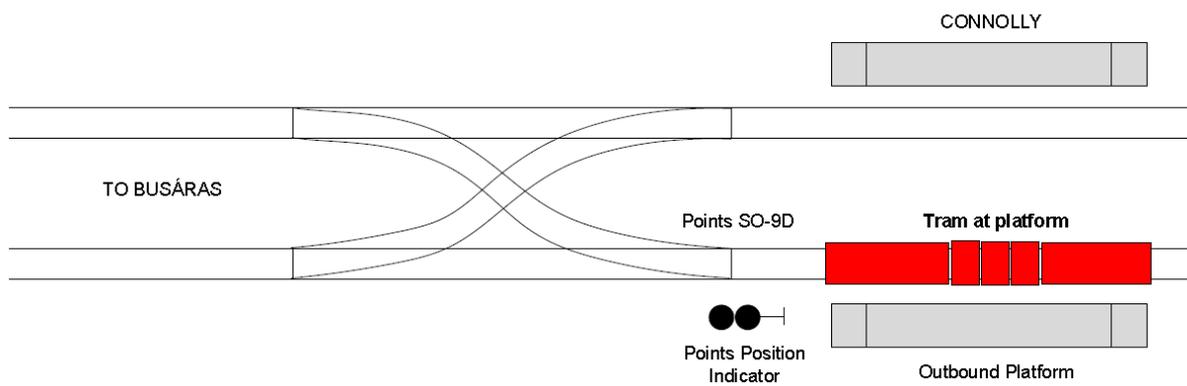
Figure 4 – Tram standing at outbound platform

The tram driver drove into Connolly station and terminated on the outbound platform and then changed cab ends (Figure 4). The driver boarded passengers. The driver stated that he visually checked the points but cannot recall whether he checked the PPI aspect. The driver exited the outbound platform with a single dot aspect, showing 'position of points not detected'.

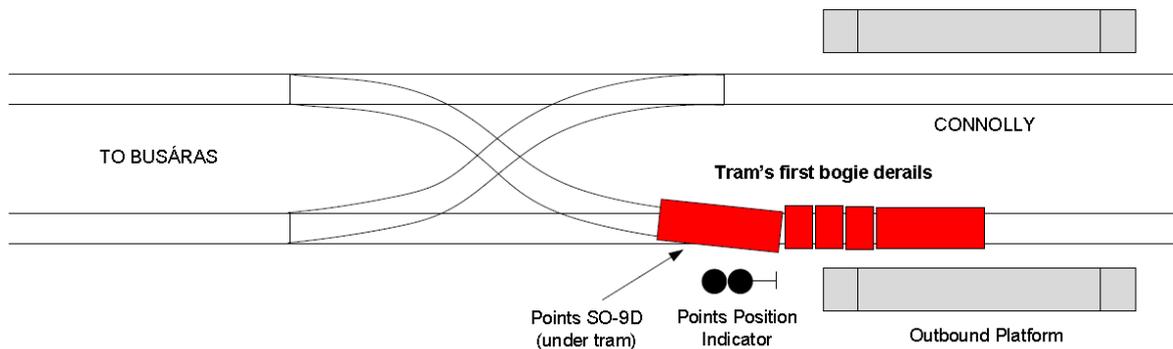
Figure 5 – First bogie derails

The tram exited the platform outbound for Tallaght. The wheelmarks on the concrete, and concrete dust on the second *wheelset* of the first bogie, indicates that this is the wheelset derailed (Figure 5); and re-railed (Figure 6) as a result of the dragging force of the first bogie. This re-railment caused a loud bang, which the tram driver hears and as a result stops the tram.

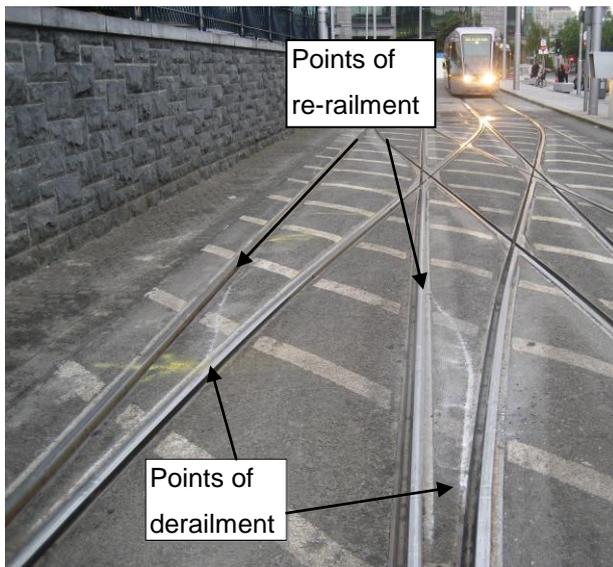
Photo 4 – Derailment marks (from Connolly)

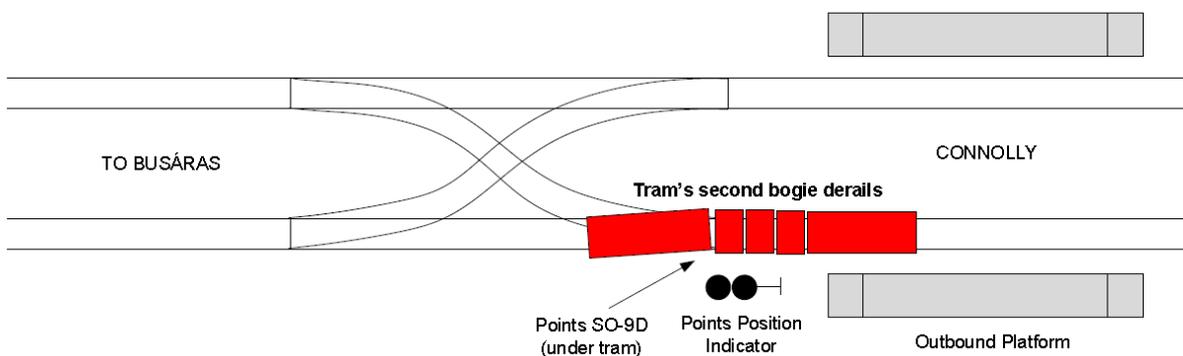
Two off-duty Veolia staff were present at Connolly and checked the tram, not noticing any sign of derailment, however they did notice what appeared to be an item of clothing under the tram. The driver then continued a further 10m before stopping when seeing the driving cab was swerving towards the wall, as the second wheelset travelled in the diverging direction.

Figure 7 – Second bogie travelling in wrong direction.

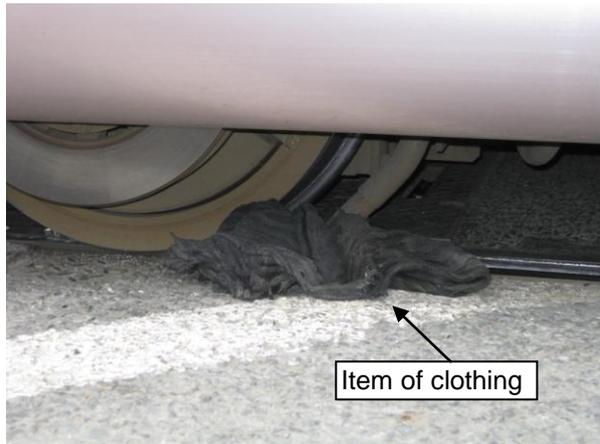
From the download of information from the DCS file it was established that the points were showing a 'position error' alert, indicating that the points were not detected in either the normal or reverse position, suggesting they had been stuck in a position between the two.

On examination of the points after the derailment it was found that there was an item of clothing trapped in the points, shown in Photo 6.

Photo 6 – Clothing trapped in the points

- The points did not return to normal after the passage of the tram into the outbound platform as there was an item of clothing stuck in facing points SO-9D.

The points were damaged as a result of the derailment resulting in the replacement of some components of the points.
