Investigation Report 2010 – R005

Irregular operation of Automatic Half Barriers at Ferns Lock,
County Kildare, on the Dublin to Sligo Line,
2nd September 2009

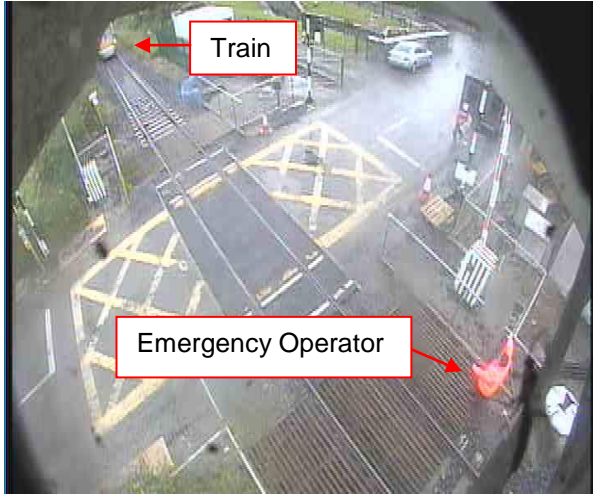
Photograph 1 – EO signalling to A907 train

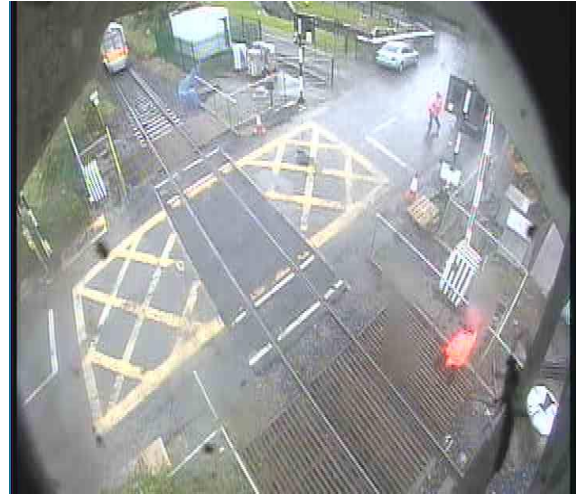
Photograph 2 – A907 approaching crossing

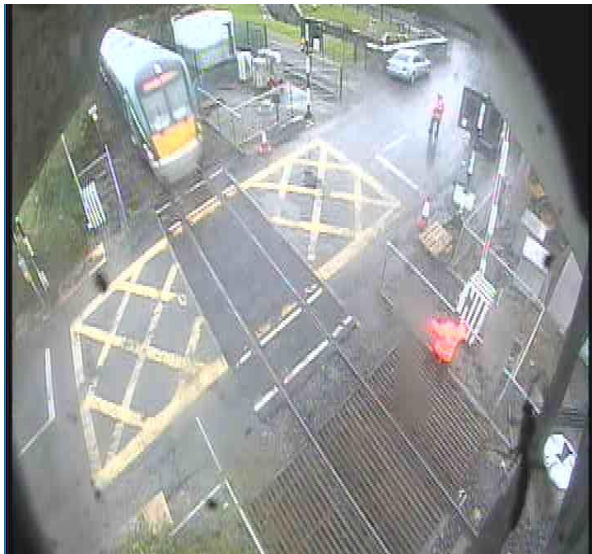
Photograph 3 – A907 entering crossing

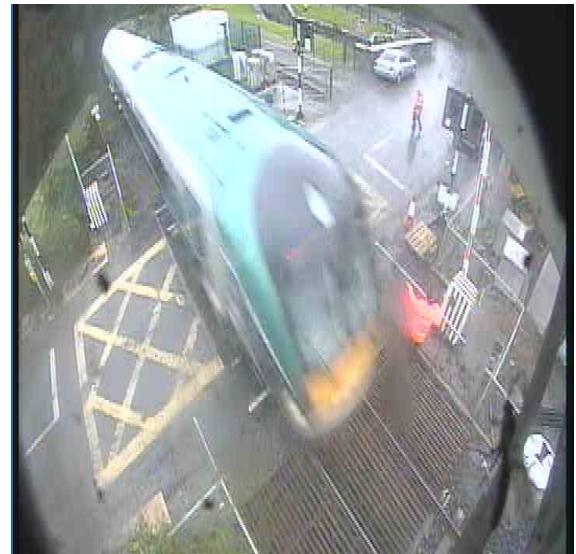
Photograph 4 – A907 on crossing

- 13.33 hrs The train passed through XG019 at approximately 65 kph while the barriers were in the raised position.
- 13.34.02 hrs The EO phoned the Sligo & Northern Line Signalling console and asked Signalman B why and who had let the train through the crossing from Enfield as the barriers were not lowered. Signalman B advised the EO that he had signalled the train from Enfield because he was advised by Signalman A that the EO was switching XG019 into local control to lower the barriers.

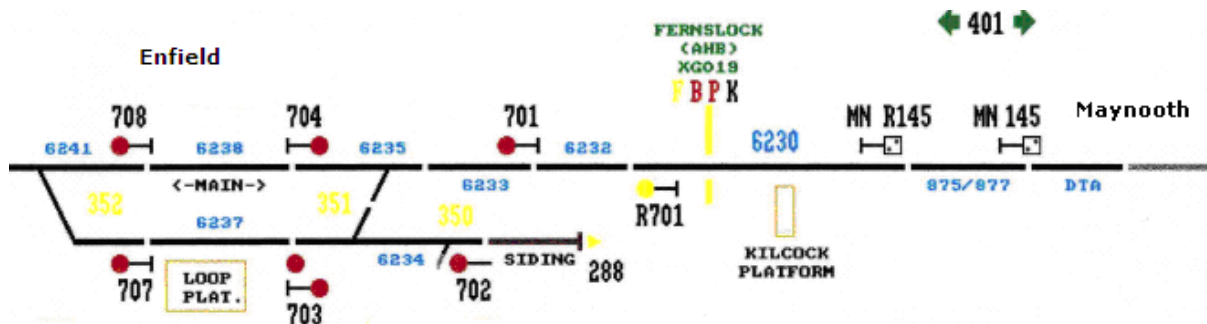
Figure 2 – Sligo & Northern Line Console with Ferns Lock AHB

XG019 is displayed on the Sligo & Northern Line Console (console), see Figure 2, which includes XG019 illustrated as a vertical line intersecting the track, and letters giving indications to the controlling signalman.

Signalman B, would have seen the display with the red F, again, assuming that no intervention was required on his part. In addition, a red vertical line was displayed, indicating that the barriers were raised to road traffic. However, this did not prompt any action for Signalman B, as again he incorrectly assumed that no intervention was required on his part.
