Railway Accident Investigation Unit

INVESTIGATION REPORT

Fog signal activation in DART driving cab,
Bray, 6th March 2012

RAIU Report No: R2013 – 003

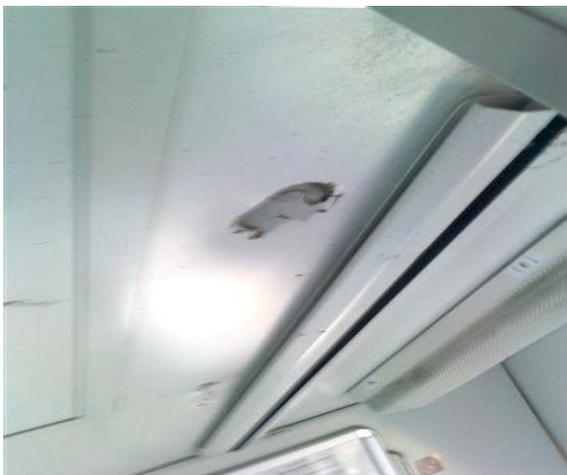
Figure 2 – Damage to driving cab ceiling

11 The rear wall, floor and ceiling (see Figure 2) of the interior of the driving cab were damaged.

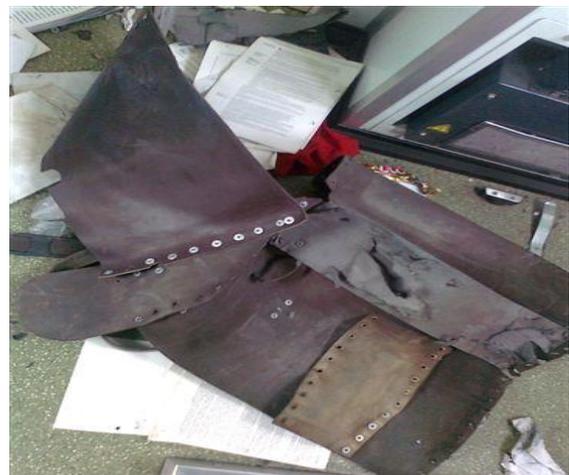
Figure 3 – Damage to driver's bag

12 The leather bag, carried by the driver, was badly damaged as were the contents consisting of signal flags and rule books, see Figure 3.

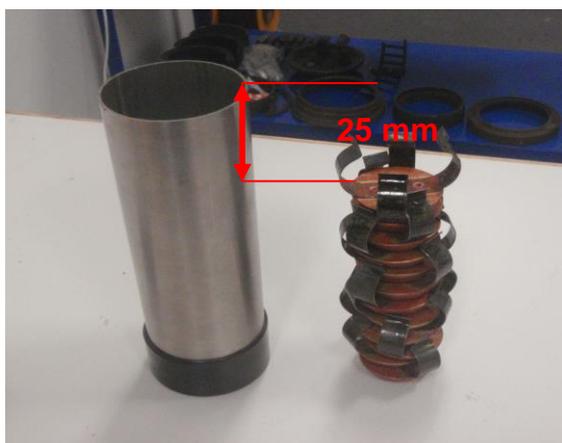
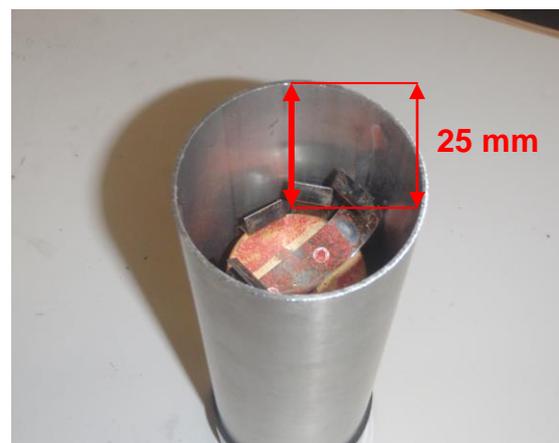
Figure 16 – Photographs illustrating the gap in the tube when the fog signals are stacked

- 36 When the fog signals are placed into the carrying tube there is a gap between the end of the clip and the end cap of 25 millimetres (mm) allowing the fog signals to move up and down within the container, see Figure 16.

64 The 25 mm free space in the stainless steel tube allowed for movement (as discussed in paragraph 36) this unrestricted movement may have led to a certain amount of degradation of the units over a period of ten months and on the 6th March 2012.

67 In relation to the stainless steel tubes, the fog signals are free to move within the tube as there was 25 mm free space in the tube (paragraph 64) when the fog signals were stacked may have contributed to the activation of the fog signals. This action appeared of no consequence with the Lacroix fog signal but with the less rugged initiation system in the Alsetex device it is within the balance of probability that the movement within the carrying tube was sufficient to degrade one or more of the fog signals over time resulting in the explosion within the DART cab in Bray when the driver dropped his bag onto the floor as he commenced driving duties.

- CoF-01 – The fog signals storage tube, designed by IÉ, allowed the fog signals to impact on one another which may have caused them to degrade over time;

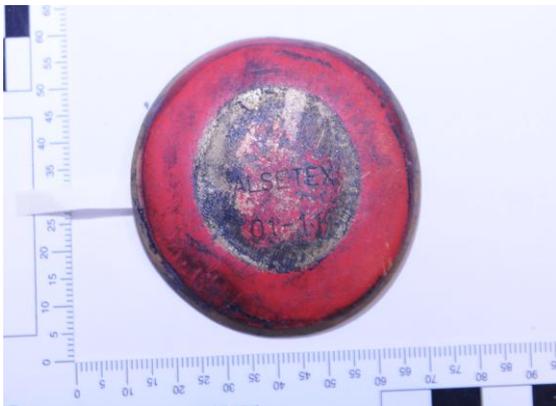
- 40 Eleven of the twelve fog signals exploded. The eleven exploded fog signals were marked as 'Irish Rail Alsetex' while the remaining unexploded fog signal was marked 'Irish Rail Lacroix'. The Lacroix fog signal was out of date at the time of the explosion; the date on the case was 01-06 (indicating this was the first batch of 2006), meaning that it should have been replaced five years later, in January 2011.
- 41 An examination of the carrying tube revealed that the majority of its down facing edge had been burnt in the explosion; also the fog signals at the bottom of the tube had rubber burnt onto its surface, see Figure 20; and the rim of the tube was burnt, Figure 21.

Figure 20 – Fog signal that was found at the bottom of the tube

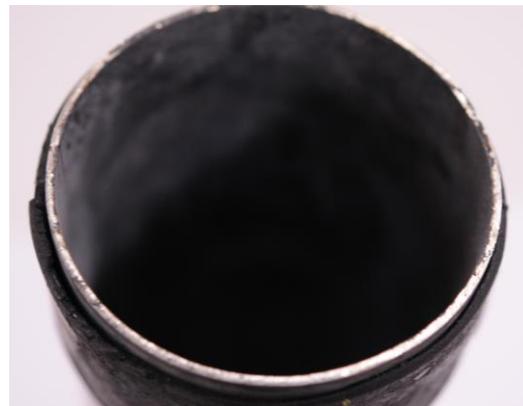
Figure 21 – Rim of the tube

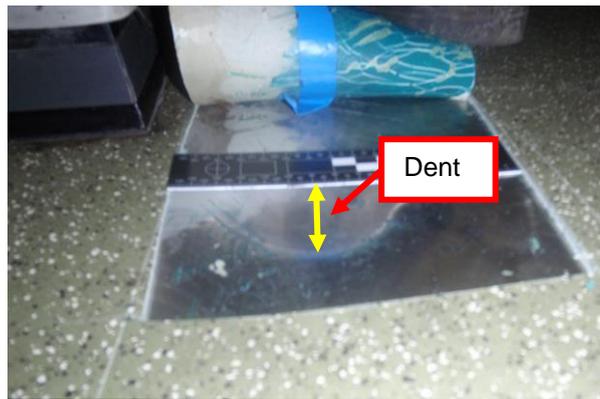
- 43 The source of the explosion was within the drivers cab to the right of the driver's seat, indicating that the initiation occurred where the bag had first been put by the driver.
- 44 When the linoleum covering was removed from the floor, the stainless steel underneath had a large dent at the point of the explosion, see Figure 22. The shape of the dent matched the shape of the fog signal container. Fragments of the fog signals were also embedded into the sides and roof of the driving cab.

Figure 22 – Dent in the floor

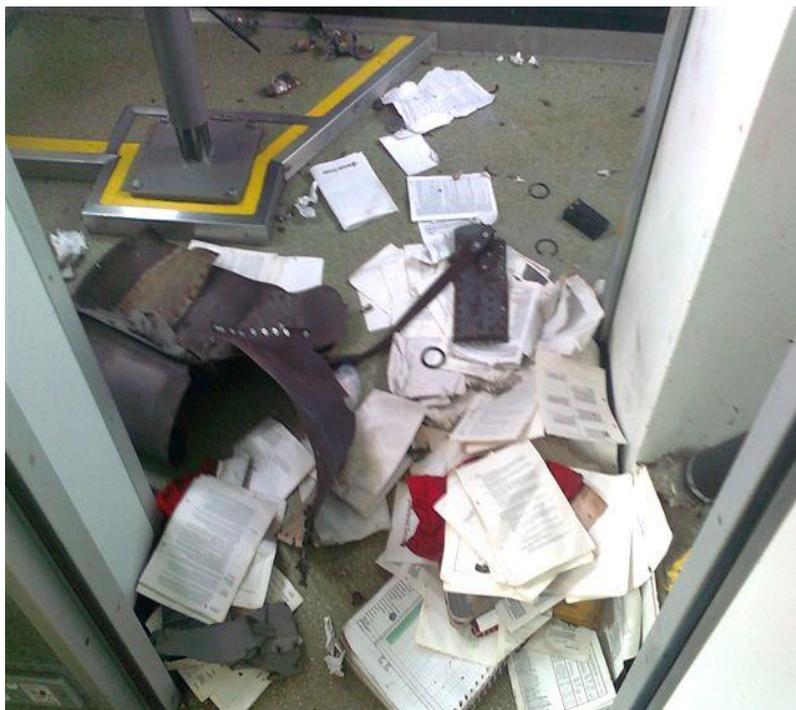
- 50 When the bag was dropped onto the floor of the driving cab there was an explosion from fog signals within the bag.
- 51 The driver was dazed but was able to immediately exit the driving cab back on to the platform, see Figure 23 for a view inside the driving cab.

Figure 23 – Inside the driving cab
