**Railway Accident
Investigation Unit**

INVESTIGATION REPORT
Tram fire on approach to Busáras Luas Stop
7th November 2013

RAIU Report No: R2014 – 004
Published: 28th August 2014

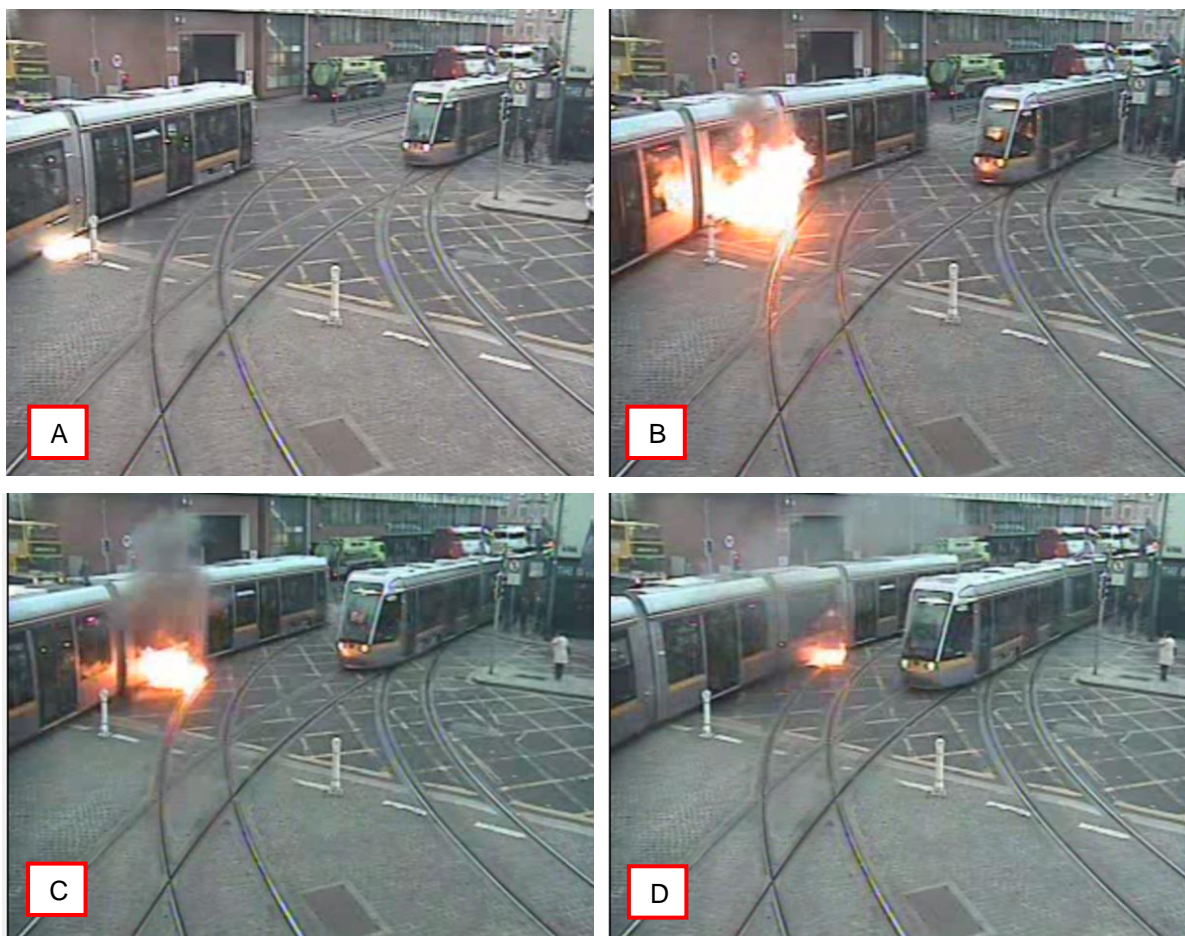
Figure 2 – CCTV showing Trams 3002 and 4011 passing through the junction

- 7 Closed Circuit Television (CCTV) footage shows that as Tram 3002 passes through the junction, flames can be seen escaping from underneath the second *bogie*. The volume of flames varies as the Tram travels through the junction and into the stop as shown in Figure 2.

- 8 During the first two seconds after ignition the initial burst of flames grows and reaches its peak volume which is sustained for under a second (Figure 2B). The flame then begins to recede in size (Figure 2C and 2D) until the Tram is stationary in the Stop and the flames are contained to within the side skirts of the Tram.
- 9 Dublin Fire Brigade were on site from 16:35 hrs and took control of the site to manage the fire.
- 10 Full service was restored to the Luas Red Line at 17:49 hrs.
- 11 There were no reported injuries as a result of this accident.

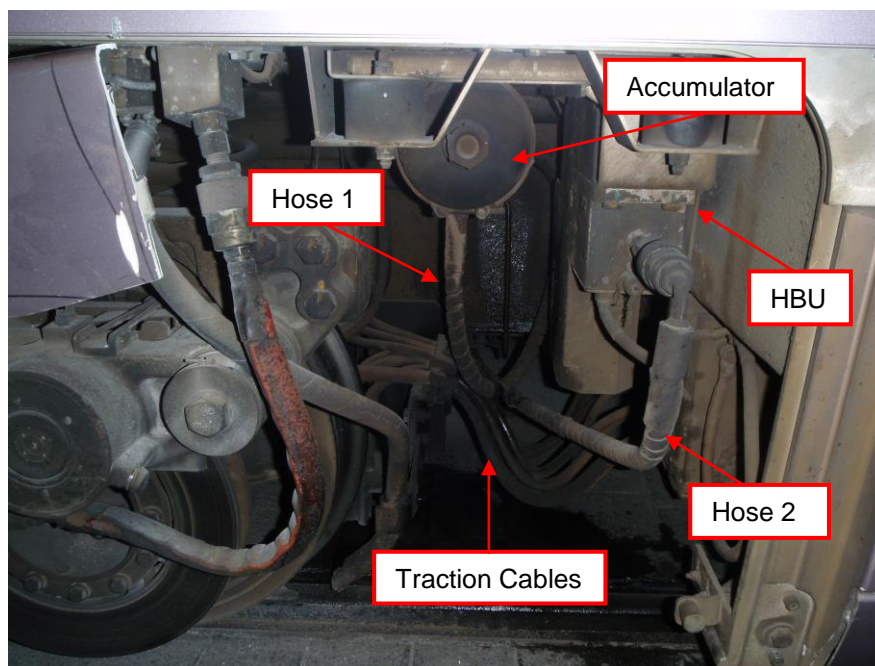
Figure 5 – MIC bogie post accident

38 Hydraulic fluid is used to transfer forces through high pressure hoses in the hydraulic braking circuit. The component arrangement in the area the fire originated is shown in Figure 5 and the following two components are of particular interest in this investigation:

- Hose 1 which is a vertical connection between the accumulator and the HBU;
- Hose 2 which runs horizontally between a central manifold in the tram and the HBU.

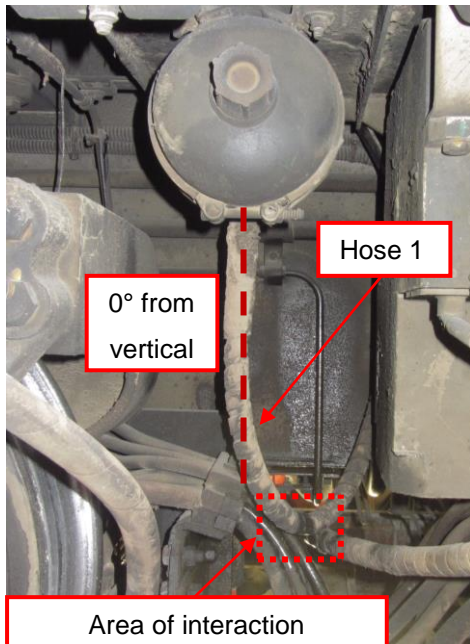
Figure 9 – Post accident position of Hose 1

- 54 Initial inspection of the MIC bogie on Tram 3002 showed that Hose 1 from the accumulator was being held just past the vertical and orientated slightly towards the centre of the bogie (Figure 9). It was also noted the lower end of this hose was in very close proximity to the traction cables below creating an area of potential interaction (Figure 10).

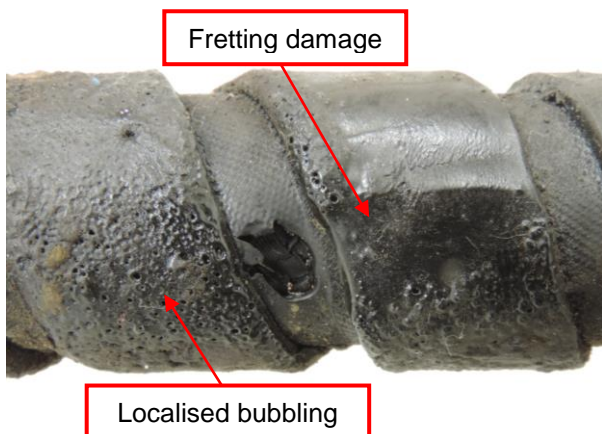
Figure 11 – Damage to Hose 1

Figure 7 – Design for arrangement for Hose 1 in MIC (view from centreline of bogie).

- 55 Damage to Hose 1 was noted where it was in close proximity to the traction cables. There was a small hole 5mm in diameter surrounded by an area of smoothness on the outer anti-abrasion spiral wrap as shown in Figure 11. The smoothness is consistent with damage caused by *fretting* with a second surface.

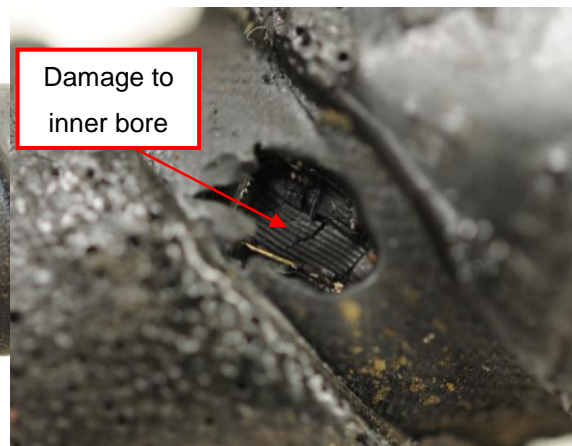
Figure 12 – Point of rupture in Hose 1

- 56 An enlarged view of this hole (Figure 12) shows damage to the inner bore of the hose indicating that this is the point of the rupture in Hose 1. The physical size of this rupture and high pressure operating conditions of this hose would mean the escaping fluid would be released in an atomised spray.

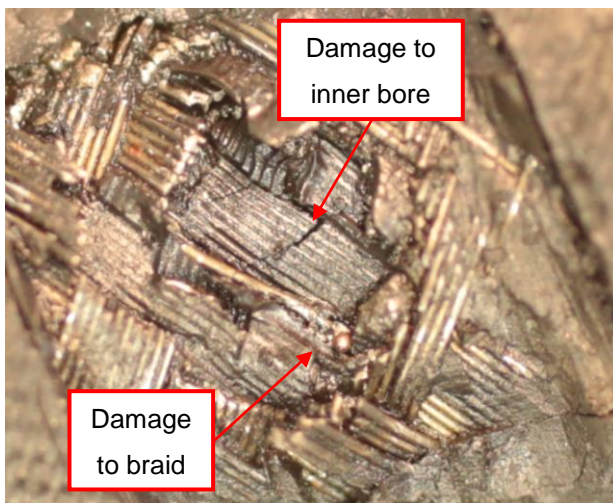
Figure 13 – Damage to braid in Hose 1

- 60 When the outer surfaces were removed, it was clearer to see the damage to the braid. There were no signs that there had been a mechanical penetration or impact of the braid in the area of the hole. However, globules of metal were observed in the remaining braid around the hole which are potentially indicative of an electrical arc (Figure 13).

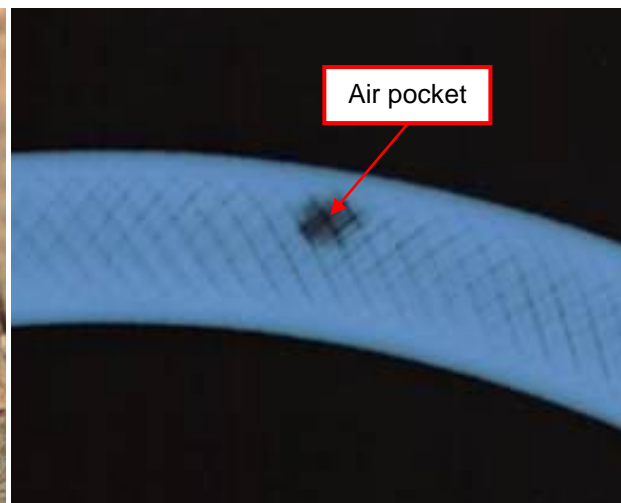
Figure 14 – Radiograph of Hose 1

- 61 A radiograph of Hose 1 confirmed that as designed a steel braid was present throughout the hose. An electrical continuity test verified that the steel braid ran and imparted electrical continuity to the full length of the hose and therefore any bare conductor that comes into contact with the

braid would arc to ground due to the voltage difference. The hole in the braid at the point of failure can be identified by the black air pocket shown in Figure 14.

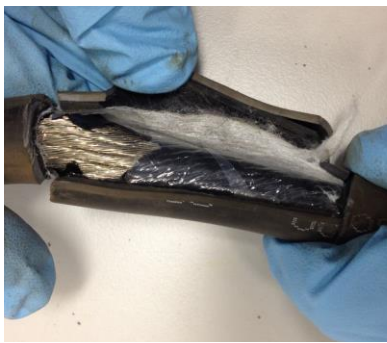
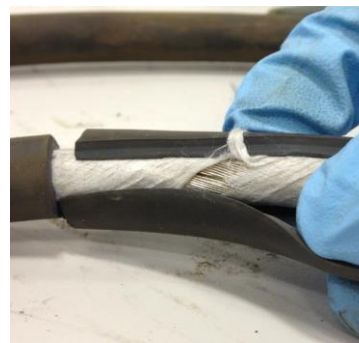
- The interaction between Hose 1 and Cable 1 led to both components sustaining damage that ultimately initiated the fire;
- The cable involved in the accident did not contain the protective braid which was present in the original 401 fleet which may have provided additional protection to the conductor;
- A number of the free lengths on the traction cables were measured to be longer than the length detailed in the original design which may have allowed a greater degree of movement in the cables during operation;
- The electrical protection built into the traction system did not isolate the arcing fault, which may have led to the arc being sustained for a longer period of time.

69 Two types of cable were installed on Tram 3002 both of which had insulation that differed from that shown in Figure 18. Cables 2,4,5 and 6 were manufactured in either 2006 or 2007 by a different manufacturer and contained a protective sheath and silicone rubber insulation as shown in Figure 19. Cables 1 and 3 were manufactured in 2010 by the same company as the original cables but were a Y series cable. The copper core of this cable which is surrounded by a polyester tape and insulated by approximately 3.2 mm of silicone rubber shown in Figure 20.

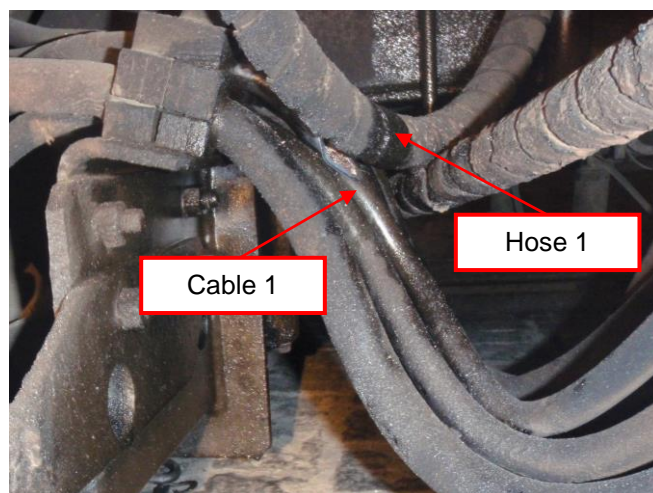
Figure 21 – Position of traction cables and hydraulic hoses

- 85 Examination of the MIC bogie showed significant wear on Cable 1 had occurred in a location where it was in close proximity to Hose 1 (which runs between the accumulator and the HBU) as shown in Figure 21. The inner core of Cable 1 was exposed and early signs of wear on the Earth Cable, Cable 2 and Cable 3.

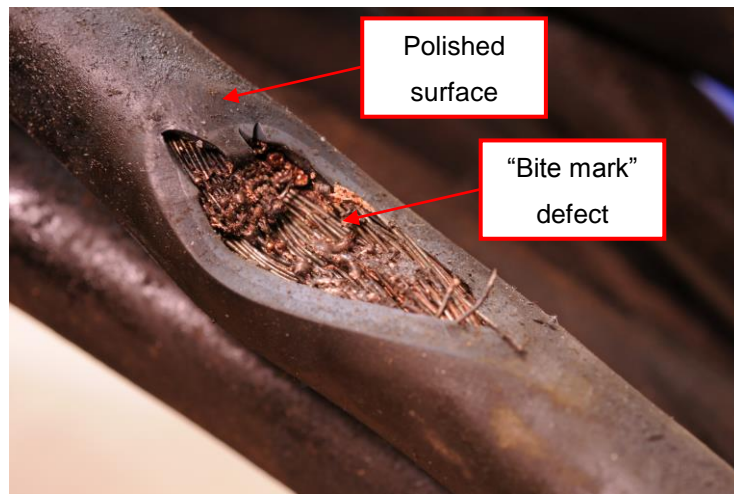
Figure 22 – Damage to Cable 1

- 86 Closer inspection of Cable 1 in Figure 22 shows a polished surface on the insulation and outer sheath in the area of the damaged core indicating that fretting has taken place. In addition to this

localised melting in the core itself and the “bite mark” shape of this damage would indicate that arcing has taken place.

- 87 The damage to the insulation of Cable 1 indicates that fretting has occurred with a second surface over a period of time prior to the cable becoming exposed. The concave nature of this defect is consistent with damage caused by a cylindrical surface which would indicate that the damage was caused by Hose 1.

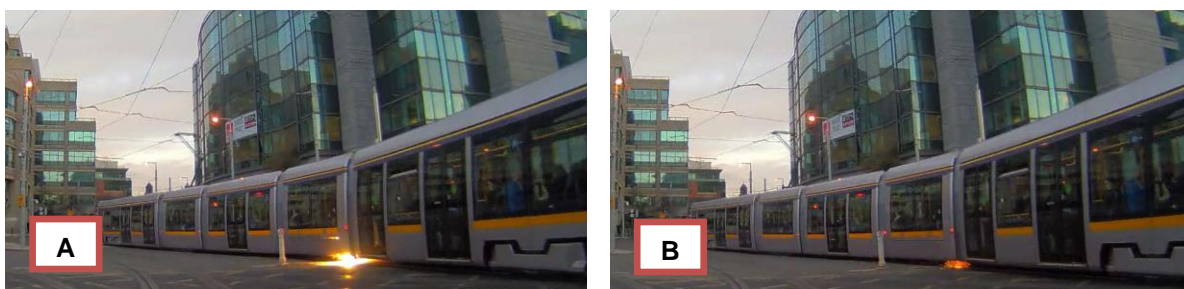
Figure 23 – CCTV images of initial flash and fire initiation

96 Initially a flash can be observed and combustion occurring as shown in Figure 23A and 23B, respectively.

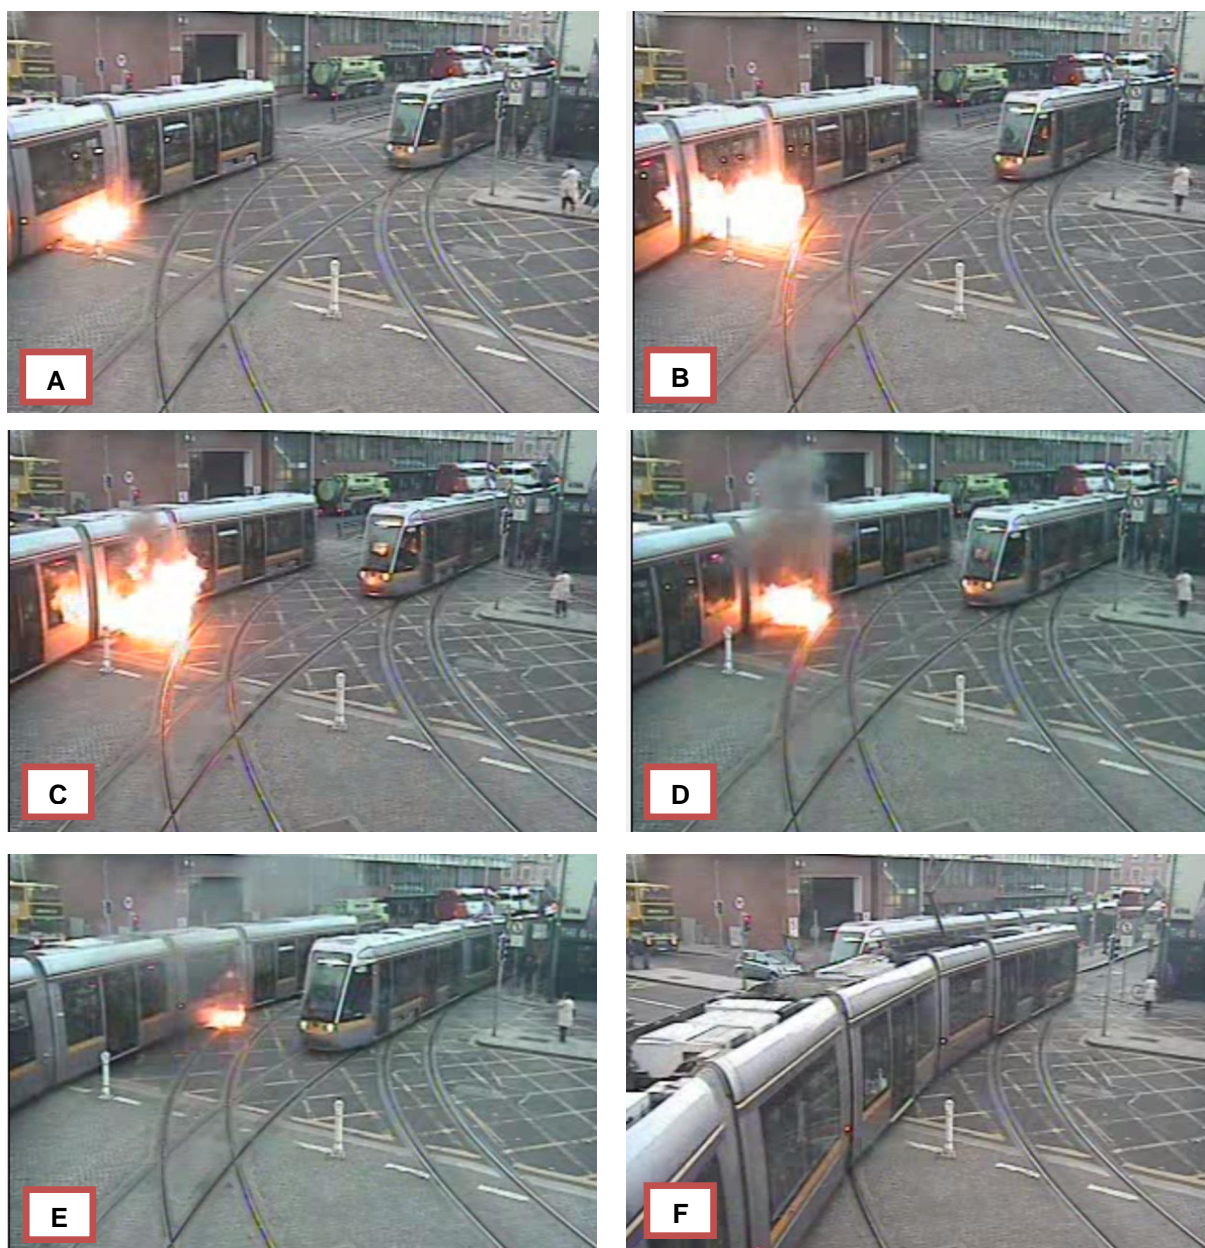
Figure 24 – CCTV images of events during the accident

97 During the first 2 seconds after ignition the initial burst of flames grows and reaches its peak volume which is sustained for under a second (Figure 24C). The flame then begins to recede in size (Figure 24D and 24E) until the Tram is stationary in the stop and the flames are contained to within the side skirts of the Tram. At no point did the fire penetrate into the passenger area of the tram.

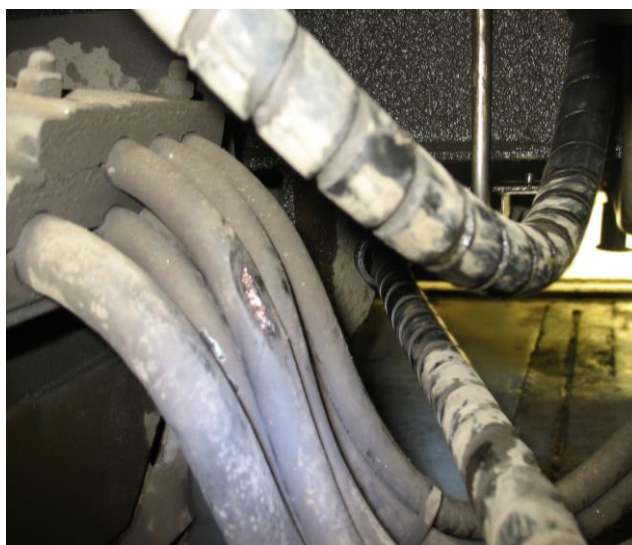
Figure 25 – Damage on AC cable in 2008 incident

103 On the 8th December 2008 a brake release failure occurred on a 401 Type Tram. The post incident inspection identified that the hydraulic hose was worn through and that caused the leak, however the core of the power cable (400 V) was also found to be exposed as shown in Figure 25.
