## PART 1 – Occurrence Description

Time & Date	10/02/2025 @ approximately 23:30 hours
Organisation	Iarnród Éireann Railway Undertaking (IÉ-RU) & IÉ Infrastructure Manager (IÉ-IM)
Location	Westport Yard
Rolling Stock	Rolling stock involved: <ul style="list-style-type: none"><li>• Intercity Railcar (ICR) Set 22 – six piece 22139 (leading), 22739, 22639, 22539, 22439 and 22339.</li><li>• Locomotive 076 and twelve empty timber wagons.</li></ul>
Parties	The parties involved were the driver and shunter.
Accident Description	<p>On the 10<sup>th</sup> February 2025, an ICR was driven onto the Shed Road in Westport Yard in expectation of the arrival of the Timber Train into the Cabin Siding. The ICR was fouling into the loop.</p> <p>The driver for Locomotive 076 undertook a number of shunting movements before propelling the timber wagons down the loop siding, colliding with the ICR which was fouling the loop, causing damage to the leading cab (22139) and a timber wagon.</p> <p>The physical damage is estimated to be €100,000; the actual value will not be known until the remedial works have been undertaken.</p>

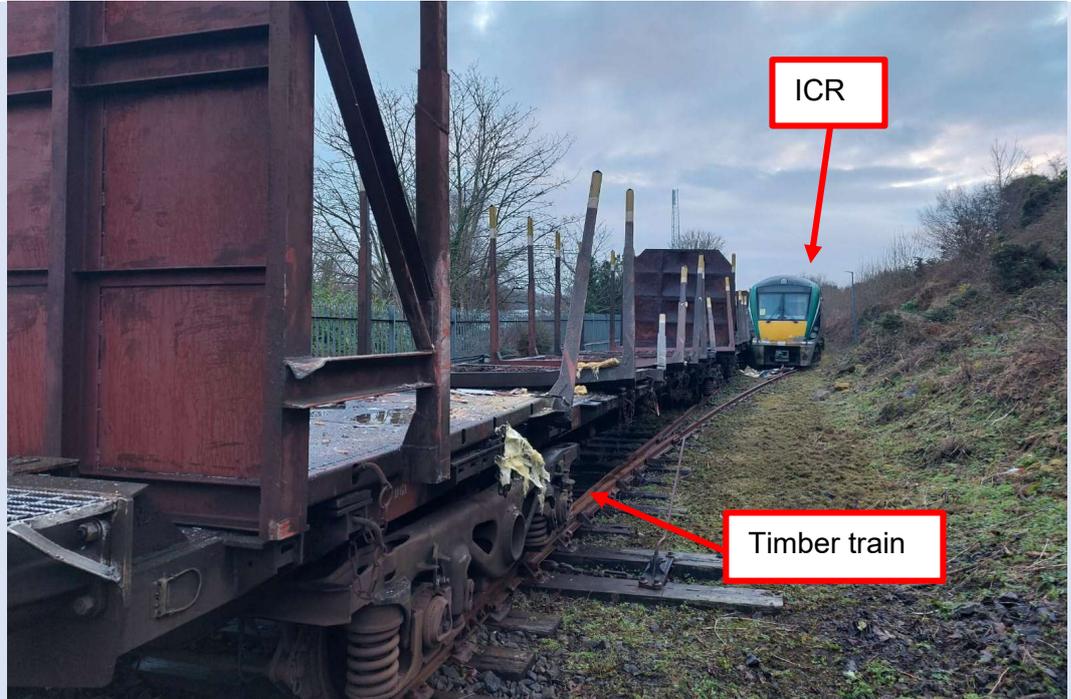
Figure 1 – Timber train and ICR

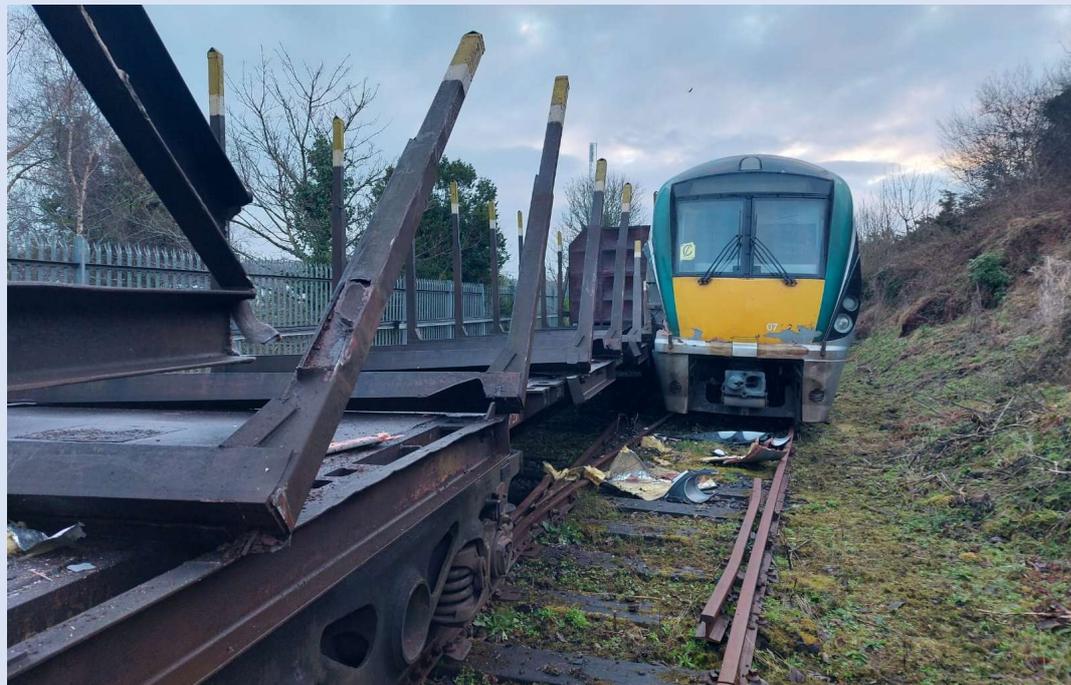
Figure 2 – Timber train and ICR

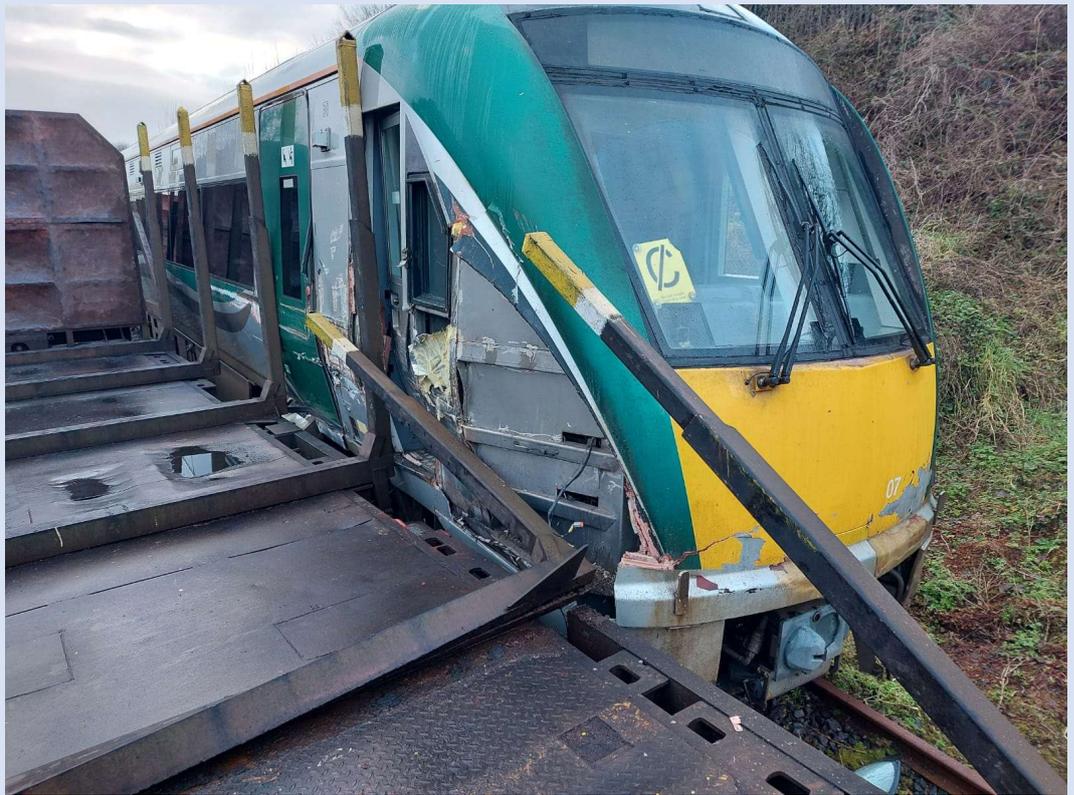
Figure 3 – Damage to ICR

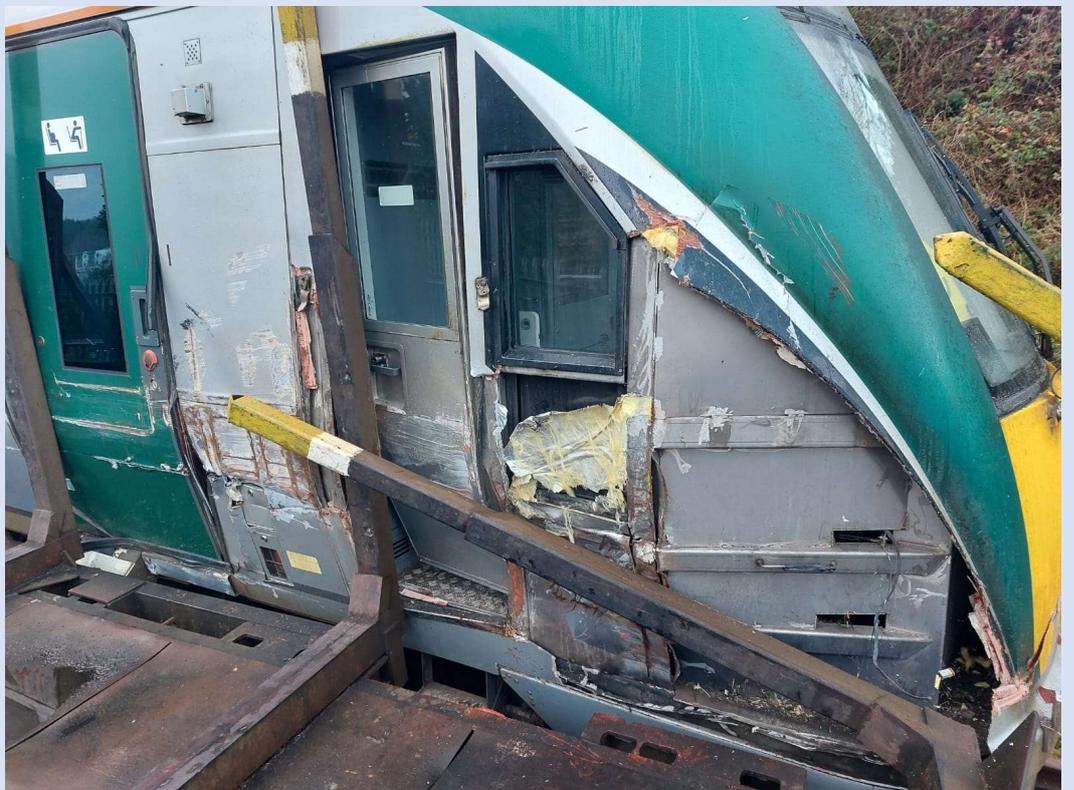
Figure 4 – Damage to ICR

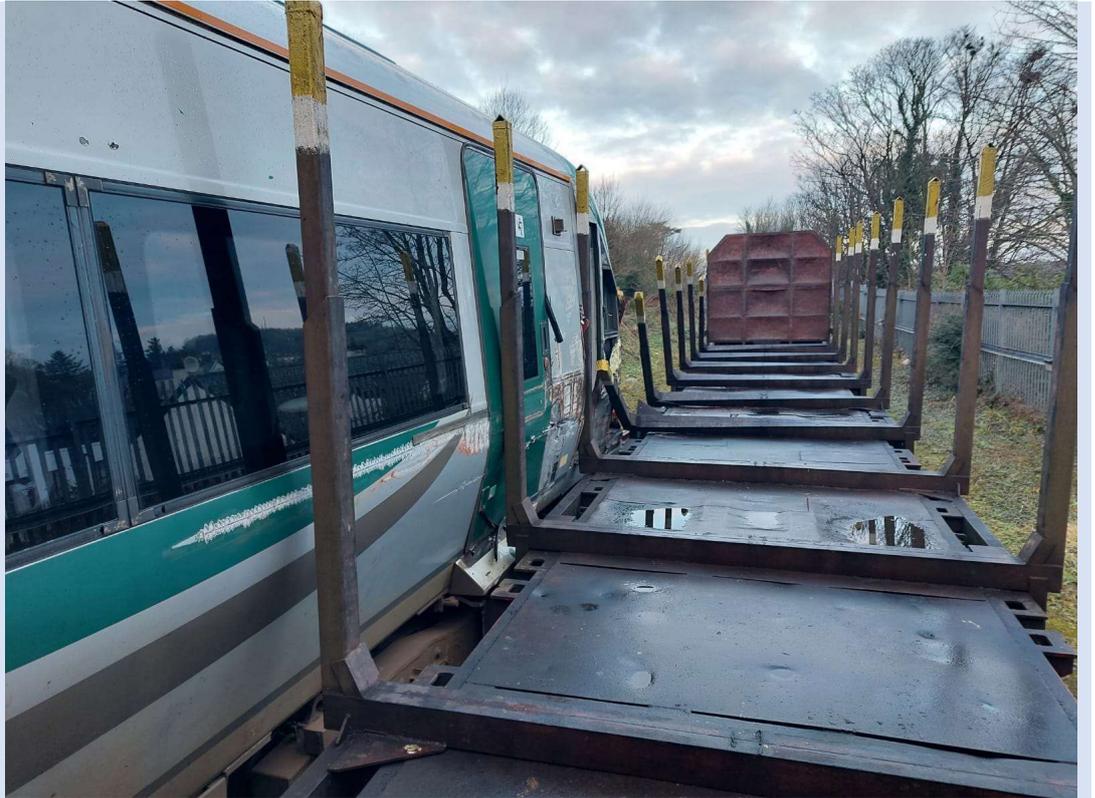
Figure 5 – Stopped position of timber train in relation to the ICR

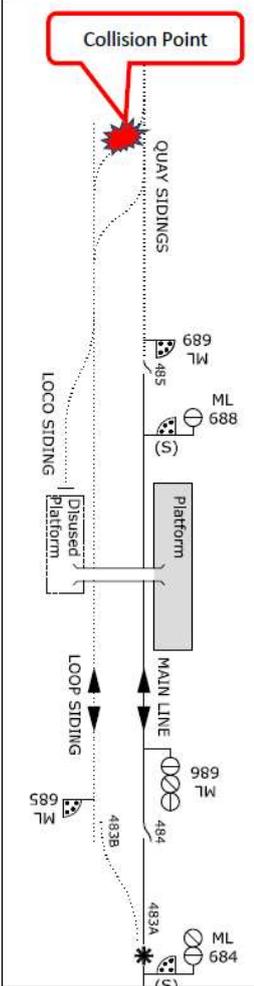
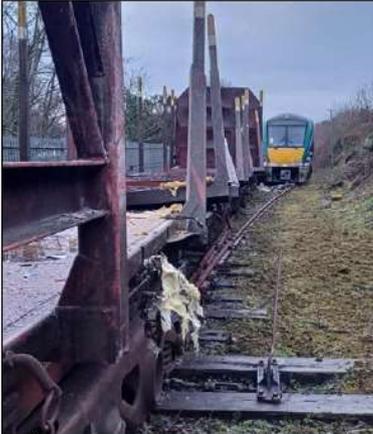
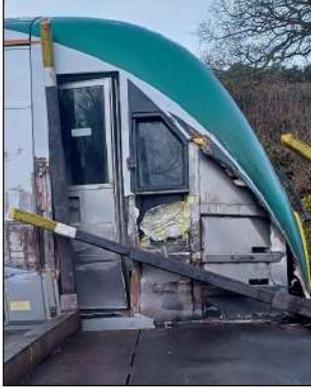
Figure 6 – Safety Alert

<b>Iarnród Éireann</b> <b>Irish Rail</b>		<b>RU Safety Department</b>		Reference No.	RU-Ops-SA111
				Status	Live
				Issue No.	1.0
				Date of Issue	13/02/2025
				Prepared by	Kevin Corkery
				Checked by	Nora Balfe John Geraghty
				Approved by	Joe Sullivan
<b>Date/Time:</b> 10/02/2025 23:30 approx.		<b>Location:</b> Westport			
<b>What happened?</b> (Based on available details)		<ul style="list-style-type: none"> <li>Empty 6 car ICR set was stabled on the Loop Siding in Westport</li> <li>The ICR was positioned fouling the Quay Siding</li> <li>A timber train was propelled into the Quay Siding</li> <li>The timber train collided with the ICR and both trains sustained considerable damage</li> </ul>

IÉ-RU Safety Department issued a Safety Alert (Ref: RU-Ops-SA11) on the 13<sup>th</sup> February 2025 outlining the occurrence, stating what happened, where it occurred and photographs showing the damage to the trains (noting no additional shunting instructions), see Figure 6.
