**Railway Accident
Investigation Unit
Ireland**

INVESTIGATION REPORT

**Passenger trap-and-drag occurrence on Luas tram
at Heuston Stop,**

26th March 2019

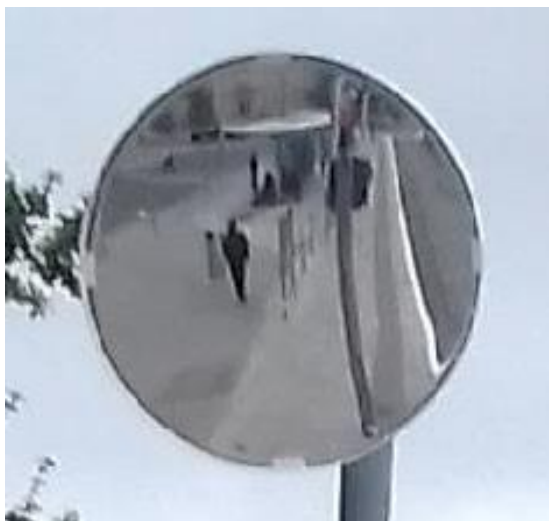
Figure 8 – Mirror Close-Up

54 A close up of the mirror at Heuston Stop (Figure 8) shows that the signal pole is obstructing some of the driver's view. By way of comparison in relation to platform viewing, the inbound platform at Charlemont Stop on the Green Line is fitted with a colour CCTV monitor to assist tram drivers looking at the platform and doors (Figure 9); it should be noted however, this has been installed primarily as a result of the curvature of the line.

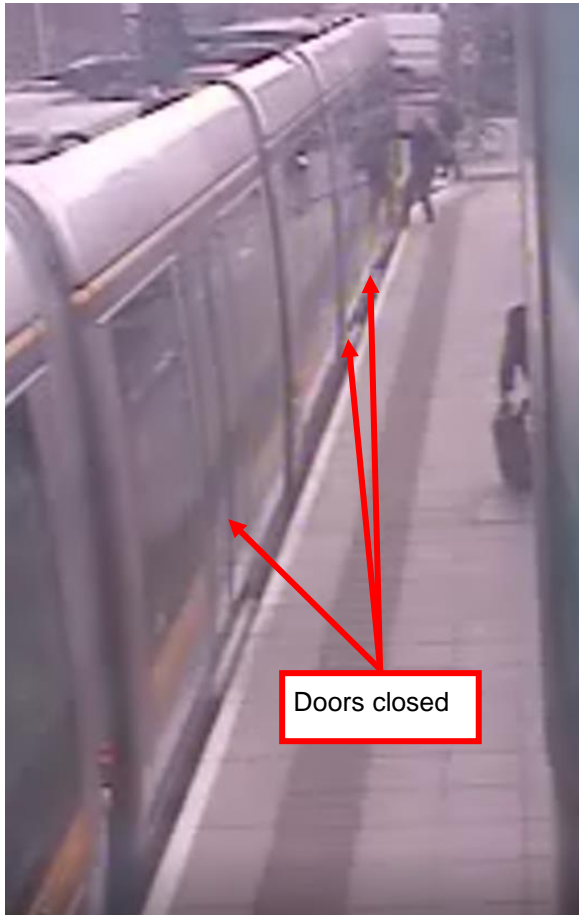
Figure 13 – Passenger's hand trapped in door

78 At 14:21:26 an intending passenger ran towards the rear most door on Tram 3011 and placed his hand between the door seal and the door pillar. All the doors closed, and the passenger's fingers became trapped in the rear door (see Figure 13).

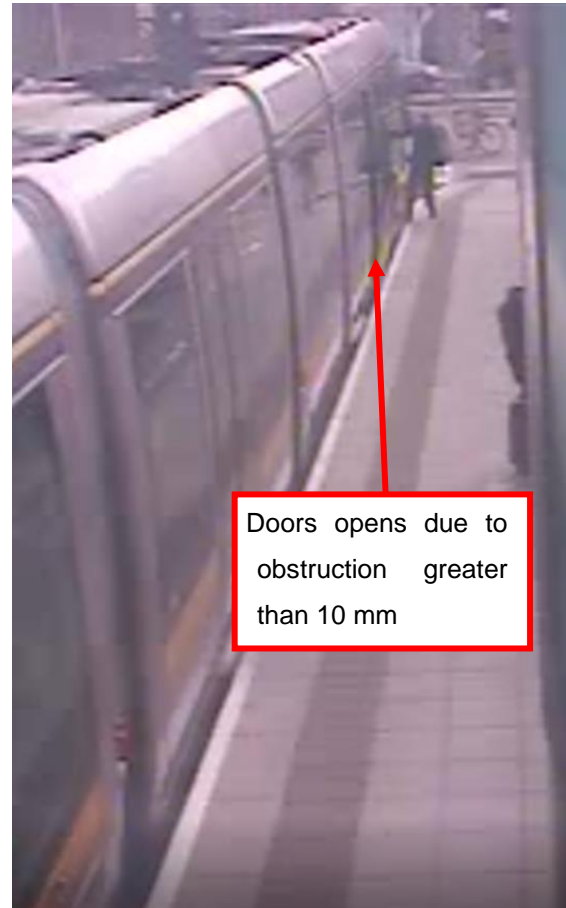
Figure 14 – Door, in front of trapped passenger's door, opens

79 The door adjacent to the passengers door re-opens, likely due to an obstruction greater than 10 mm being detected, however, on the rear most door, the passenger's hand remains trapped as the passenger's hand was less than 10 mm (Figure 14).

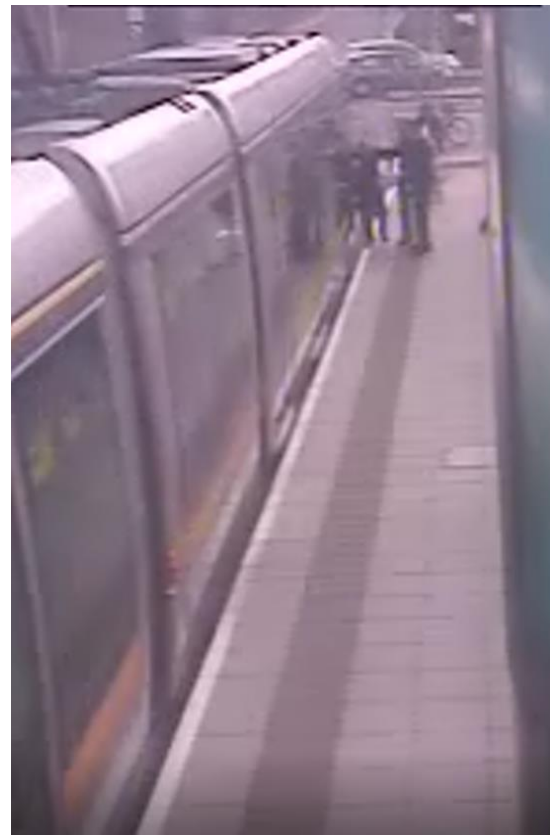
Figure 16 – Passenger & STT staff moving with the tram

83 At 14:21:46 the Driver starts to move the tram off the platform. The intending passenger walks along the platform with his hand trapped in the door as the STT staff attempt to free the passenger's fingers (see Figure 16).

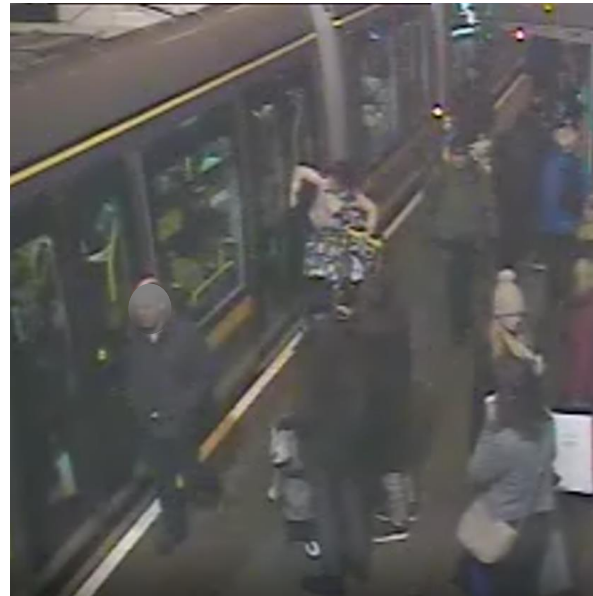
Figure 20 – Woman's hand trapped in doors

105 Approximately two seconds later, the passenger puts her hand between the doors as they are about to fully close resulting in her hand being trapped in the doors (see Figure 20); she began trying to pull her arm free after the initial trapping.

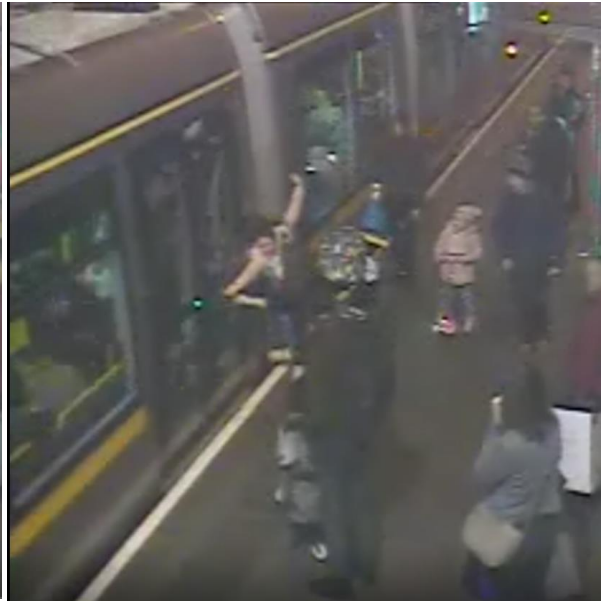
Figure 22 – Passenger being dragged along the platform

107 The woman is dragged along the platform (see Figure 22), begins to fall (see Figure 23), frees her hand and fall onto the platform (still Figure 24, which is a still of the CCTV taken three seconds after the tram begins its departure for Jervis Stop).
