REPORT OF THE INQUIRY

THE RAILWAY ACCIDENT ON THE CIE  
RAILWAY AT ARKLOW, CO WICKLOW ON  
3rd OCTOBER, 1979

Department of Transport  
Dublin

July 1982

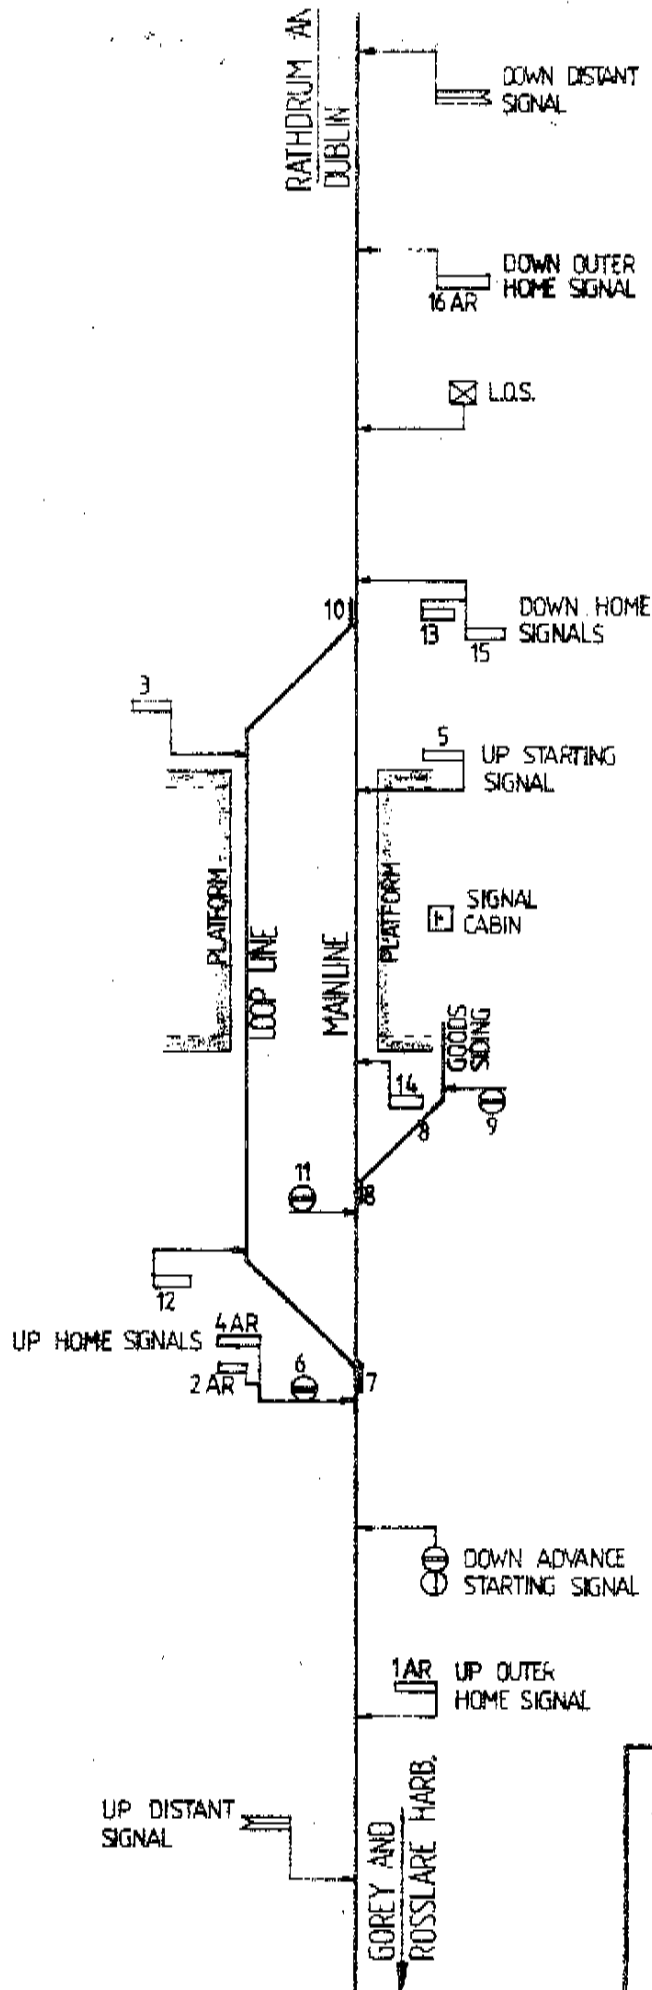
ARKLOW STATION

A diagrammatic layout of Arklow Station is at Appendix I.

In 1977 alterations were carried out to the Arklow Station signals. These alterations included moving the Up Outer Home and Distant semaphore signals 150 yards outwards towards Gorey and installing a new colour-light Down Advance Starting signal 300 yards from the Up Home signals. This signal replaced the Limit of Shunt Board.

The trains collided on the mainline near the Down Advance Starting signal which is between the Up Outer Home and Home signals. Five wagons of the cement train were extensively damaged. The locomotive of the passenger train was severely damaged and some damage was caused to the passenger coaches. There was substantial damage to the permanent way.

The accident on 3rd October, 1979 occurred because the 17.40 hours ex Rosslare Harbour Up passenger train, when approaching Arklow Station, could not be halted before it collided with a cement train which, in shunting, was propelling along the mainline towards Gorey and had almost reached the Down Advance Starting signal, which is located between the Up Outer Home and Home signals.
