REPORT OF THE INVESTIGATION

THE ACCIDENT ON THE CIE RAILWAY

CHERRYVILLE JUNCTION, CO. KILDARE

21st AUGUST, 1983

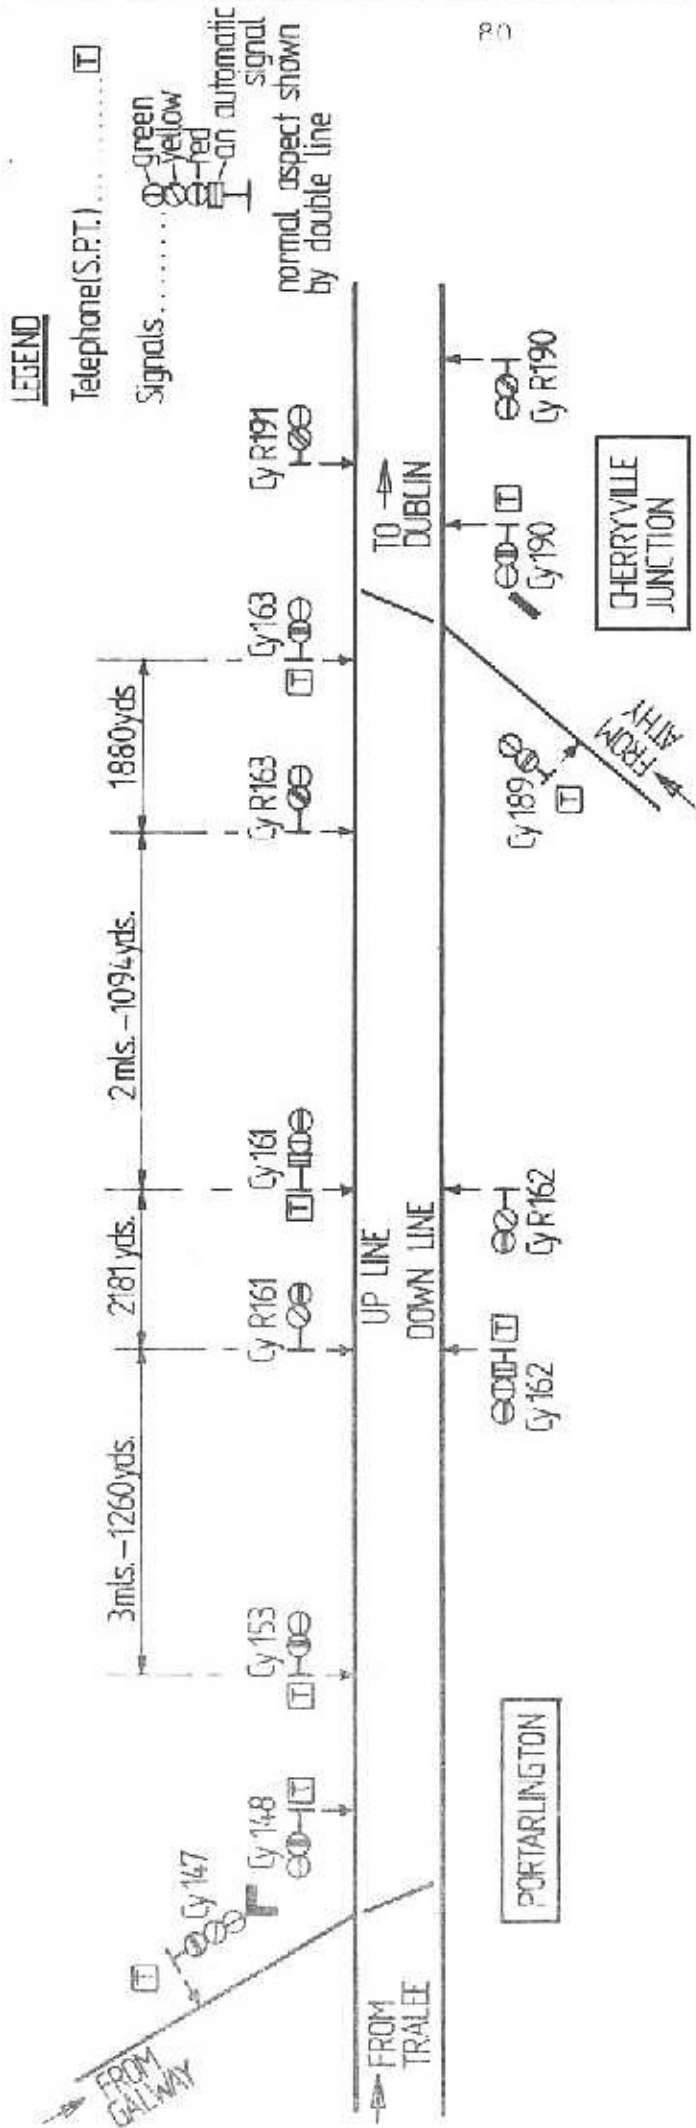
DIAGRAM SHOWING RELEVANT SIGNALS BETWEEN PORTARLINGTON AND CHERRYVILLE JUNCTION (Not to scale)

A diagram of the accident site showing relevant signals is at Appendix IV. The accident site is between signals CYR 163 and CY 163. The published maximum permitted line speed at that location was 75 m.p.h. and there is a rising gradient of 1 in 180 for traffic travelling towards Dublin.
