2008

Railway Accident Investigation Unit (Ireland) Annual Report

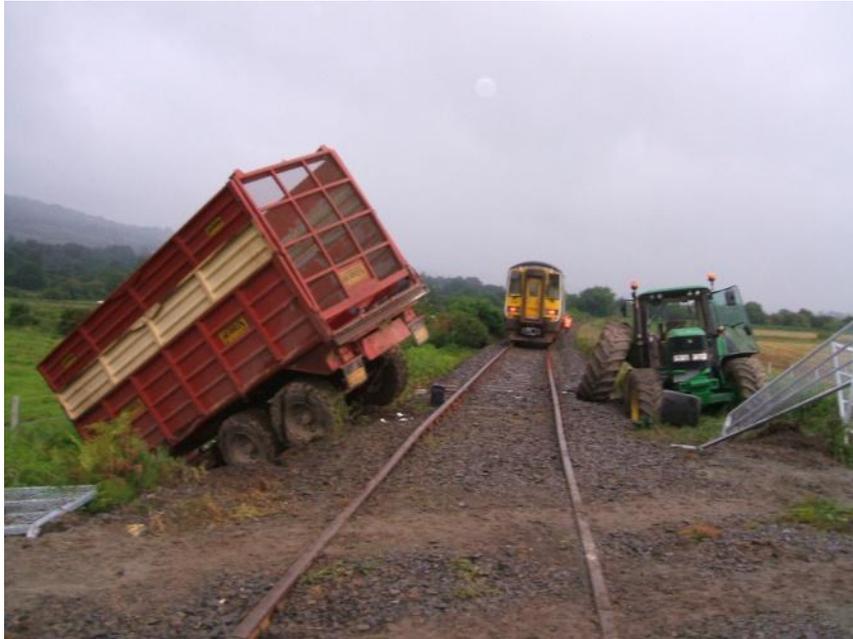
Photograph 1: Level Crossing XN104

The train was not derailed and came safely to a stop eighty-one metres beyond the crossing. The tractor and trailer uncoupled. The tractor struck fencing and then came to a stop on top of the signalpost, to the right of the direction of travel of the train, parallel to the railway line, facing the direction of Ballybrophy. The trailer struck fencing on the Down side and came to a stop in the ditch to the left of the direction of travel of the train, at an angle of approximately 60° to the railway line.

The immediate cause of the accident was that the tractor driver drove across the railway without stopping and checking for the approach of a train.

Causal factors were that the gates of the crossing being left open for movements back and forth while work was going on in the adjacent field. There was also limited visibility of the line from the tractor due to vegetation at the lineside.

Underlying causes were that the tractor driver was unfamiliar with the correct procedure for using unmanned level crossings as set out in Iarnród Éireann's publication "The SAFE use of unattended Railway Level Crossings" (Iarnród Éireann, 2006).

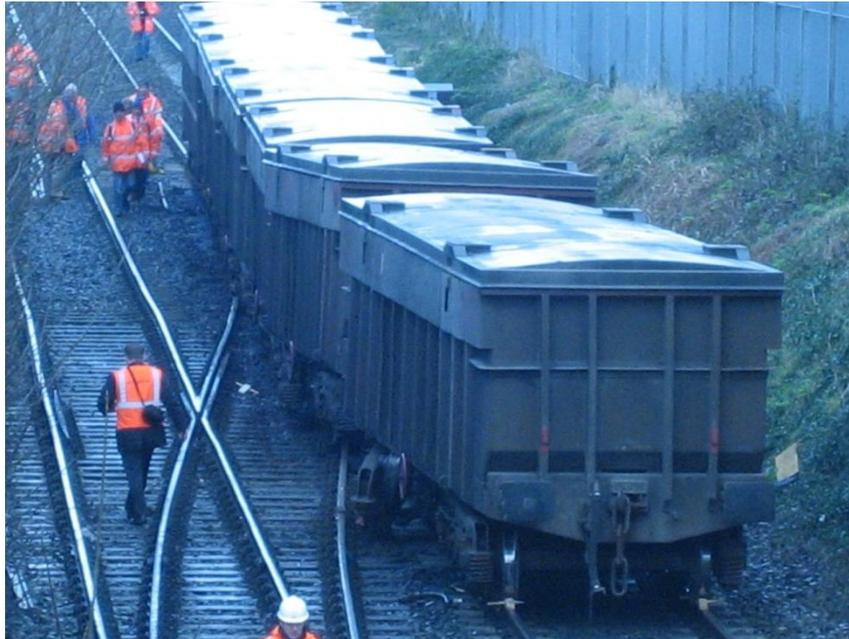
Photograph 2: Derailed Tara Mines freight train

At 22.53 hours on the 10th of January, 2008, a Tara Mines freight train operated by IÉ consisting of a locomotive and eleven wagons derailed south of Skerries station on the Dublin to Belfast line. The first wagon of the train suffered a burnt off axle journal due to a catastrophic bearing failure, it derailed at the 17 ½ milepost and continued to travel a further 230 yards, damaged crossover SK 244 resulting in the derailment of five further wagons before the train came to a stop.

Moderate damage was sustained by the leading wagon, the remaining derailed wagons suffered wheel impact damage, there was damage to sleepers over a distance of 230 yards and components of crossover SK 244 were broken as well as rail in its vicinity. There were no injuries and there was no release of the zinc concentrate that the wagons were transporting at the time.

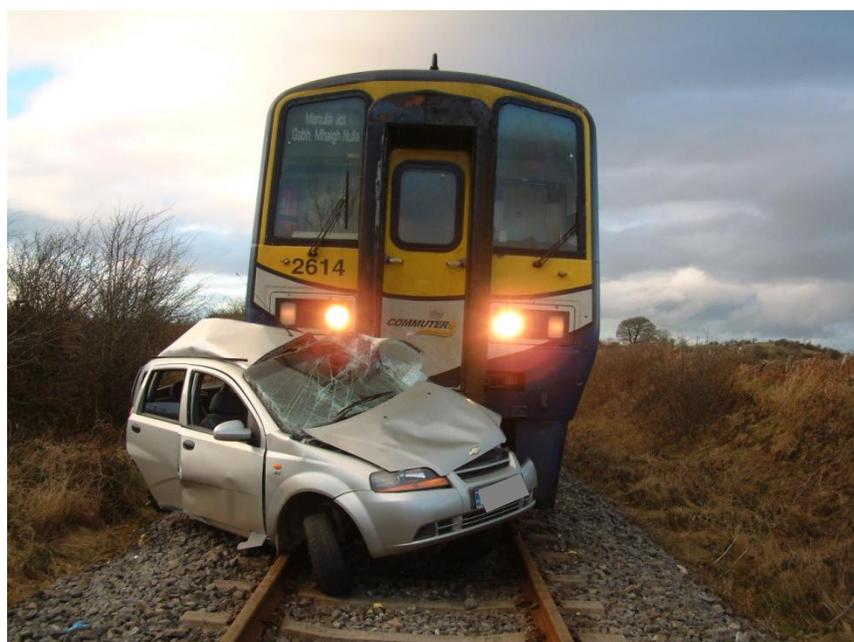
Photograph 3: Collision at level crossing XX032

The train struck the car on its left hand side. The car became lodged at the front of the train and remained there until the train came to a stop approximately 350 metres (m) from the point of collision. The leading vehicle of the train was damaged but the train was not derailed.

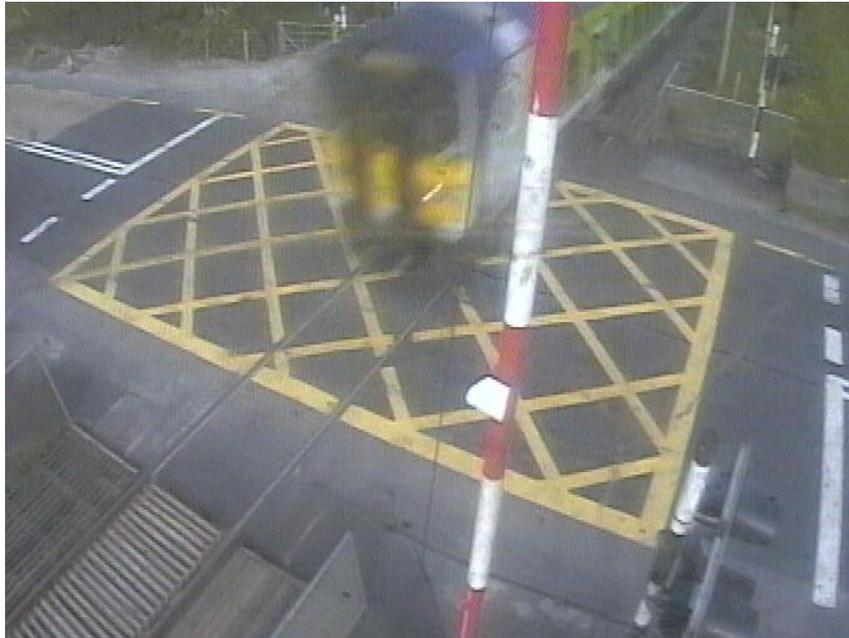
Photograph 4: CCTV image of incident

On the 14th of June 2008 at 8.50 hours an empty Diesel Multiple Unit, identification number J851, travelling from Manulla Junction to Dublin, passed through the raised barriers of Ballymurray level crossing, XM 075. Approximately two seconds prior to the Diesel Multiple Unit passing, a car crossed through the level crossing and as Diesel Multiple Unit crossed the crossing another car approached but came to a stop. The RAIU are continuing with a formal investigation of this incident and the report will be due in mid 2009.

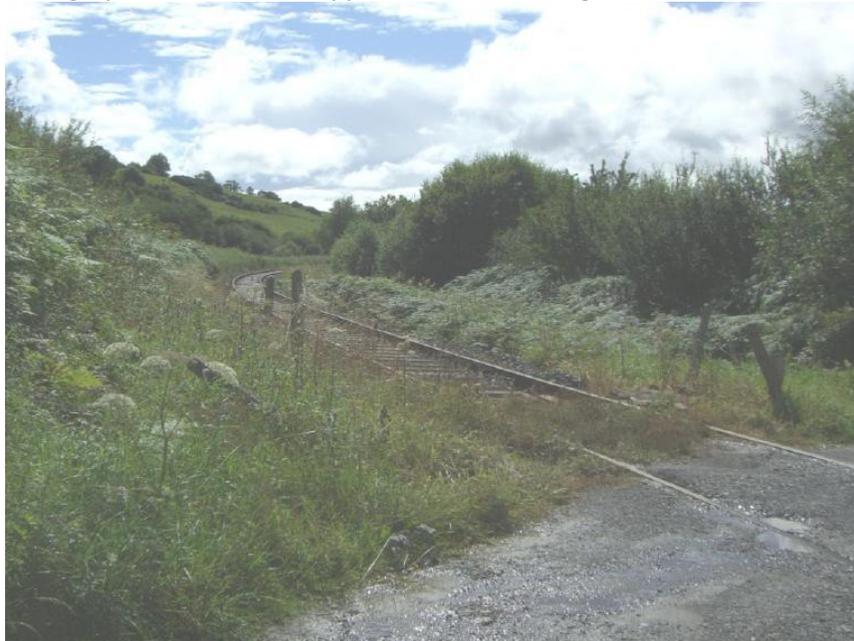
Photograph 5: View from Cappadine level crossing

On the 31st of July 2008 at approximately 17.20 hours, a Diesel Multiple Unit collided with a road vehicle at level crossing XN125 (Cappadine). The train involved was the 16.45 hours (hrs) IÉ service from Limerick to Ballybrophy (train identification number A463) departed Limerick Station. At approximately 17.20 hrs, on the approach to Level Crossing XN125, located in the townland of Cappadine in county Tipperary, the train driver saw a road vehicle stopped with its front end protruding onto the railway line. The train driver sounded the horn and made an emergency brake application. The train struck the road vehicle, a Toyota Corolla car, and then continued to travel approximately 130 metres past the level crossing before coming to a stop. The car had been travelling from the direction of Ballinahinch towards XN125 on the road when it stopped fouling the railway line. The train was crewed by a driver and a ticket checker with four passengers on board at the time of the collision. The car was occupied by a driver and a front seat passenger. There were no injuries, the front of the car was extensively damaged and there was minor damage to the train.
