Investigation Report 08073101

Collision between a train and a road vehicle at level crossing

XN125, Cappadine, on the Ballybrophy to Killonan line

31st of July 2008

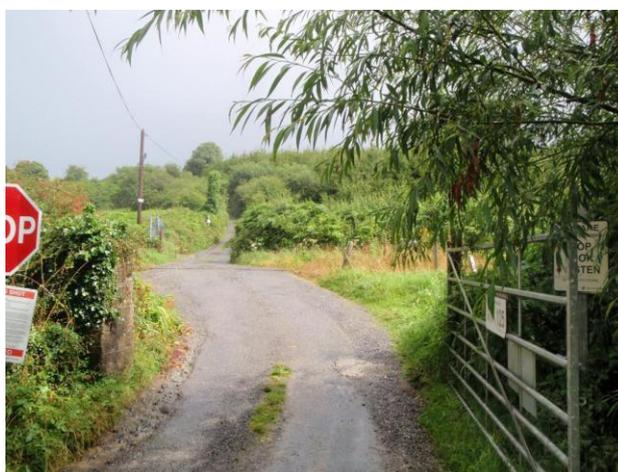
Photo 1 – View of XN125 from N7 side

The crossing had twelve foot iron gates on either side with fencing made up of concrete posts and wire between the gates and the railway line. There was an iron gate within the crossing on the Up side providing access to a field. The crossing surface was tar and chip. The route across the LC changed orientation, see photo 1, and the approach to the crossing was on a gradient at both sides, see figure 2.

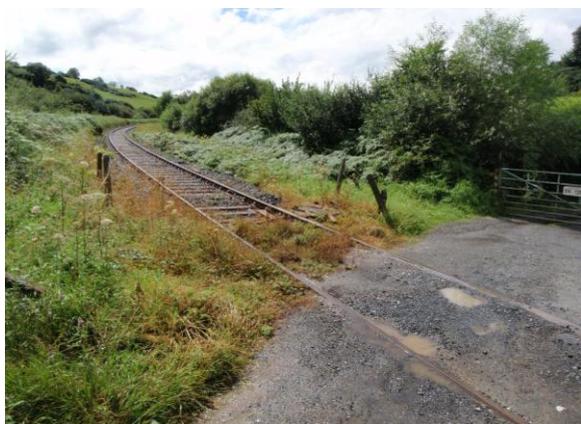
Photo 2 – LC fencing and cattle grids

The railway fencing and cattle grids at the crossing were severely damaged rendering them ineffective. The surface of the crossing and the approach road were in poor condition. See photos 2 and 3.

- The surface at XN125 has been changed to tarmac between the gates and across the track;
- New cattle grids have been installed;
- Drainage works have been undertaken;
- The views at the LC have been improved and discussions with adjacent landowners to facilitate further improvements are ongoing;
- CCTV monitoring of the LC is in the process of being set up.
