Investigation Report R2010-003

Derailment of an on track machine at Limerick Junction Station

on the Dublin to Cork Line

3rd of July 2009

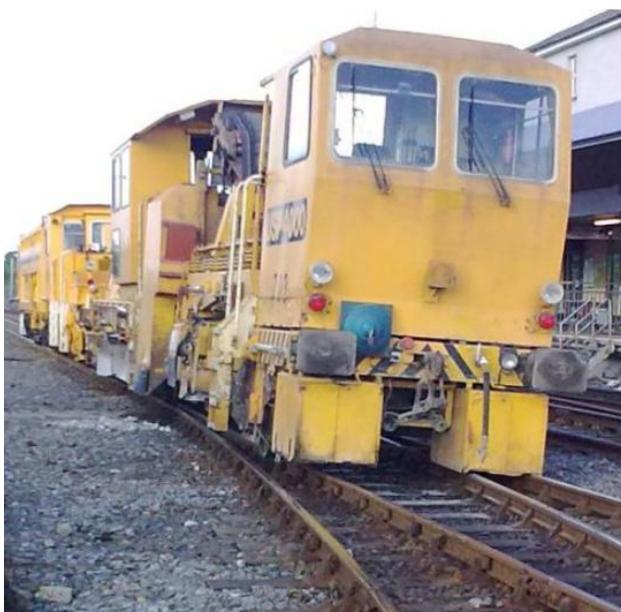
Photo 1 – Derailed OTMs on no. 27A points

The route was set by the Signaller for the train to travel from the Down Main Line to the Limerick Junction Sidings past disc signals no. 42 and no. 30. A *proceed aspect* was given at disc signal no. 42 and the *points* were set to travel straight ahead on the Down Main Line. When the train arrived at disc signal no. 30 a *proceed aspect* was displayed and the route was set for the train to travel over the *crossover* at the no. 27A points into the Limerick Junction Sidings. The train travelled onto the no. 27A points and derailed, see photo 1.

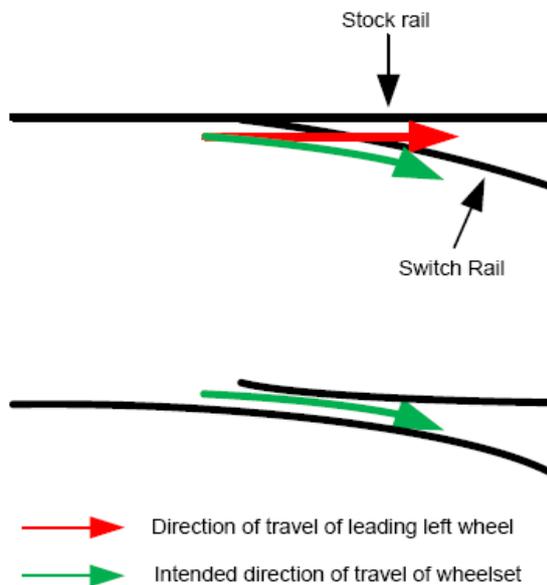
Figure 3 – Direction of travel of wheels

The leading left wheel of unit 703 did not follow the route that the no. 27A points were set for, it travelled over the top of the left *switch rail* of the points and along the *stock rail*, see figure 3 and photo 2.

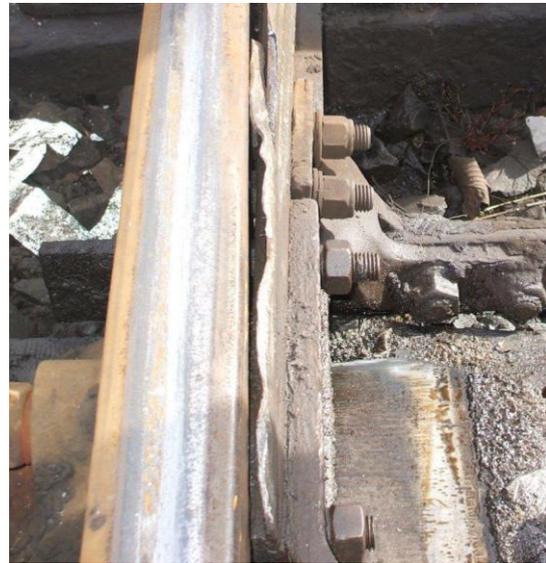
Photo 2 – Damaged switch rail

The left switch in the direction of travel was found to be bent and broken following the accident, see photo 2.

The tip of the left switch rail of the no. 27A points was bent and broken, the second stretcher bar was bent and four chairs were damaged.

Following the derailment of unit 703 the condition of the track at the no. 27A points was found to be poor, the ballast required renewal, the second stretcher bar was bent, some of the special chairs were indented into the sleepers, the tip of the right switch was worn and the tip of the left switch rail was bent and broken. The damage to the left switch indicated that the flange of the wheel had travelled along the top of the switch rail, see photo 2. During the inspections of the no. 27A points on the 25th of April 2009 and on the 9th of April 2008, a rating of 30% and 28% were given to the points out of a possible 100%.

IE should put in place a formalised process to ensure that life expired points are removed from service, where this is not possible a risk assessment should be carried out and appropriate controls should be implemented to manage the risks identified.

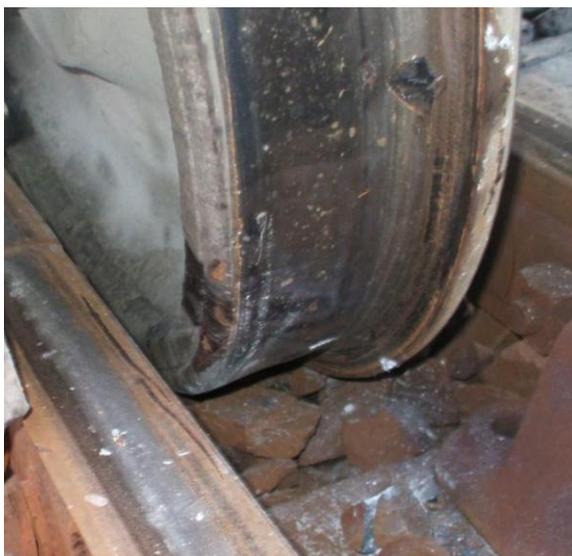
Photo 3 – Left derailed wheel

The right wheel of the leading *wheelset* of unit 703 and the second wheelset followed the correct route along the no. 27A points. The two wheels on the leading wheelset of unit 703 derailed as the route of the wheels diverged, see photos 3 and 4. The driver of unit 703 contacted the Signalman to let him know the train had derailed. The accident occurred during hours of darkness and the weather was dry.

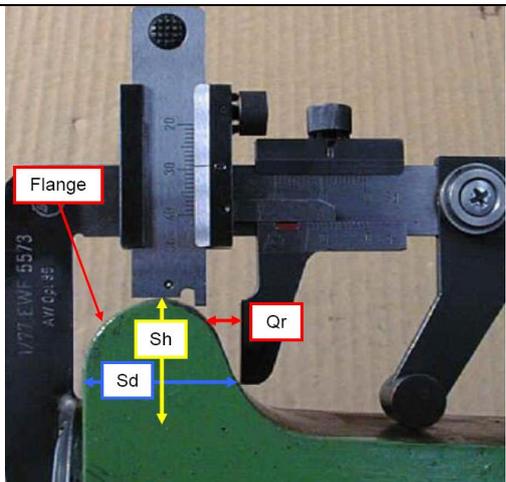
Table 3 – Wheel Profile Flange Service Limits

Flange thickness, Sd: Greater than 24 mm.	27.666 mm	25.229 mm
	Flange height, Sh: Less than 38 mm.	30.326 mm	30.415 mm
	Flange sharpness, Qr: Greater than 6.5 mm.	5.396 mm	3.760 mm

The profile of the wheels on the leading wheelset of unit 703 did not meet minimum tolerances defined by IÉ for travel on the railway network as the flange sharpness was below 6.5 mm. Examination of the wheel profiles is required as part of the PM3 and PM4 inspections, however, the staff were not trained to verify the critical dimensions identified in wagon instruction no. 23 and at the last inspection only visual checks were carried out which are not sufficient to establish the acceptability of the wheel profile.

IE should ensure OTM maintenance personnel are trained and competent to examine wheelsets.
