**Investigation Report 2011-R003**

**Tram derailment at The Point Stop, Luas Red Line**

**13<sup>th</sup> May 2010**

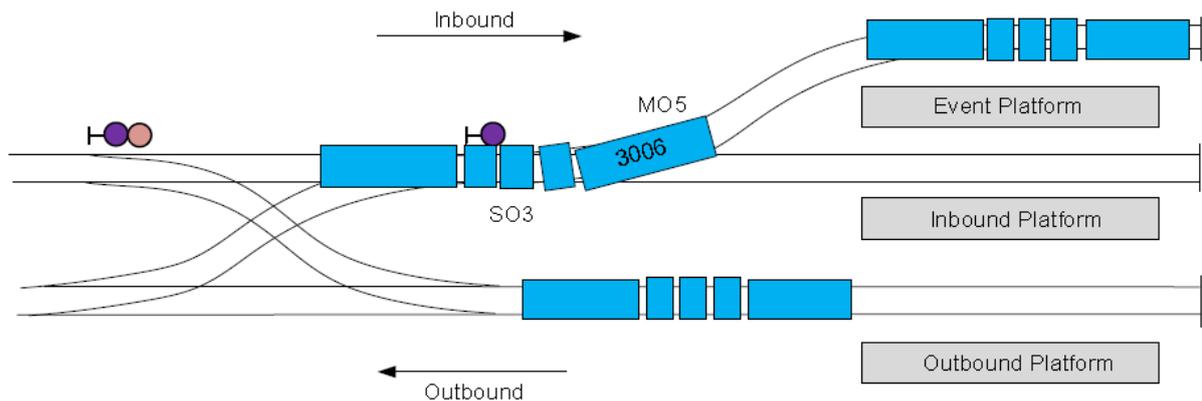
Figure 3 – Tram 3006 travelling towards the Event Platform

The Tram Driver continued forward over facing points SO3, and as he began to travel over MO5 points, Tram 3006 started to travel towards the Event Platform, see Figure 3.

In this case, the Tram Driver, did not select MO5 points for the Inbound Platform, where he had intended to travel, and therefore travelled for a distance of 64m towards the Event Platform, for which MO5 points had been set. The driver stopped Tram 3006 and informed CCR.

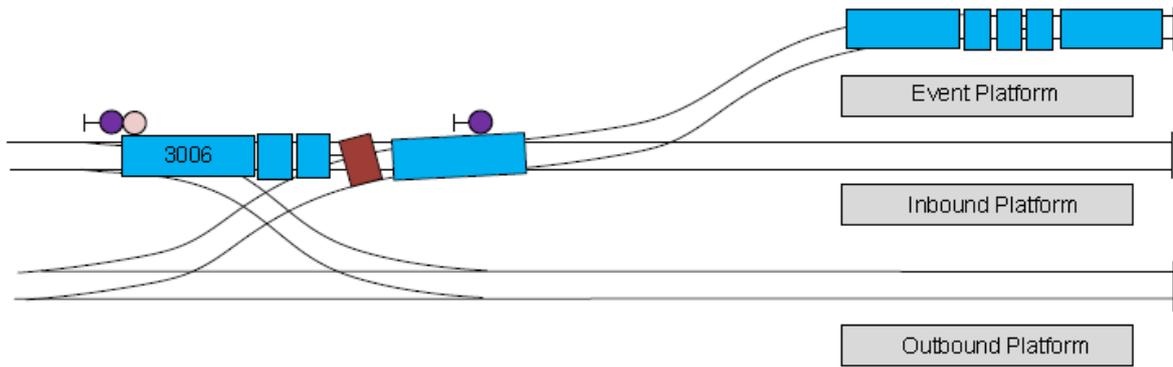
Figure 4 – Position of derailed Tram 3006

As the more experienced driver boarded Tram 3006, the Tram Driver who had changed cab ends at this stage, drove Tram 3006 in the outbound direction. Tram 3006 travelled outbound 24 m when the first *wheelset* on *bogie* number 3 (no. 3) in the direction of travel, derailed, see Figure 4. The Tram Driver immediately stopped and informed CCR of the derailment.

Tram 3006 had not finished travelling over MO5 points in the position he had stopped. As mentioned previously, inbound trams push through the spring loaded points, which then 'spring back' and reset to the default outbound direction. As Tram 3006 had not completely cleared SO1 points, when Tram 3006 began to travel in the outbound direction, the first three sections of Tram 3006 travelled back along the inbound track and the last two sections began to travel on the outbound track, leading to the bogie on the fourth section derailing as it was dragged by the first three sections towards the inbound track.

As Tram 3006 had not travelled far enough through the spring points, therefore when the outbound manoeuvre was made the tram derailed.

Tram 3006 should have been driven forward a short distance, clearing the spring points, before starting the reverse manoeuvre.

Veolia Safety Department are in the process of having all spring points clearly marked with a Red painted identification and a clearly marked area which must be passed should a reverse move over the points be necessary.

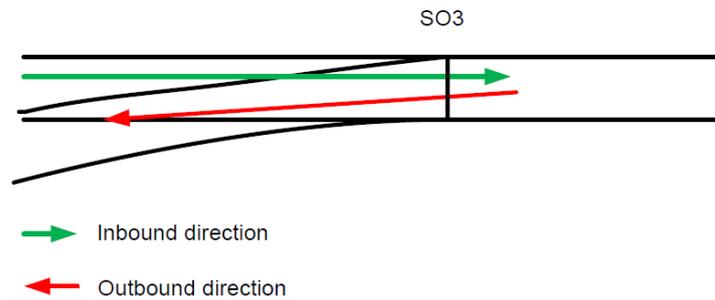
Figure 6 – SO3 spring points

Points SO3 are spring points. Inbound trams push through the spring loaded points, see Figure 6. The spring points then 'spring back' and reset to the default outbound direction.

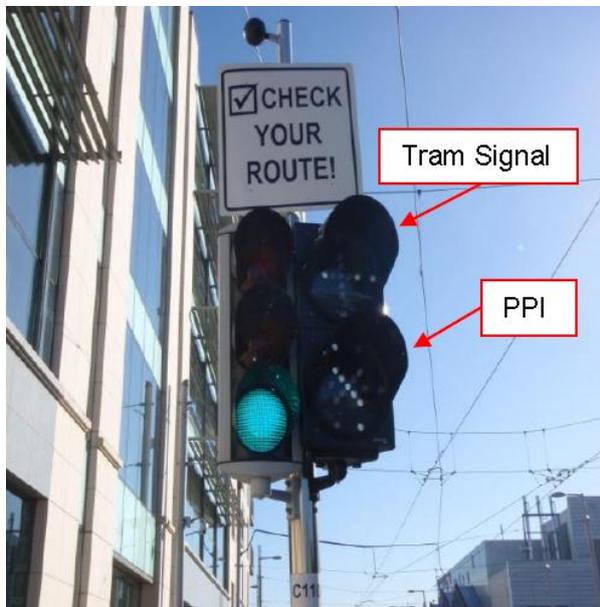
Photograph 1 – Tram signal & PPI at crossover

On approach to the crossover (for points MO1) there is a tram signal with a PPI mounted below it beside a road traffic signal, see Photograph 1 and Figure 9. (The road traffic signals are not used by Luas trams and the check your route sign was added after the accident).

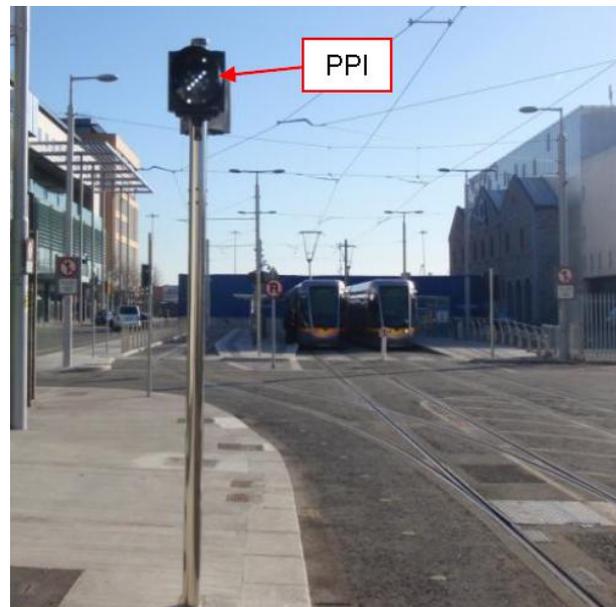
Photograph 2 – Tram signal at facing points

At 45 m beyond this tram signal and PPI, there is another PPI located at facing points MO5 for the Event Platform, see Photograph 2 and Figure 9. This provides information to tram drivers in relation to the direction that the points are set i.e. Inbound Platform or Event Platform. The tram driver can then change the direction of the points, as necessary.
