RAILWAY ACCIDENT

REPORT OF INQUIRY

THE COLLISION THAT OCCURRED

AT ROSSLARE STRAND STATION

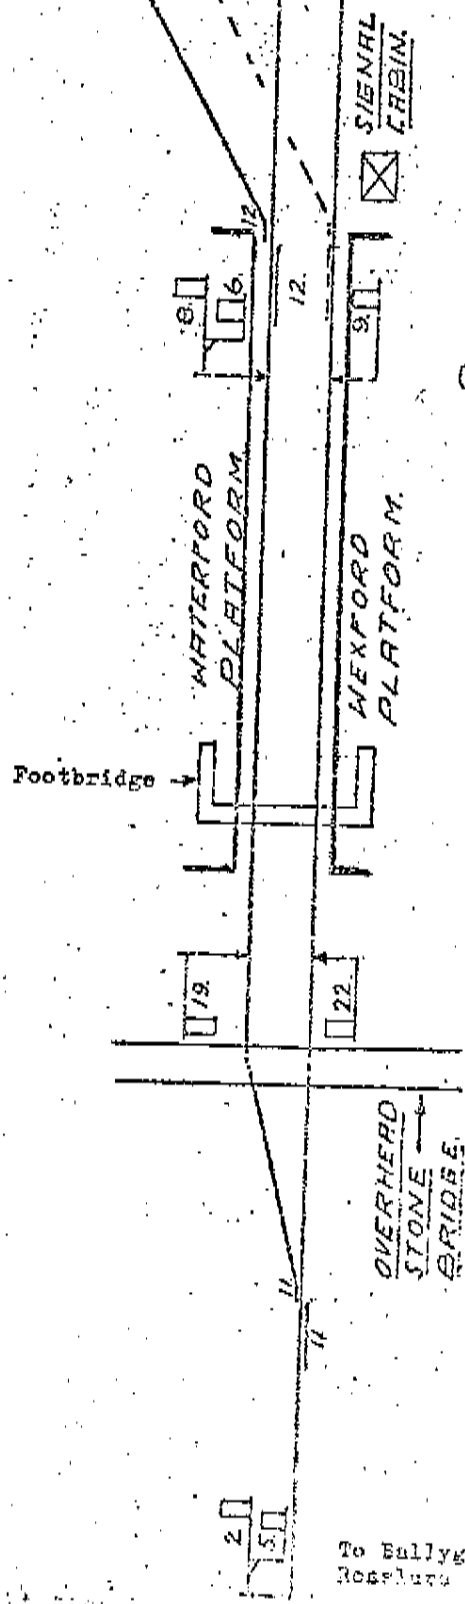
LAYOUT OF  
ROSSLAKE STRAND  
STATION  
(Not to Scale)

Site and Signalling (see Attachment A)

7. Rosslare Strand Station is the junction between the Dublin/Rosslare Harbour and Limerick/Rosslare Harbour lines. Both lines are single lines worked by electric train staff. There are two platforms at Rosslare Strand Station. The one at the right-hand side approaching from Rosslare Harbour is referred to in this report as the "Wexford" platform while the other is referred to as the "Waterford" platform. The Station Booking Office is on the Wexford platform. The Station Signal Cabin is just past the Dublin (Wexford) end of the Wexford platform. There is a double line through the Station. The Wexford platform is used by all up and down Dublin (and Wexford) trains except when two such trains have to cross at Rosslare Strand.

8. Prior to 1973 (when the connection from the Waterford line to the Down Loop was removed) Limerick/Rosslare Harbour trains could use both platforms. Since the removal of this connection Limerick/Rosslare Harbour trains cannot be brought direct to or from the Wexford platform, and all trains to and from Limerick (and Waterford) must use the Waterford platform when arriving at or departing from Rosslare Strand Station.

Section of track removed  
May, 1973.
