Railway Accident Investigation Unit Ireland

Annual Report 2015

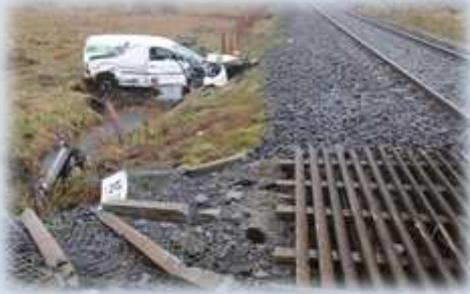
Vehicle struck by train at Corraun Level Crossing XX204, Co. Mayo, 12th February 2014

At approximately 09:55 hours (hrs) on Wednesday 12th February 2014, a post van approached Corraun Level Crossing with the gates open and drove onto the level crossing. At the same time, an IÉ passenger service from Ballina was travelling through Corraun Level Crossing and struck the van. On impact, the van was thrown clear of the train and into the adjacent drainage ditch before coming to a stop. He suffered serious injuries.

The immediate cause of the accident was that the van did not stop, as required, at the Level Crossing and drove into the path of the oncoming train. Contributory factors associated with the accident are:

- There is a history of misuse at the level crossing; with local users regularly misusing the level crossing;
- IÉ did not take sufficient actions at the level crossing to prevent its regular misuse, despite the RAIU making a safety recommendation related to preventing level crossing misuse in 2009 and re-iterating in 2011.

- The addition and purpose of the decision point line on user worked level crossings is not obvious to users of the Level Crossing and may cause confusion with statutory stop lines still at some level crossings.

- IÉ should consider options to upgrade the crossing to minimise direct action by the users;
- IÉ should carry out a full review of known misused user worked level crossings on public and private roads and either upgrade the level crossing or introduce measures to minimise their misuse;
- IÉ should ensure that where a Decision Line is present at a level crossing, that the purpose of this Decision Line is appropriately conveyed to the level crossing users.

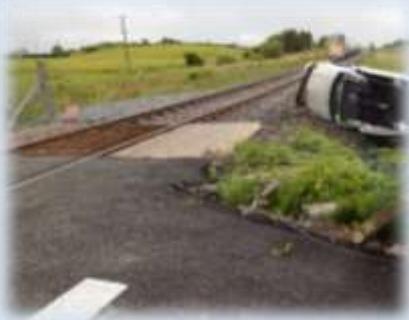
Car strikes train at Level Crossing XM 250, Knockaphunta, Co. Mayo

At approximately 18:42 hrs on Sunday 8th June 2014, a passenger service from Dublin to Westport was approaching Knockaphunta Level Crossing XM250, situated at Knockaphunta, near Castlebar, Co Mayo when a Toyota Auris approached the level crossing from the Castlebar direction. As the train travelled through the level crossing, the car drove onto the level crossing and into the side of the train. The car was thrown clear by the impact and into the adjacent drainage ditch next to the level crossing, the driver was unhurt.

The immediate cause of the accident was that a car did not stop at the level crossing and drove into the side of the passing train. Contributory factors associated with accident are:

The underlying cause associated with this accident is the fact that the many actions IÉ have taken in response to previous RAIU safety recommendations (2009 and 2011), have not resolved the issue of level crossing users leaving the gates open.

An additional observation to this accident is that the addition and purpose of the 'new Stop Line' on user worked level crossings is not obvious to users of the level crossing and may cause confusion with the statutory Stop Lines used previously at some level crossings.

- The RSC, RSA and IÉ in consultation with any relevant stakeholders should agree a common policy in connection with instructions and warnings related to user worked level crossings.
