# Railway Accident Investigation Unit of Ireland

## Annual Report 2012

Report number: 2013-AR2012

Published: 05/09/2013

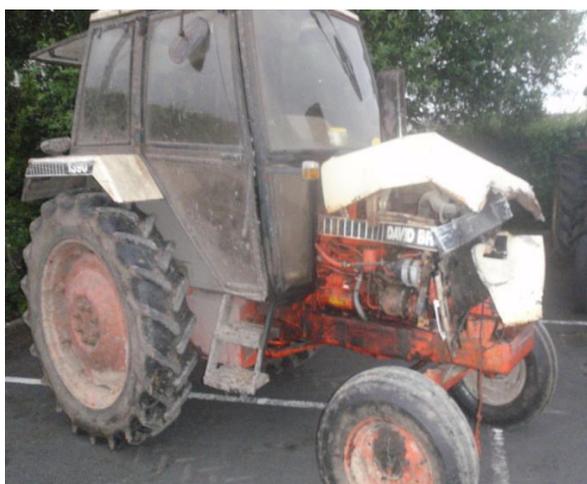
On the 20<sup>th</sup> June 2012 at 14:50 hours the 14:15 hours passenger train travelling from Limerick to Galway was involved in a collision with a tractor at level crossing number XE020 which is located close to Cratloe, County Clare on the R462. The driver of the train was initially unaware of the collision and continued to Sixmilebridge Station. The tractor driver although shocked was uninjured and the tractor sustained frontal damage.

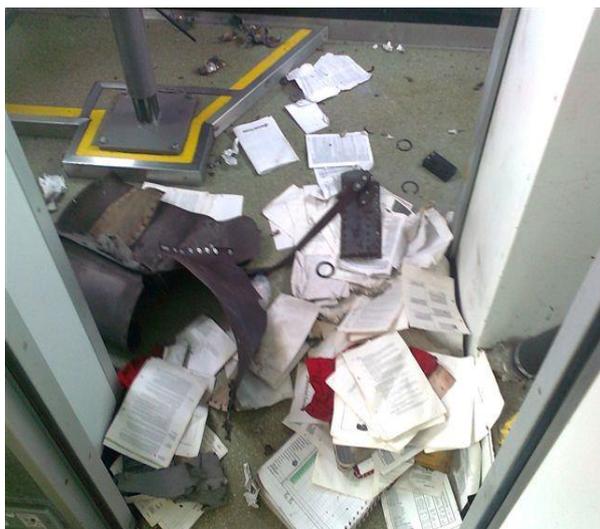
**Figure 4 – Damage to drivers' bag and cab**

As the driver placed his leather drivers' bag on the floor of the DART cab, eleven of the twelve Railway Fog signals that he was carrying in the bag exploded. The driver sustained injuries to his hand and suffered some temporary loss of hearing. The interior of the cab was superficially damaged.

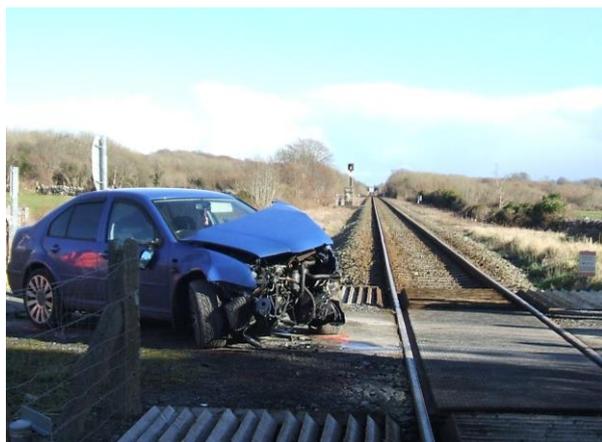
**Figure 5 – Car strike at XG173**

At approximately 12:00 hours on Monday 14<sup>th</sup> February a waste collection vehicle crew, who regularly used the Morrough level crossing (XG173) to collect waste from the private residence, Murrough House, opened the gates of the level crossing and passed over the level crossing. The crew left the level crossing gates open while they collected waste, a task that usually took only a few minutes. At approximately 12:13 hours a car approached the level crossing with the gates still open. The car slowly drove

- IÉ should review the suitability of the signage at user worked crossings on public and private roads, ensuring that human factors issues are identified and addressed;
- IÉ should liaise with local authorities where private road level crossings can be accessed from a public road to ensure there is advance warning to road users;
- IÉ should ensure that they adopt their own standards in relation to design changes to any plant, equipment, infrastructure or operations that have the potential to affect safety;
- The Railway Safety Commission should ensure that they adopt a formal approach to submissions made by IÉ in relation to design changes to any plant, equipment, infrastructure or operations that has the potential to affect safety.

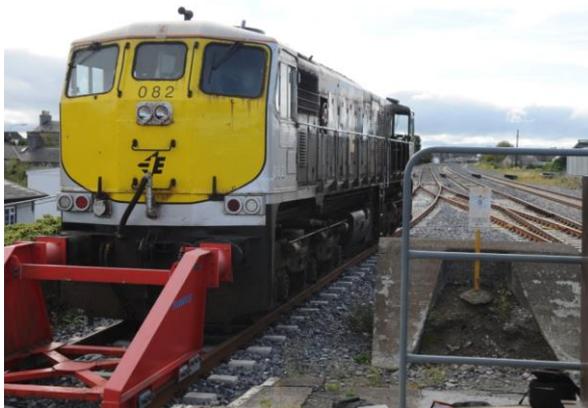
**Figure 6 – Runaway locomotive**

The immediate cause of the locomotive running away, whilst left unattended on a gradient, was the gradual release of the brakes. This was as a result of the following causal factors, which were necessary for the accident to occur:

- An air leak in part of the braking system;
- The train driver did not fully comply with the instructions for vacating and occupying locomotive cabs, set out in Iarnród Éireann's Drivers' Manual.

- IÉ should review their Vehicle Maintenance Instructions for locomotives to ensure that there are adequate braking tests at appropriate intervals;
- IÉ should adopt a quality control system, for the introduction of new maintenance procedures for locomotives;
- IÉ should review their system for introducing new train drivers' manuals, to ensure that train drivers are fully trained and assessed in all aspects of these manuals;
- IÉ should review their competency management system for train drivers to ensure that all driving tasks are routinely assessed.

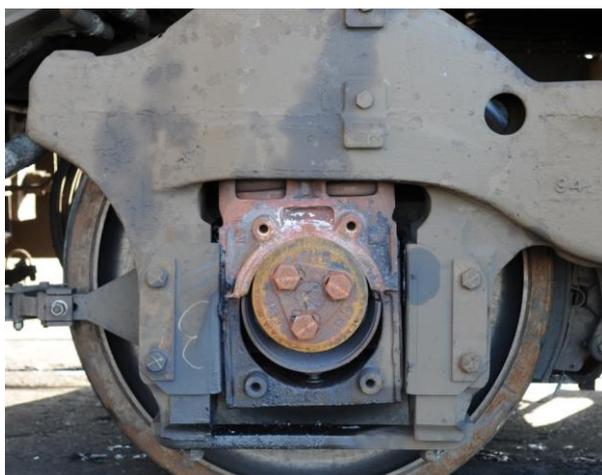
**Figure 7 – Failed bearing on locomotive 233**

The train was then allowed to continue its journey to Connolly Station. When the train arrived at Connolly Station it was inspected by a member of maintenance staff, one of the axleboxes on the locomotive was found to be red hot and smoking. An axle journal bearing on the locomotive, which was positioned at the rear of the train, had failed.

The immediate cause of the bearing failure could not be determined due to the extensive damage to the bearing, which can occur following substantial overheating and deformation of the material as in this case.
