**Railway Accident
Investigation Unit
Ireland**

INVESTIGATION REPORT

Wrongside Door Failure at Ashtown Station,

RAIU Report No: 2019 – R001

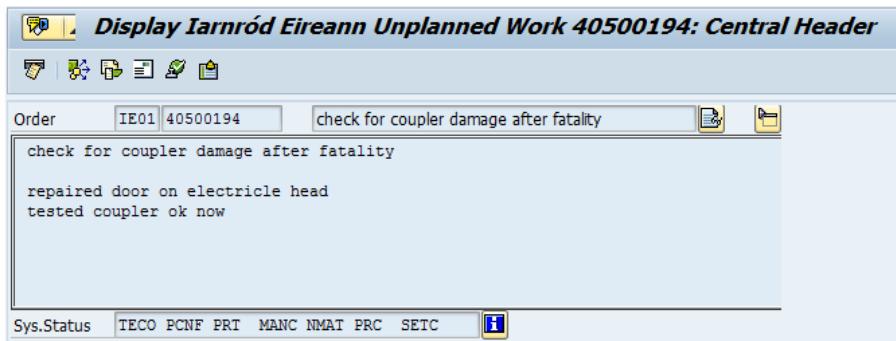
Figure 13 – CME Work Order generated for coupler on the 6th June 2018

- 55 After the fatal accident on the 6th June 2018, the steps identified in VMI Z1C29A0001 were undertaken. CME generated an unplanned ‘work order’ to “check for coupler damage after fatality”. After which the coupler was checked, repaired and tested, with the work order stating: “repaired door on electrical head” and “tested coupler ok now”, see Figure 13.

113 In terms of the unscheduled maintenance, VMI Z1C29A0001 was carried out after the collision on the 6th June 2018. The collision which directly impacted the coupler of car 29415. VMI Z1C29A0001 does not directly request the inspection of the coupler, but does have an all-encompassing step for checking for damage sustained (paragraphs 52 - 54); as a result, the external parts of the coupler was checked, damage was found to the door of the electrical head which was repaired and tested (paragraph 55). There were no checks carried out to the internal parts of the electrical head.

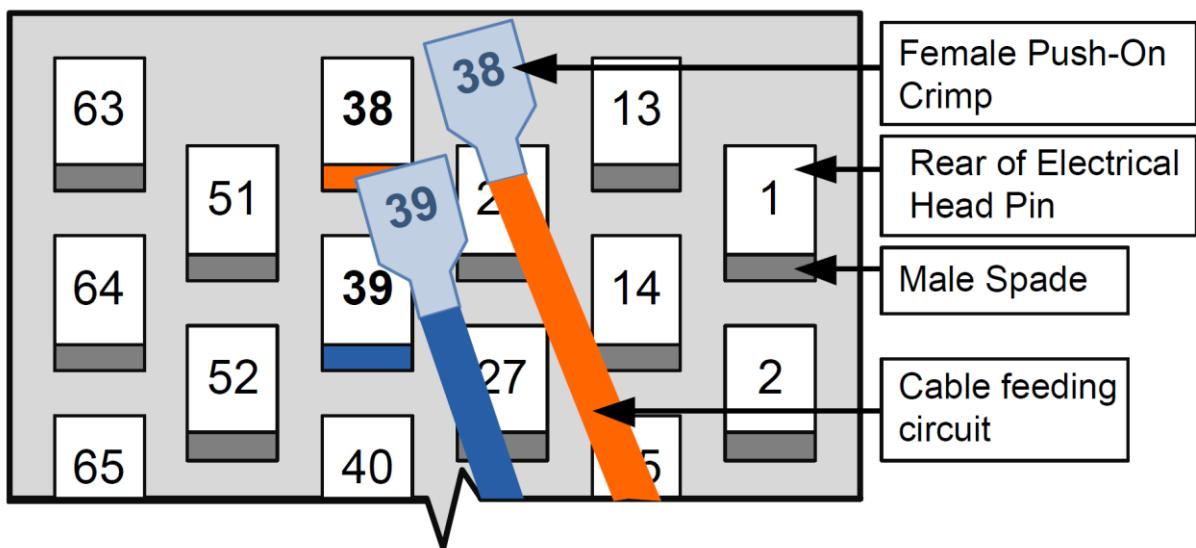
Figure 14 – Illustration of rear of coupler head

- 56 In terms of the incident on the 12th August 2018, after the wrongside door failure, the train was taken to Drogheda Train Care Depot for investigation and the fault was still present. When Unit 15 was uncoupled, the fault could not be reproduced; but when car 29415 was coupled to any other car the fault was present.
- 57 A further inspection of the rear of the coupler electrical head on car 29415 found that Crimp 38 (battery positive) and Crimp 39 (door interlock loop) were detached from Spade 38 and Spade 39, respectively; with Crimp 39 (door interlock loop) now touching Spade 38 (battery positive). See Figure 14 for an illustration of the contact and Figure 15 for a photograph taken after the incident (which shows the detachment, however, Crimp 39 is no longer touching Spade 38).

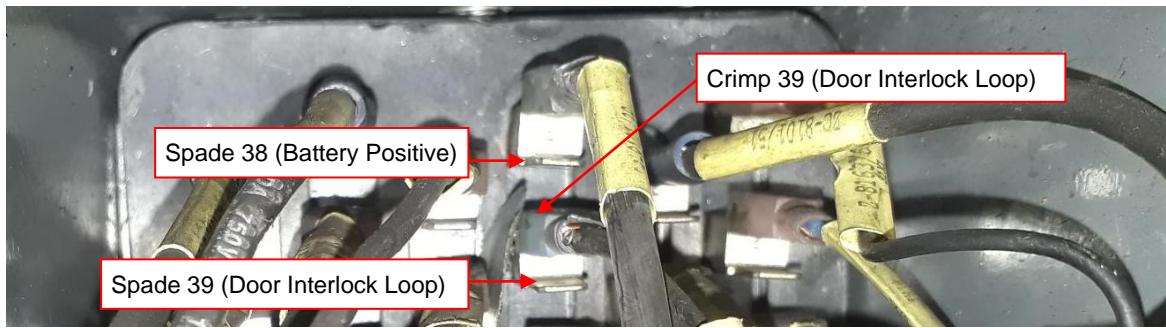
Figure 15 – Photograph taken after the incident (Crimp 39 is no longer touching Spade 38)

- 58 The contact resulted in the Door Interlock Loop (from Crimp 39) being supplied with a 24V Direct Current (DC) from the battery positive contact (from Spade 38), effectively meaning that the Door Interlock Loop circuit and the battery positive circuit became one combined circuit, see Figure 16. This resulted in the Door Interlock Loop circuit completing, when a door was opened by a passenger on the front set and the doors of the rear set remained closed.

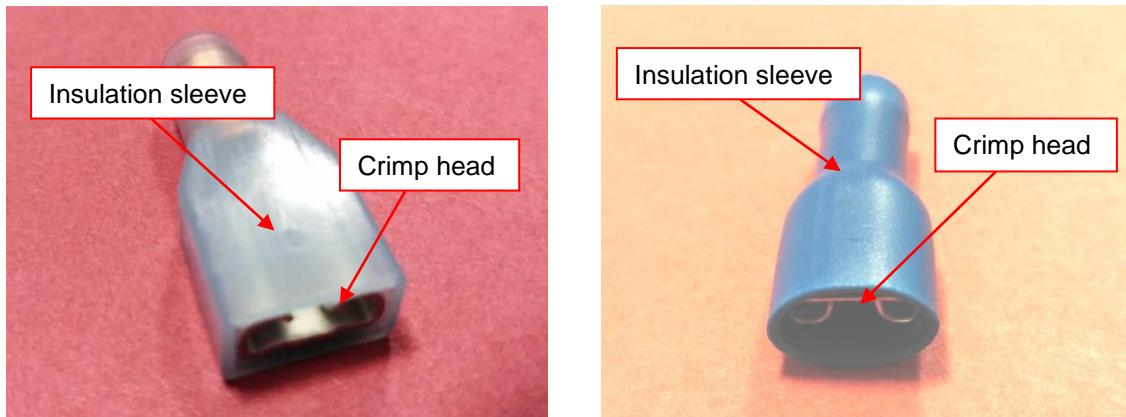
Figure 17 – Push-on Crimp Spades

59 The physical condition of the crimps and spades showed no signs of wear. When they were reconnected to the correct terminals, both were found to be a tight fit and required force to make the connections. An inspection of the crimps found that the insulation sleeve did not protrude beyond the head of the crimp (see white insulation sleeve in Figure 17); this allowed the crimp to make direct contact with the spade. Figure 17 also illustrates a crimp with a protruding sleeve (see blue insulation sleeve covering the head of the crimp).
