Railway Accident Investigation Unit

INVESTIGATION REPORT DART Wrongside Door Failure, Salthill & Monkstown Station, 10th August 2013

RAIU Report No: R2014 – 003
Report published: 30th July 2014

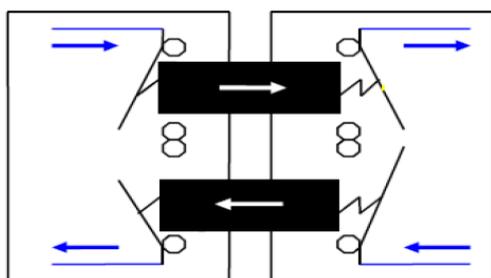
33 The CME FTS August 2012 Report includes the two diagrams below. Figure 7 shows that when the coupler heads are correctly coupled, the pins press together to open the normally closed contacts, which sends the circuit through to the next car. Figure 8 shows that when the coupler heads are uncoupled or incorrectly coupled, the pins do not press together, leaving the normally closed contacts closed; which returns the circuit signal to the leading/driving cab, omitting any connected carriages.

Figure 7 - Correctly coupled autocoupler

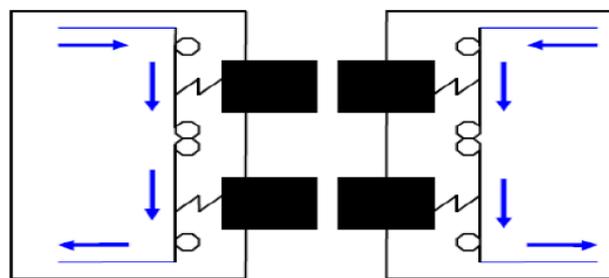
Figure 8 - Uncoupled or incorrectly coupled autocoupler

- 34 The CME FTS August 2012 Report concluded that the “reliance of normally closed spring loaded contacts to send the signal on to the remaining vehicles in the consist is seen as a weakness that could lead to similar occurrences if the autocoupler electrical heads are damaged or not coupled correctly”. This design weakness was identified by IÉ on the autocouplers for the entire EMU fleet.

- 36 Two recommendations made in the CME FTS August 2012 Report are as follows:
- A review of the door closed indication circuit with a view to a modification to remove the dependence upon the autocoupler pin spring loaded normally closed switches should be undertaken;

- Testing the integrity of Door Closed Indication Circuit should be considered for EMU trains after vehicles have been coupled.
- 37 In relation to the first of these recommendations, relating to the review of the Door Closed Indication Circuit. The CME Drawing and Design technicians commenced the review in November 2012, which requires the CME to request an Engineering Change Instruction (ECI). Due to the requirements involved in the coupler design, seven iterations of ECI were required with the finalised design being agreed and validated on the 26th March 2014 (after the incidents in August and September 2013). Between November 2012 to September 2013 (the date of the introduction of the ‘Coupler Head Integrity Test’ no other mitigations (design or operational) were introduced to prevent the re-occurrence of incidents similar to those in February, despite the risk of re-occurrence being identified in August 2012 (in the CME FTS August 2012 Report).

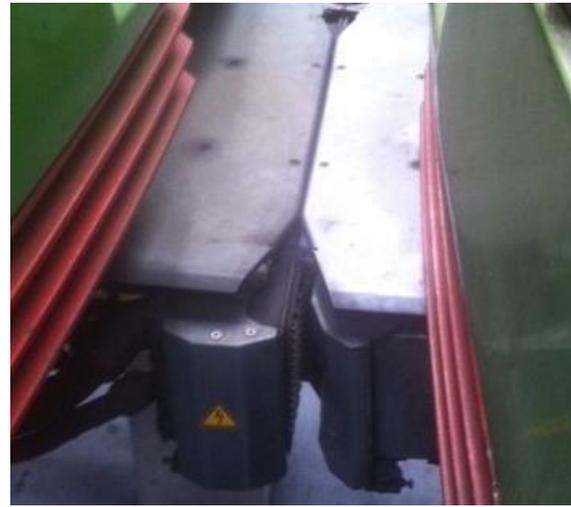
49 The autocoupler was examined when returned to Fairview depot on the 10th August 2013. One of the electrical coupler head covers was damaged (Figure 9) which prevented the electrical coupler head from moving in either direction (Figure 10); this resulted in the opposing electrical pins not connecting, resulting in the autocoupler being incorrectly coupled.

Figure 10 – Closed electrical head cover

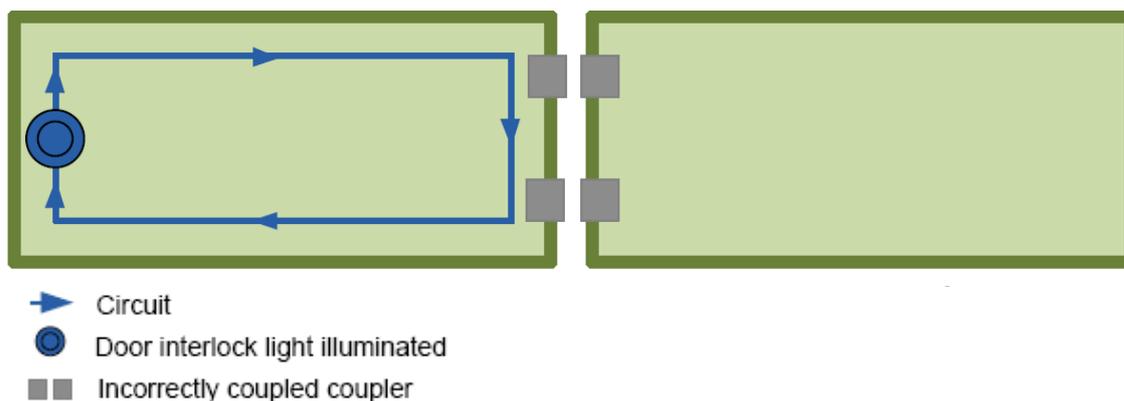
100 This omission of the circuit not passing through the incorrectly coupled units, is similar to the units not being coupled, see Figure 27.

Figure 27 – Uncoupled units, with blue Door Interlock Light illuminated
