Investigation Report 08120201

**Collision of a train with the gates of level crossing XH066,
Bridgetown, on the Limerick Junction to Rosslare Strand line**

2nd of December 2008

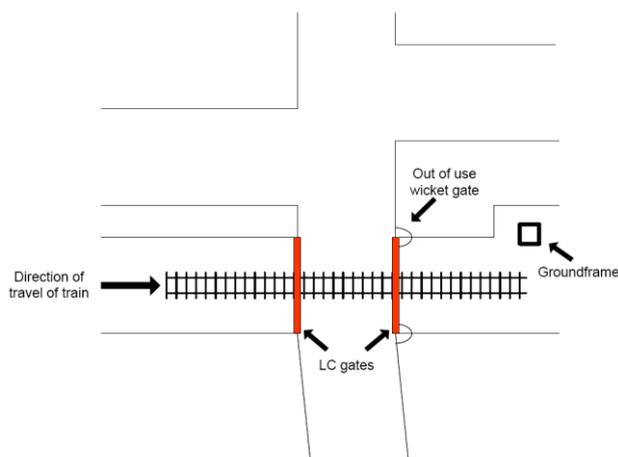
Figure 2 – Layout of XH066

The LC gates consist of two 5.18 m wide, 1.06 m high, wooden gates that pivot about gate posts. Each gate is fitted with large retro-reflective Xs on both sides. The surface of the LC is rubber Strail units to provide a level surface for road users. There are out-of-use wicket gates on the Rosslare side of the LC. See Figure 2 and Photo 1.
