Investigation Report 2010 – R005

Irregular operation of Automatic Half Barriers at Ferns Lock,
County Kildare, on the Dublin to Sligo Line,
2nd September 2009

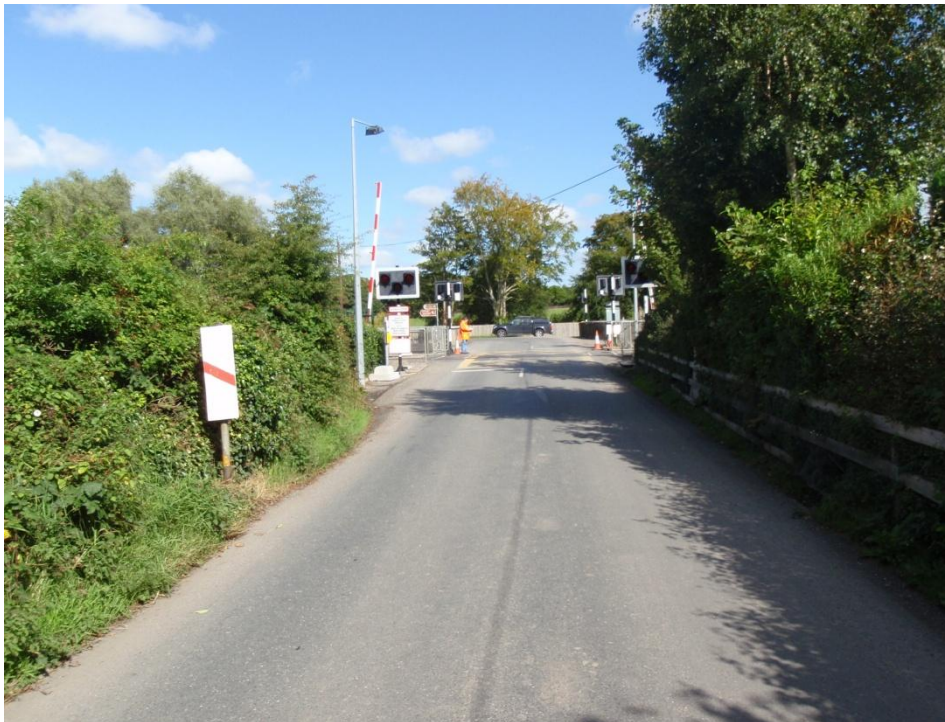
Photograph 5 – Approach to Ferns Lock AHB

The Ferns Lock level crossing is an AHB type level crossing and is situated in the townland of Ferrans, County Kildare, 20 miles and 1,660 yards from Broadstone on the Dublin to Sligo Line, see Photograph 5. The railway line runs in a south easterly direction from Enfield to Maynooth and at the crossing is a single line track with a maximum permitted line side speed of 110km/h through the section of line concerned. The public road over the crossing runs north/south between Kilcock and Rathmolyon.

At an AHB access for road users is prevented by means of two half-barriers that block the flow of road traffic approaching the crossing. The crossing is protected by a combination of road traffic light signals, audible warning devices and the physical half-barriers with road markings and signage on approach, see Photograph 5.
