Railway Accident Investigation Unit

INVESTIGATION REPORT

Fog signal activation in DART driving cab,
Bray, 6th March 2012

RAIU Report No: R2013 – 003

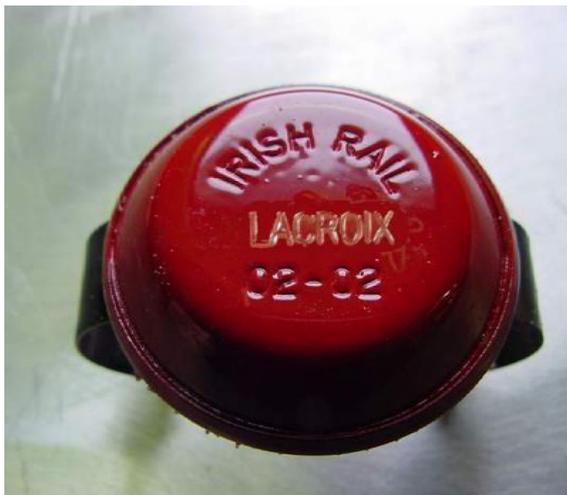
Figure 4 – Lacroix branded fog signal

31 The factory part number identification has never changed, since 1997, and IÉ routinely ordered a supply of fog signals in 2010, using factory part number IAA1007. The order was processed in the normal way by Lacroix; however, Lacroix had now purchased Alsetex and supplied IÉ with the Alsetex fog signals instead of Lacroix fog signals. Both fog signals look very similar externally, see Figure 4 and Figure 5, but have different internal design features.

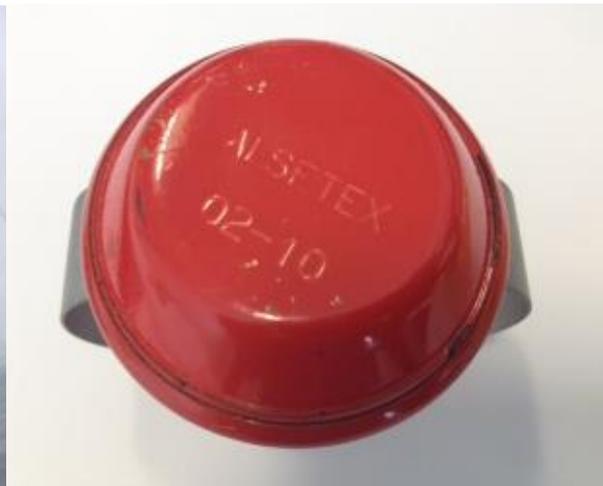
Figure 5 – Alsetex branded fog signal

During the investigation it was found that the fog signal supplier had changed the fog signals supplied to Iarnród Éireann to a less robust fog signal. Iarnród Éireann had not been notified of this change and had not noticed the difference in fog signals until after the accident.

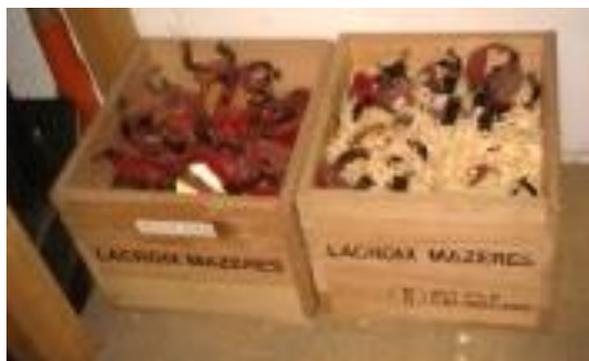
Figure 13 – Fog signal storage boxes

33 The fog signals are transported to Irish Rail Central Stores in Inchicore within a United Nations (UN) approved container designed and approved for this type of pyrotechnic which is categorised as a Class 1.4 explosive, see Figure 13. These boxes are made of wood construction and contain one hundred fog signals with sawdust chippings between the fog signals. The boxes are labelled 'Lacroix'. Central Stores is licensed by the Local Authority Fire Officer for the storage of the fog signals and all transportation from this location is done in compliance with the European Regulations for the transportation of dangerous goods by road.

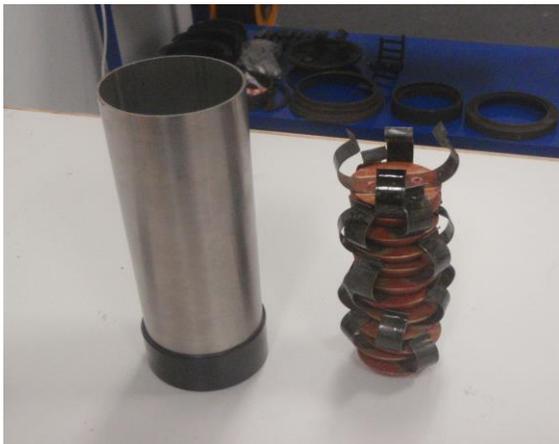
Figure 14 – Twelve stacked fog signals

- 34 The fog signals are issued to drivers directly from these boxes. When inspections identify out of date signals, they are exchanged on a one for one basis. There is no formalised procedure for the issuing of the fog signals.
- 35 The fog signals are issued to drivers in a batch of twelve. They are stored by stacking them (Figure 14) inside a purpose made stainless steel tube with removable plastic covers at either end, see Figure 15. The stainless steel tube weighs 1,478g; the twelve fog signals clipped together weigh 793g.

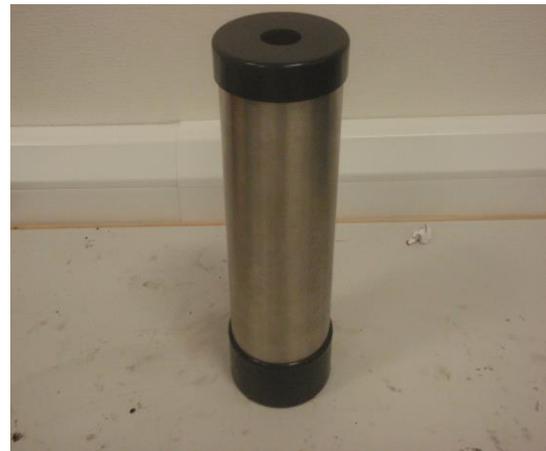
Figure 15 – Stainless steel tube with cap

- The fog signals storage tube, designed by Iarnród Éireann, allowed the fog signals to impact on one another which may have caused them to degrade over time;

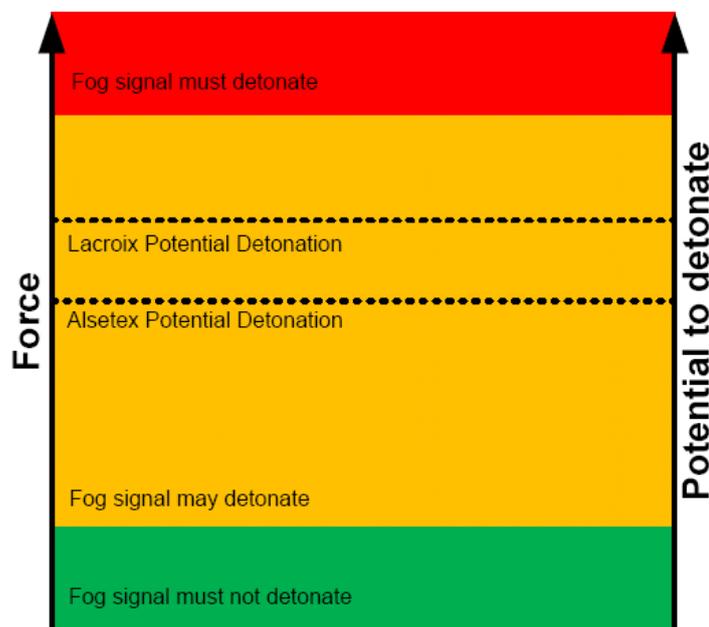
Figure 27– Alsetex and Lacroix potential to detonate

61 Reviewing the CT444 specifications (paragraph 25) for fog signals there is a large spectrum between when a fog signal must detonate and must not detonate (orange area in Figure 27). For example, a fog signal could detonate when a weight of 1 kg is dropped from a height of 4 m or when a weight of 4kg is dropped from a height of 1 m.
