**Railway Accident
Investigation Unit**

INVESTIGATION REPORT
Tram fire on approach to Busáras Luas Stop
7th November 2013

RAIU Report No: R2014 – 004
Published: 28th August 2014

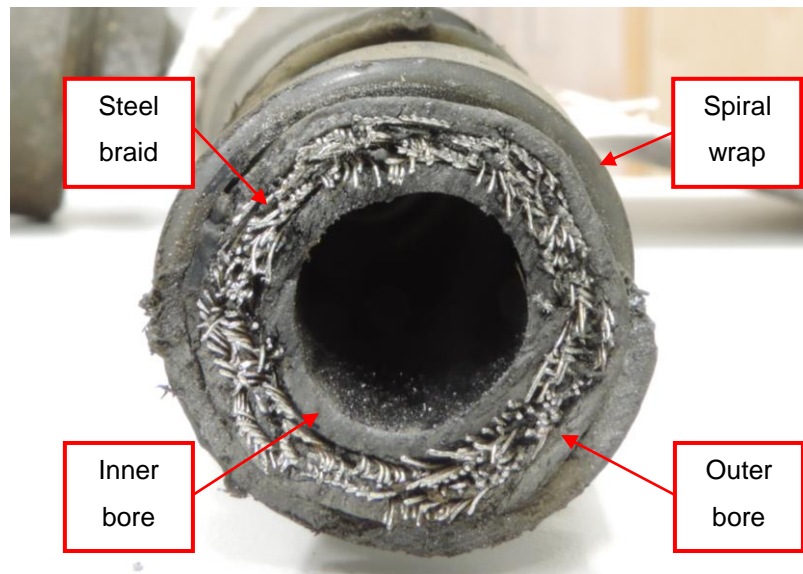
Figure 6 – Cross section of hydraulic hose

40 Each hydraulic hose is designed to comply with the European Standard EN 857 – Rubber hoses and hose assemblies - Wire braid reinforced compact type for hydraulic applications – and to have a working range up to 16 megapascal (MPa). Both hoses have an inner bore of approximately 12 millimetres (mm) diameter with an outer bore of 20.3 mm. The hoses are constructed of an inner and outer layer of rubber about 1.4 mm thick with a layer of steel braid

approximately 1.8 mm thick enclosed between them. Each hose is then surrounded in a protective spiral wrap around 2 mm thick (Figure 6).

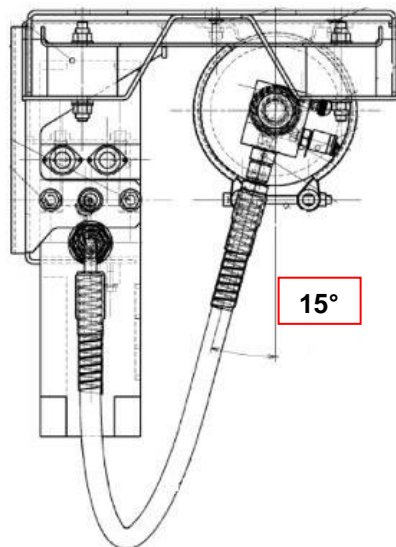
Figure 7 – Design for arrangement for Hose 1 in MIC (view from centreline of bogie).

- 41 Hose 1 and 2 are designed to be approximately 0.785 m and 1.275 m in length respectively. Both Hose 1 and Hose 2 were within the required specification with regards to length.
- 42 Figure 7 is taken from the original design drawings for the area where the fire was observed to have occurred. It can be seen that Hose 1 is installed at a 15° offset to the vertical. This orientates the hydraulic hose away from the traction cables.

- 43 Separation of powered systems is a requirements of GDRIRS section 6.4.1.4 which states: “Flexible connections, air lines, control cables etc. should be positioned to avoid mechanical damage during normal and adverse train movements, the action of brake block sparks and other accidental damage during train running”.
- 44 In the NRSA submission by the RPA this item was addressed by the statement that “flexible connections are positioned to avoid mechanical damage”.
- 45 At the time of the accident the hazard log for the 401 fleet identified the following undesirable events:
- Abnormal heating of oil;
 - Discharge of oil on rails.

These events were mitigated by separation from the brake discs and the maintenance and inspection of proven fittings, respectively. The 401 fleet hazard log did not identify the risk associated with the interaction between the braking hoses and traction cables and the resultant hazards, for example a flash fire.

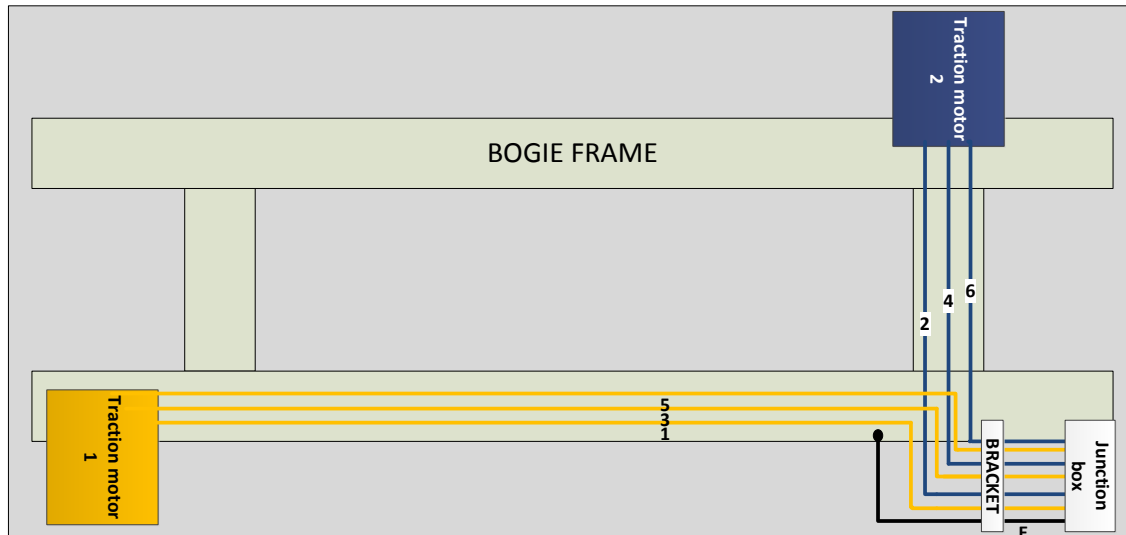
Figure 15 – Illustration of the traction cable network

63 The traction cable network consists of seven cables. One of these cables is a larger diameter earth cable (E). The others are separated into two groups and are used to power the two traction motors positioned on the MIC bogie. Three of the cables (Cables 2,4 and 6) are approximately 2.25m in length and connected to the traction motor on the opposite side of the tram and the other three (Cables 1,3 and 5) are longer (approximately 4.62m in length) and are used to power the traction motor on the same side of the tram (Figure 15).

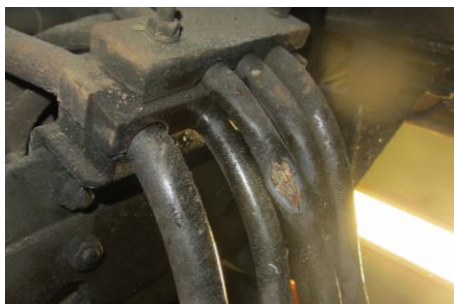
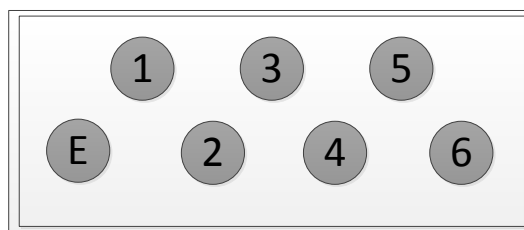
Figure 16 – Cable holding bracket Figure 17 – Cable arrangement in holding bracket

65 In the area where the fire originated the traction cables leave a junction box and pass through a bracket where they are held as shown in Figure 16 and 17.

66 The design of the MIC bogie prescribes the free lengths of the traction cables between the junction box and the bracket. A comparison of the designed lengths and measured lengths post accident identified that six out of the seven cables were installed with a free length in excess of the design. This included Cable 1 which had a free length of 475mm instead of the designed 400mm. There were no installation tolerances for the free length measurements stated on the design drawings.

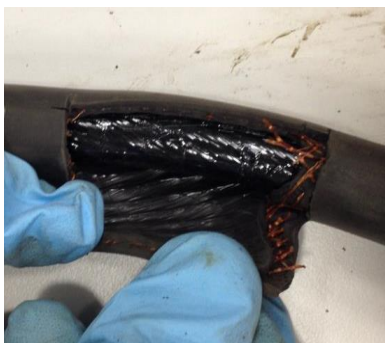
Figure 18 – Z series cable from original build

68 The cables originally installed on the 401 Type Tram were Z series and are shown in Figure 18. This shows that the insulation surrounding the cable core contained a braid in the insulation rubber. NF-F 63-826 does not state that the installation of a braid is required.

69 Two types of cable were installed on Tram 3002 both of which had insulation that differed from that shown in Figure 18. Cables 2,4,5 and 6 were manufactured in either 2006 or 2007 by a different manufacturer and contained a protective sheath and silicone rubber insulation as shown in Figure 19. Cables 1 and 3 were manufactured in 2010 by the same company as the original cables but were a Y series cable. The copper core of this cable which is surrounded by a polyester tape and insulated by approximately 3.2 mm of silicone rubber shown in Figure 20.
