**Railway Accident
Investigation Unit
Ireland**

INVESTIGATION REPORT

**Passenger trap-and-drag occurrence on Luas tram
at Heuston Stop,**

26th March 2019

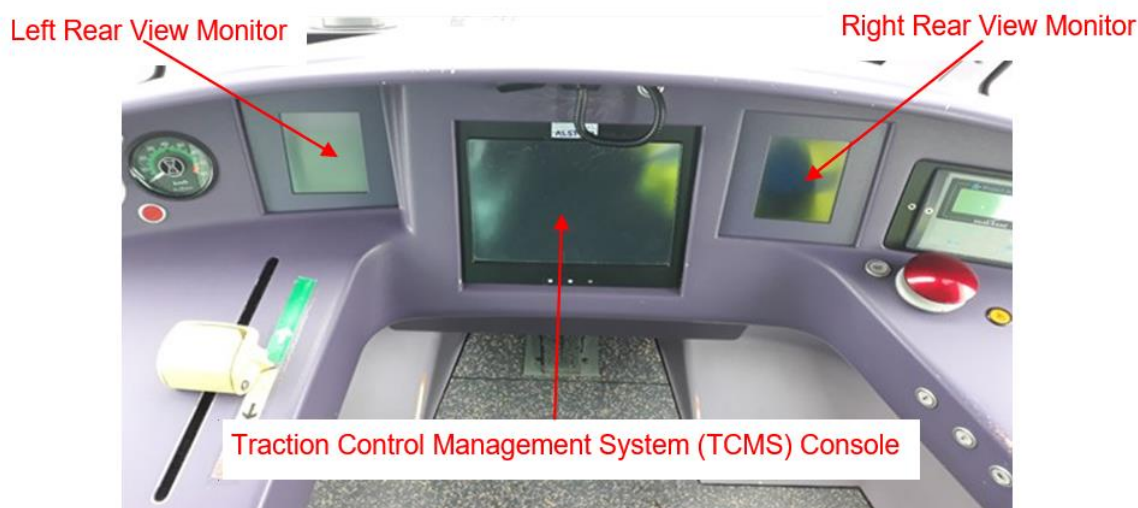
Figure 4 – Rear View Monitors & TCMS Console

- 43 When a door is open the Door Indicator Light on the driver's console is illuminated and the internal amber lights above the door flash. The driver can view the platform side from the Left and Right Rear View Monitors on the driver's console; the image on the Rear View Monitors on the Red Line are black-and-white whereas the images on the newer fleets on the Green Line are full colour and give a clearer picture.

- Safety Recommendation 2020001-03 – TII should conduct a risk-based review on whether the tram fleet operating on the Red Line should be upgraded with coloured rear view monitors;

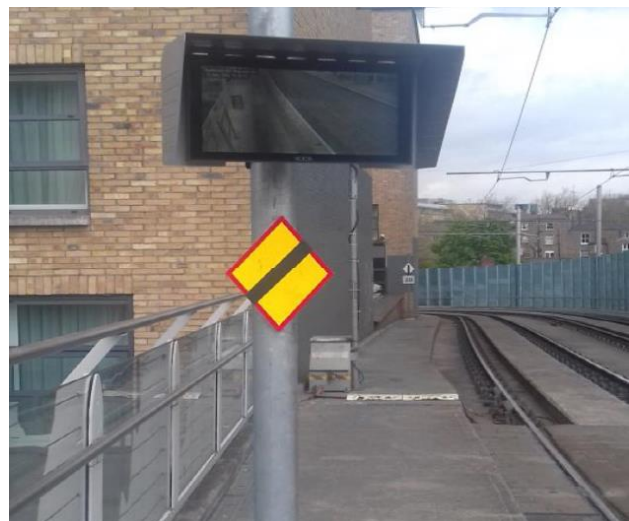
Figure 9 – Charlemont CCTV Monitor

54 A close up of the mirror at Heuston Stop (Figure 8) shows that the signal pole is obstructing some of the driver's view. By way of comparison in relation to platform viewing, the inbound platform at Charlemont Stop on the Green Line is fitted with a colour CCTV monitor to assist tram drivers looking at the platform and doors (Figure 9); it should be noted however, this has been installed primarily as a result of the curvature of the line.

118 CCTV monitor on the Charlemont inbound platform gives a clear image of the platform and tram (paragraph 54, Figure 9).

- Safety Recommendation 2020001-02 – Transport Infrastructure Ireland (TII) should conduct a risk-based review on whether CCTV platform monitors should be installed at high-use tram stops;

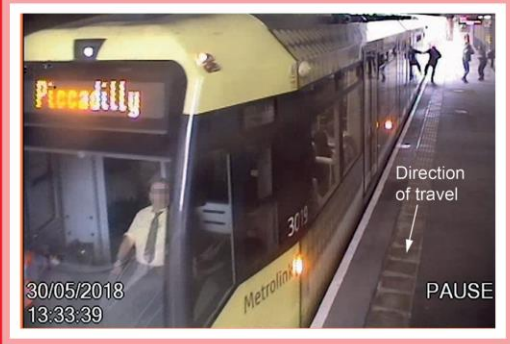
Figure 10 – Safety Alert for Tram Drivers in relation to passenger doors

73 After an incident in Greater Manchester (UK), in May 2018, where a passenger was trapped in a door, the Safety Department issued a Safety Alert (Figure 10) soon afterwards.

- The importance of tram drivers not relying on tram doors closed and locked indications (interlock system) as an assurance that nothing is trapped in the doors
- The need for managers to provide comprehensive and consistent safety messages to their staff in response to safety incidents

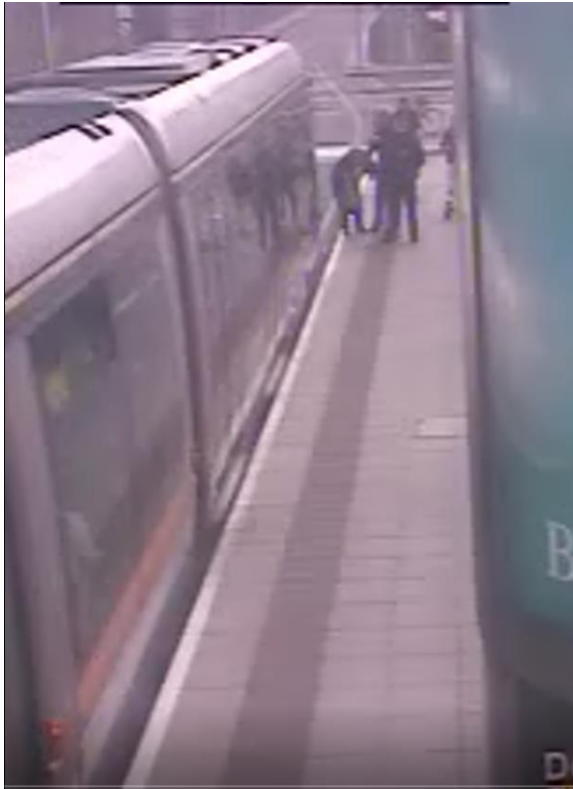
Figure 17 – Passenger’s hand is freed

84 At 14:21:51 the STT staff are successful in freeing the passengers trapped fingers.

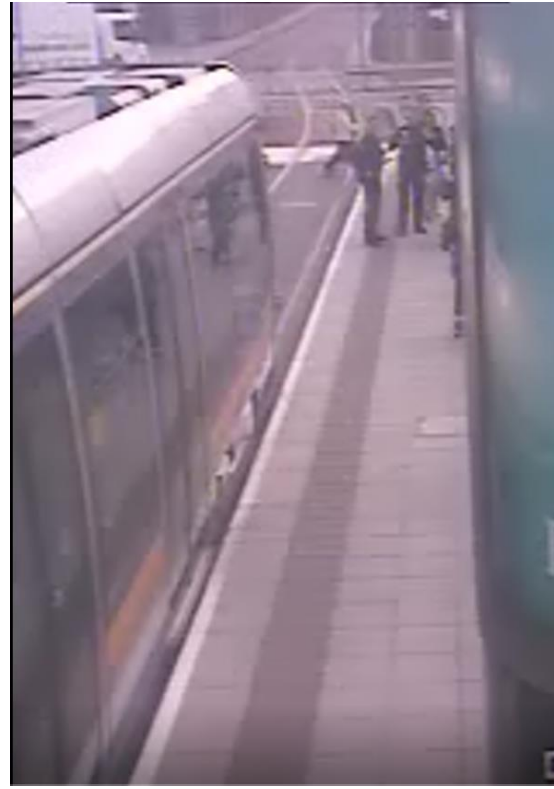
Figure 18 – Tram stops

85 A jogger passing near the front of the tram shouts at the Driver to stop his tram.

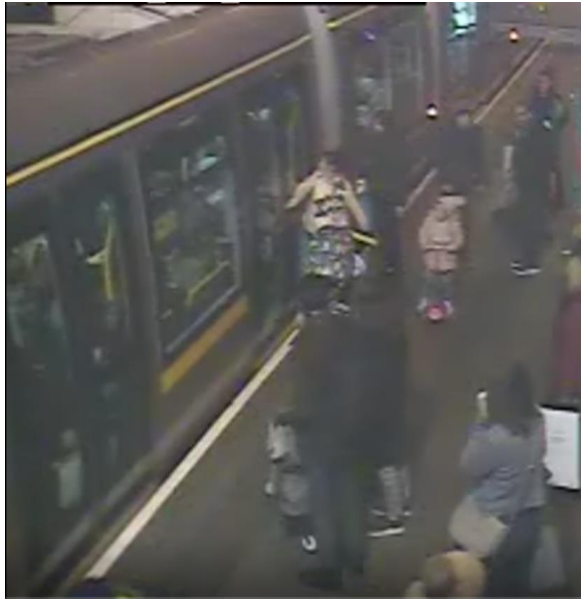
Figure 21 – Tram begins to depart with hand trapped in doors

106 At the same time the driver viewed the door open indicator lamp had extinguished on the driver's console and the TCMS Console showed all passenger doors were closed and locked. The driver sent an RTS command. The driver checked his rear-view monitors (he did not see the passenger with her hand trapped) and checked the pedestrian crossing in front of the tram; before he commenced his departure from Jervis Stop (five seconds after the passenger first got her hand trapped) with the passenger's hand remaining trapped in the door (Figure 21). The driver was unaware that the passenger's hand is trapped.

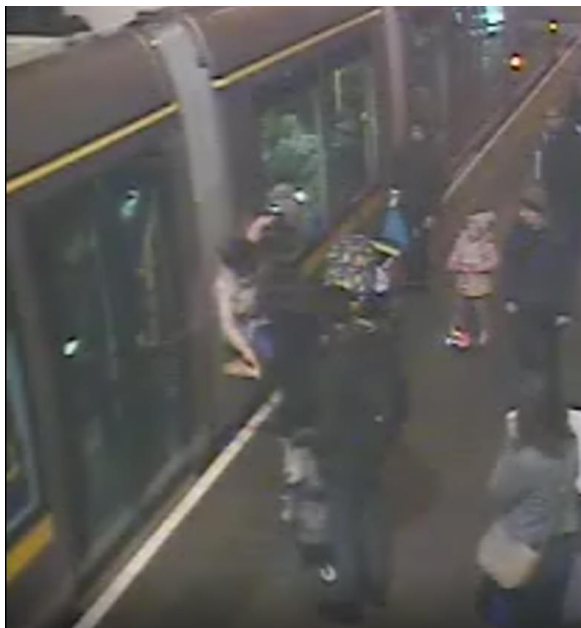
Figure 23 – Passenger frees hand and begins to fall onto the platform

107 The woman is dragged along the platform (see Figure 22), begins to fall (see Figure 23), frees her hand and fall onto the platform (still Figure 24, which is a still of the CCTV taken three seconds after the tram begins its departure for Jervis Stop).

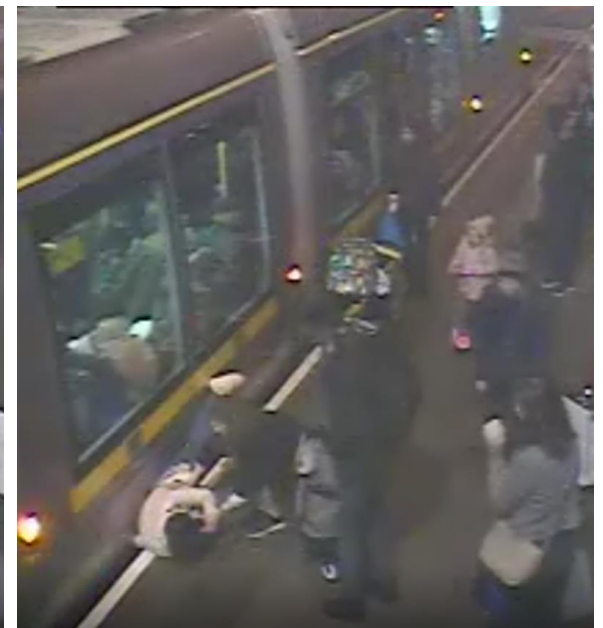
Figure 24 – Passenger falls onto the platform

108 Security staff, present at Jervis Stop, attended to the passenger and accompanied her on another tram to her destination; she did not request medical attention and was uninjured.
