Investigation Report R2010-003

Derailment of an on track machine at Limerick Junction Station

on the Dublin to Cork Line

3rd of July 2009

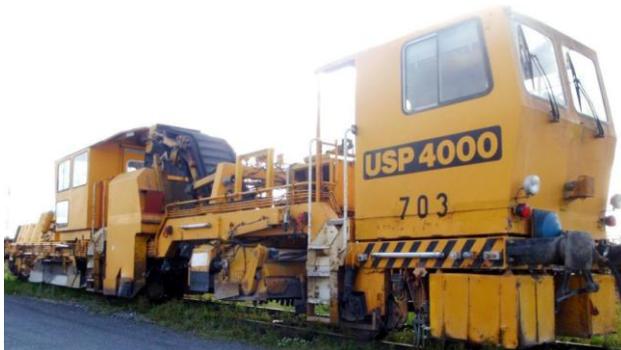
Photo 5 – Unit 703

Unit 703 is a USP-400 *ballast regulator* manufactured by Plasser and Theurer in 1994, see photo 5. It has a mass of 35,430 kilograms (kg) and is 21.52 metres (m) long. There is a driving cab at each end of unit 703 with the driving position situated on the right hand side. There is a mobile radio unit on the vehicle. Unit 703 has three wheelsets, two of which are powered. The wheelset that derailed is not powered. There is no event recorder fitted to unit 703.

The 24 weekly and annual inspections include checking the wheel profile. The wheel profile inspections were found not to have been carried out. The maintenance instructions did not clearly state that measurement of the profiles was required, the IÉ staff responsible for the maintenance of the OTMs were not trained to measure the wheel profiles. The records of the last inspection, which was completed on the 25th of June 2009, indicated that only a visual inspection of the wheel profiles was carried out as part of the maintenance. Full PM4 inspections were completed on the 25th of February 2009, the 17th of November 2008 and the 22nd of February 2008, the checklists for these inspections have no entry against the checking of the wheel profiles indicating that they were not carried out. The wheels on unit 703 were last re-profiled on the 13th and 14th of January 2003.

No defined wheel profile was available for the Regulator. General minimum acceptable limits for *flange* dimensions⁶ have been set by IÉ for any wheel profile used on the network, beyond these limits the wheel must either be re-profiled or scrapped, see table 3. The wheel profiles for the wheelsets on unit 703 were checked following the derailment. The leading wheelset was found not to meet the minimum acceptable limits for wheel profiles on the IÉ network, see table 3.

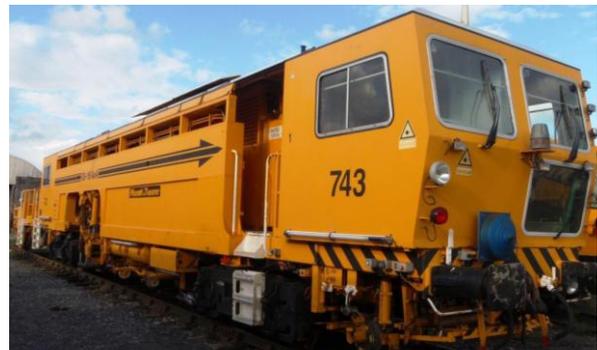
Photo 6 – Unit 743

Unit 743 is a *tamping machine* manufactured by Plasser and Theurer in 1999, see photo 6. It has a mass of 62,040 kg and is 24.1 m long. There are two driving cabs, for travel in either direction. Unit 743 has five wheelsets, two of which are powered. There is no event recorder fitted to unit 743.
