**Investigation Report 2011-R003**

**Tram derailment at The Point Stop, Luas Red Line**

**13<sup>th</sup> May 2010**

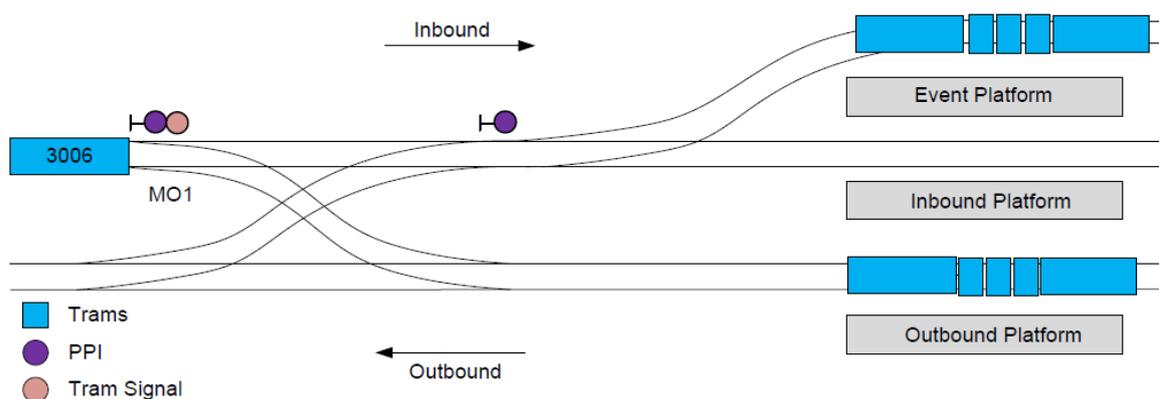
Figure 2 – Layout at The Point Stop, showing trams stabled at the Event and Outbound Platforms

At approximately 22:10 Tram 3006 approached the Point Stop, stopping at points MO1, which is signalled by a *Points Position Indicator (PPI)* and a *Tram Signal*, see Figure 2. At this time two trams were stabled in the Outbound Platform and Event Platform, see Figure 2. (It should be noted that this was the first time that the Tram Driver had encountered this situation).

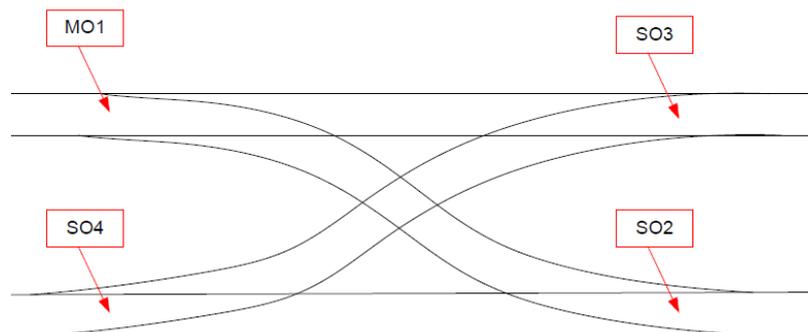
Figure 5 – Scissor Crossover

A scissor crossover leads towards the Inbound and Outbound Platforms, see Figure 2. The *facing points* (MO1 in the inbound direction and SO3 in the outbound direction) at the approach to the scissor crossover, see Figure 5. MO1 are motorised points actuated by the tram driver, who selects the required platform.

The points exiting the scissor crossover in the inbound direction are *spring points*, SO3 and SO2, which allow a tram to move through the crossover resetting to their original position once the tram has passed.

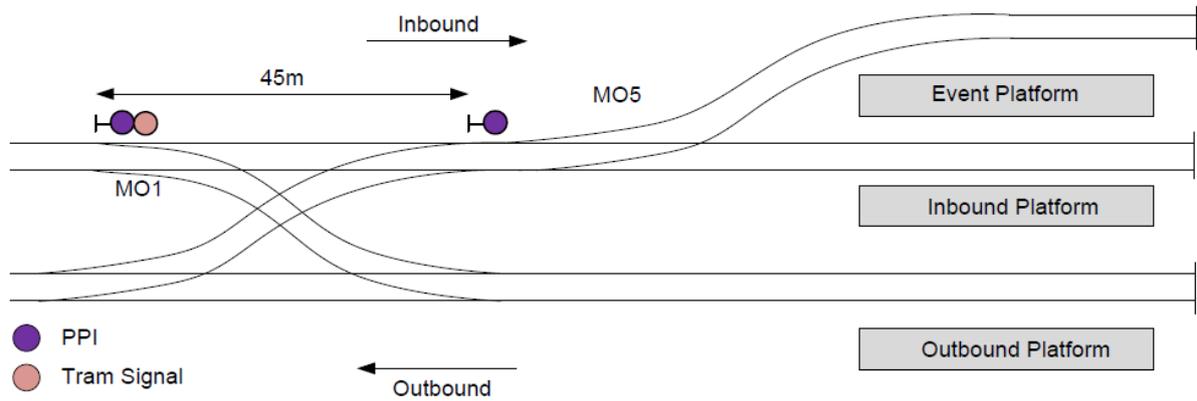
Figure 9 – Layout of tram signals and PPIs in relation to MO1 and MO5

At 45 m beyond this tram signal and PPI, there is another PPI located at facing points MO5 for the Event Platform, see Photograph 2 and Figure 9. This provides information to tram drivers in relation to the direction that the points are set i.e. Inbound Platform or Event Platform. The tram driver can then change the direction of the points, as necessary.
